# Diagnosis report of 2021 PEUGEOT 3008 Active

# Preparation and repair report of 2021 PEUGEOT 3008 Active

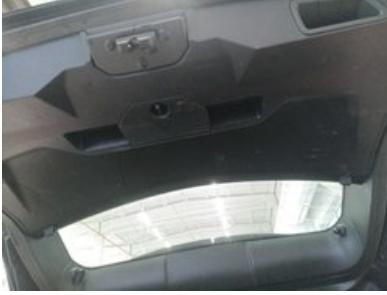
✓ **1. Inside:** Trims - Condition

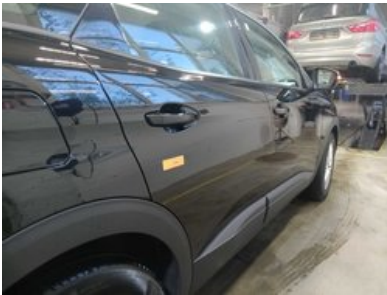
✓ **1. Side:** Left and Right Side - Visual Damage and Scratches

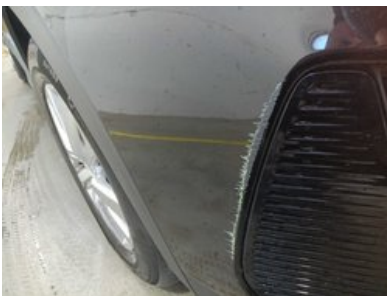
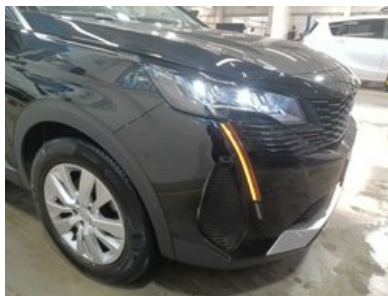
✓ **2. Front:** Front Bumper - Condition and Alignment
