# Diagnosis report of 2018 NISSAN JUKE Acenta

During the comprehensive diagnosis conducted by Longo, 7 issues were identified in the vehicle.

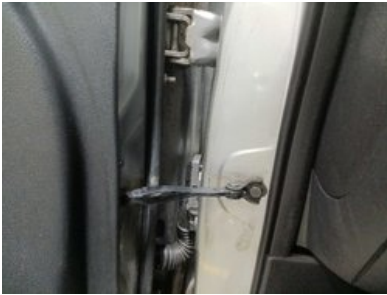
✓ **2. Doors:** All Four Doors - Opening, Closing, and Handle Operation

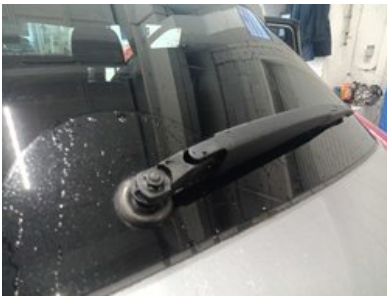
✓ **3. Front:** Window Wiper Rubber and Handle (Front and Rear) - Condition

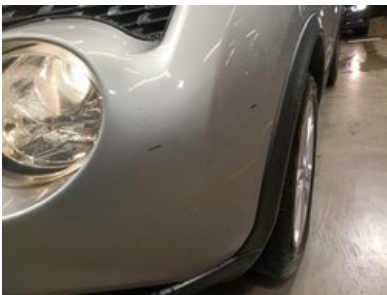
✓ **1. Front:** Front Bumper - Condition and Alignment

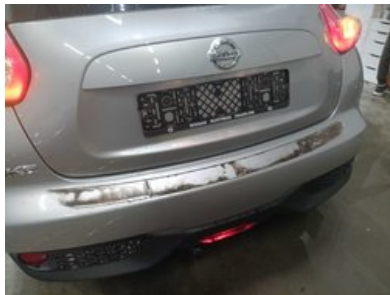
✓ **2. Other:** Additional Polishing Tasks

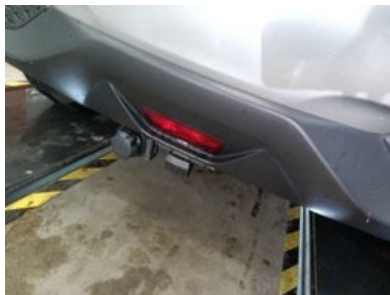
✓ **3. Rear:** Tow Hitch (Attachment, Removal Mechanism, External Light Connector, Connector Thickness)
