# Diagnosis report of 2017 TOYOTA AURIS Executive

Color: Blue	CO <sub>2</sub> NEDC Emission: 82 g/km
Fuel type: Petrol / Hybrid	
Body type: Hatchback	Gross Vehicle Weight (GVW): 1840 kg
Number of doors: 5	Engine size: 1.80 l
Number of seats: 5	Cylinders: 4
Mileage: 241 889 km	Power: 100 kw
VIN Code: SB1MS3JE30E290152	Fuel consumption: 3.60 l/100km
Gearbox: Automatic	Tire size: 205/55 - 16"
Drive type: Front-Wheel Drive	Longo Stock ID: N434755
Longo Certified

## Summary of diagnosed issues

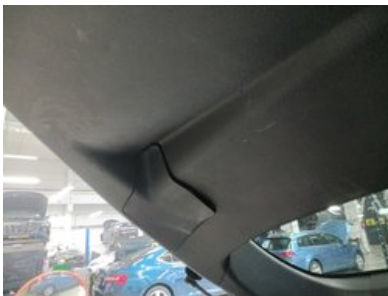
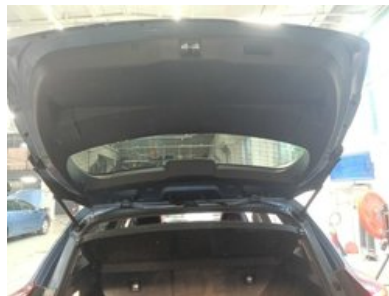
- ✔ **1. Inside:** Trims - Condition

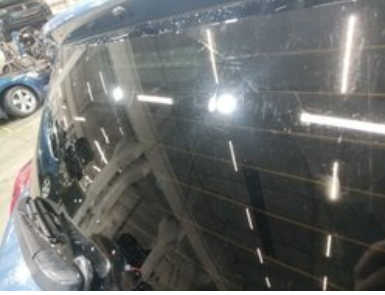
### ✓ 1. Rear: Rear Window Integrity

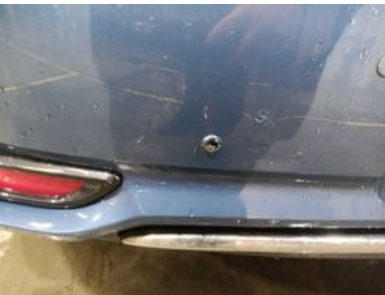
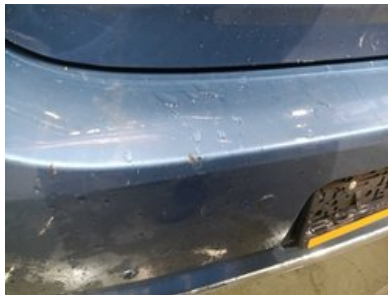
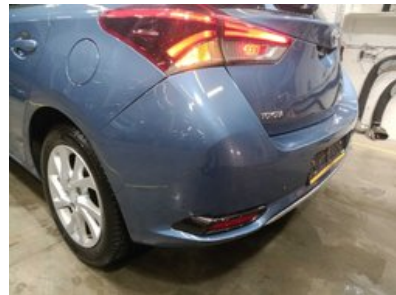
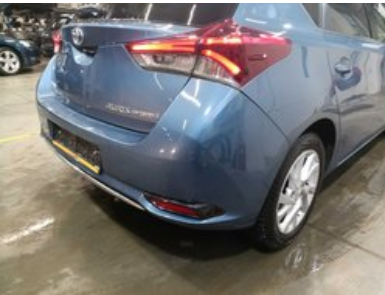
### ✓ 2. Rear: Rear Bumper - Condition and Alignment

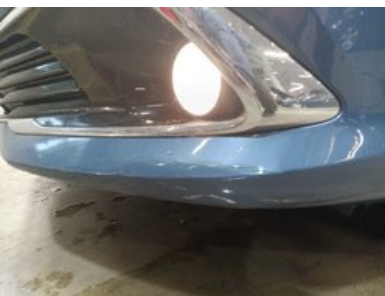
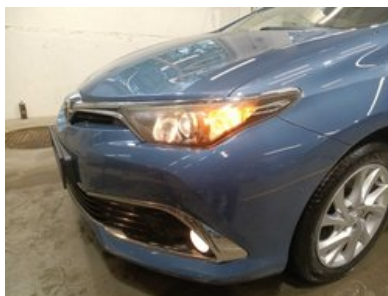
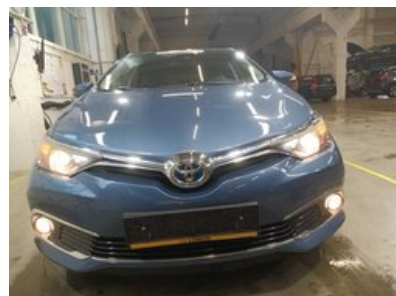
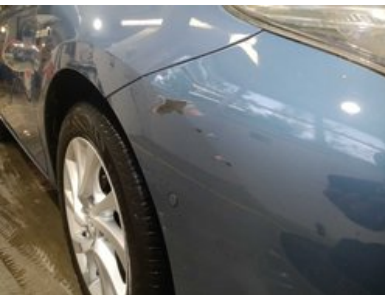
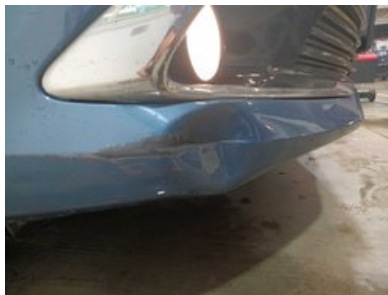
### ✓ 3. Front: Front Bumper - Condition and Alignment

- ✓ 1. Paint Front Bumper

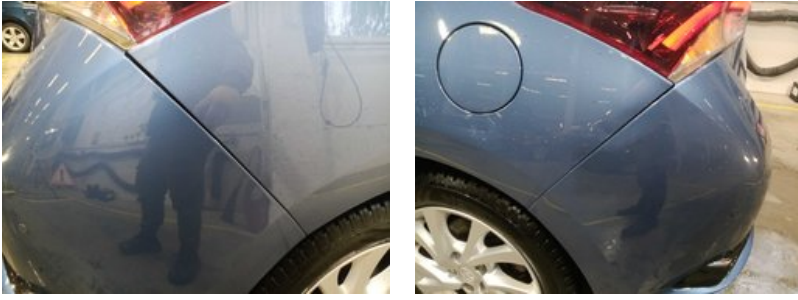
✔ **4. Side:** Body Panel Geometry

- ✓ 1. Correct Body Panel Geometry

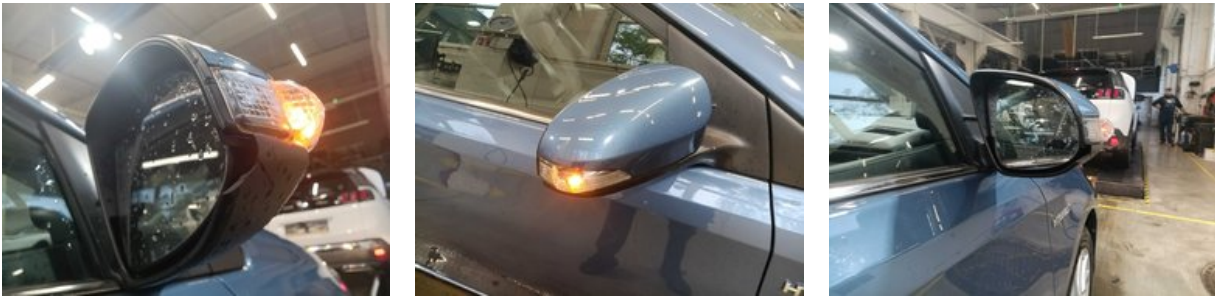
✔ **5. Side:** Exterior Mirrors - Mirror Integrity and Car Attachment

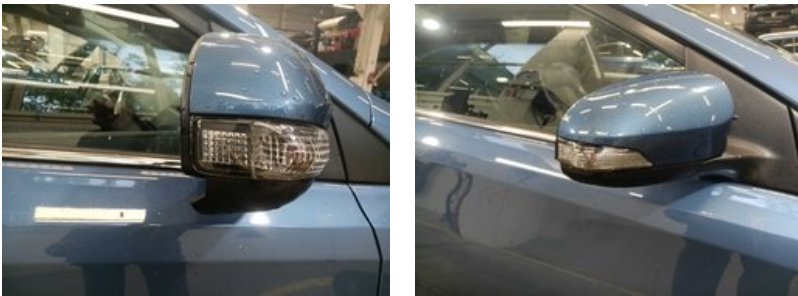
✔ **6. Lights:** Car Side Lights - Basic Functioning, Damage, and Color
