# Diagnosis report of 2015 TOYOTA AURIS Aspiration

# Preparation and repair report of 2015 TOYOTA AURIS Aspiration

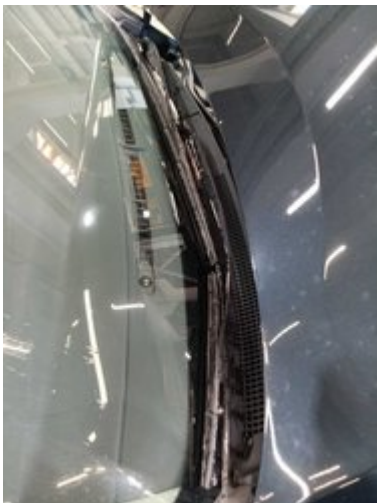
- ✔ **1. Front:** Window Wiper Rubber and Handle (Front and Rear) - Condition

- ✓ 1. Change Front Wiper (Mechanical)
- ✓ 2. Charge Battery
- ✓ 3. Engine Oil & Filter Change

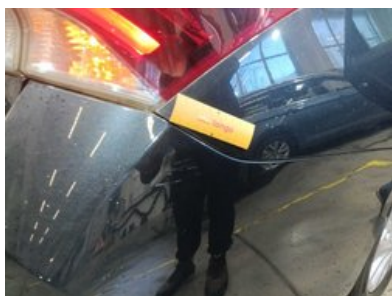
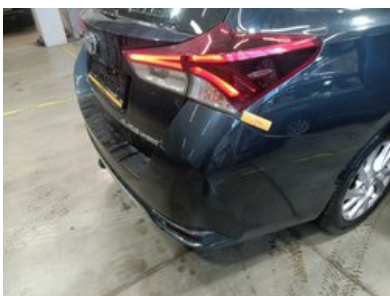
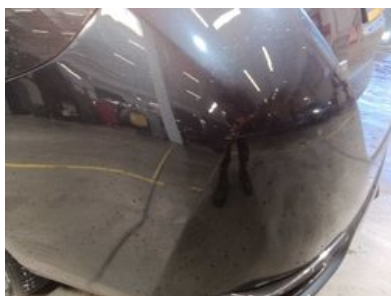
✔ **1. Rear:** Rear Bumper - Condition and Alignment

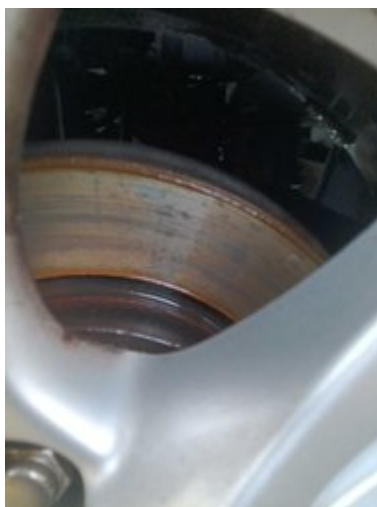
✔ **3. BRAKES:** Rear Brake Disc (Both)
