# Diagnosis report of 2014 KIA CARENS ComfortLine

During the comprehensive diagnosis conducted by Longo, 11 issues were identified in the vehicle.

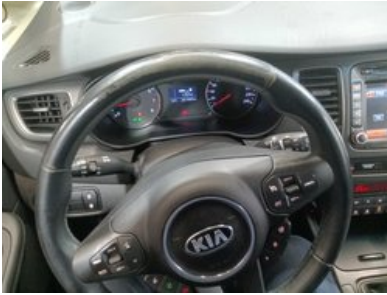
### ✓ 1. Front: Steering Wheel - Condition

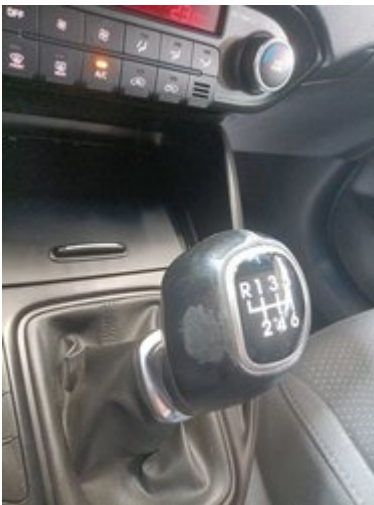
### ✓ 2. Inside: Gear Shift Boot and Gear Shift Knob - Condition

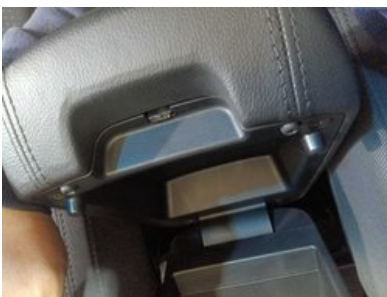
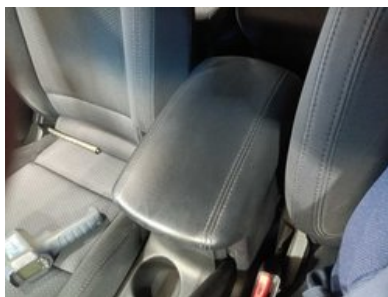
### ✓ 3. Inside: Armrest - Operation and Condition
