# Diagnosis report of 2016 PEUGEOT 2008 GT-line

## Diagnosis details

## Summary of diagnosed issues

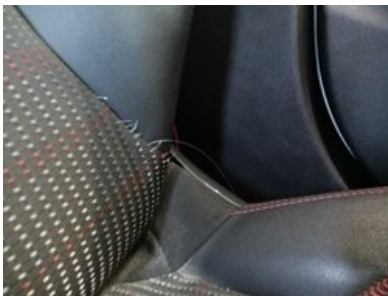
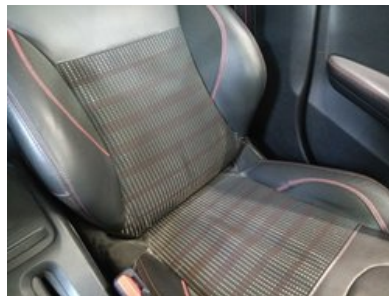
- ✔ **1. Seats:** All Seats - Condition

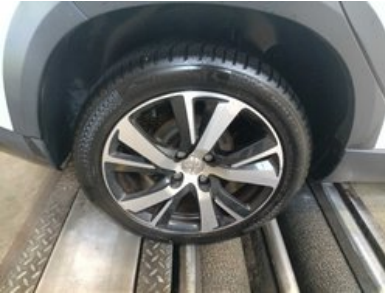
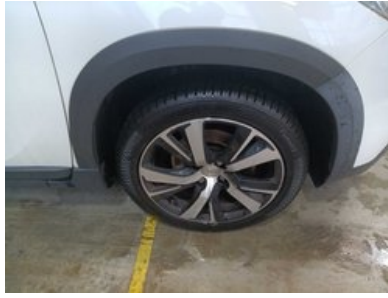
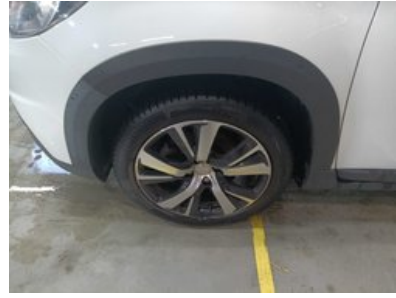
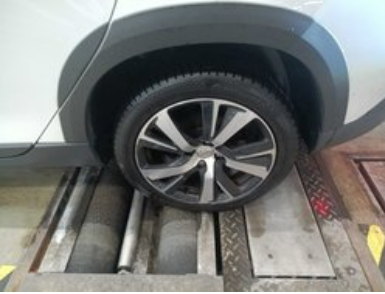
### ✓ 1. Side: Wheels - Condition

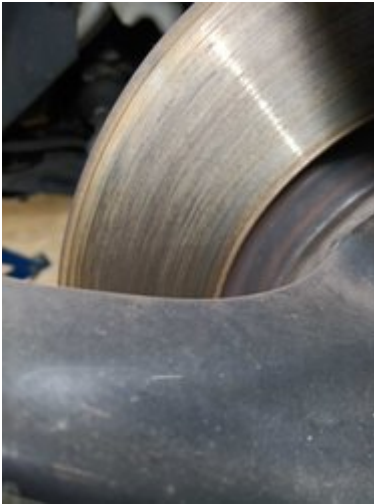
✓ **3. OTHER:** Front Brake Discs with Pads

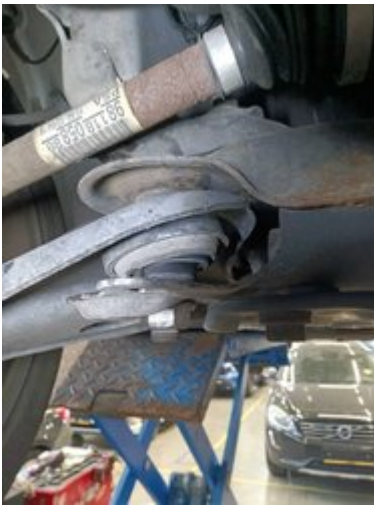
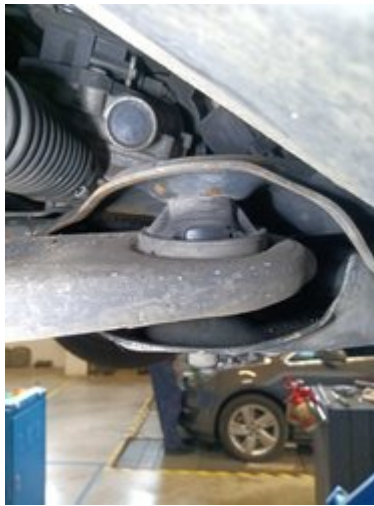
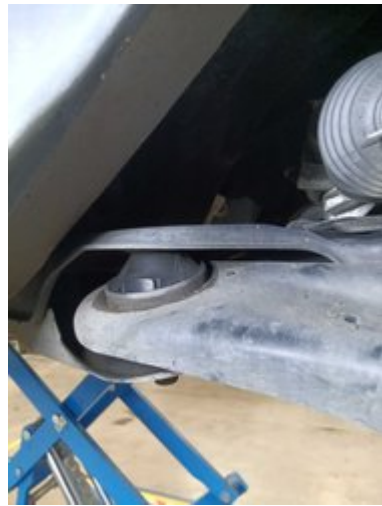
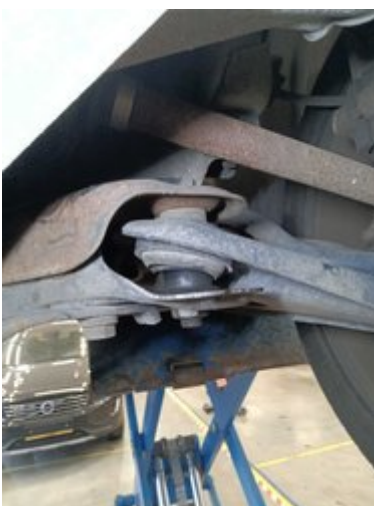
✓ **4. OTHER:** Suspension Lower Arm

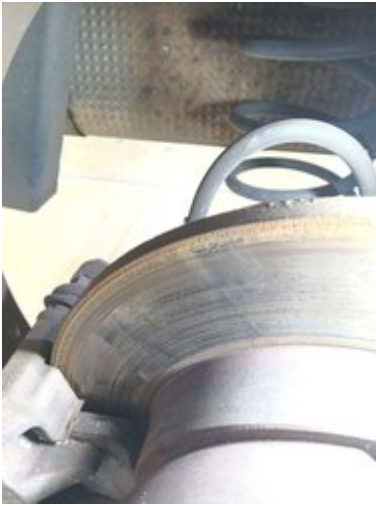
✓ **5. OTHER: Rear Brake Discs With Brake Pads**
