# Diagnosis report of 2015 TOYOTA AURIS Executive

# Preparation and repair report of 2015 TOYOTA AURIS Executive

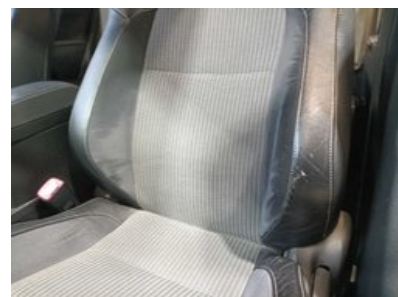
- ✔ 1. Seats: All Seats - Condition

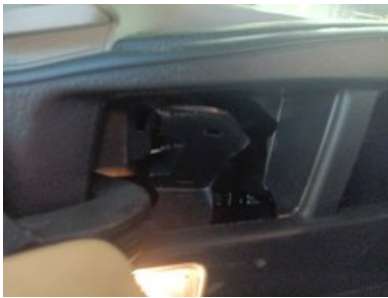
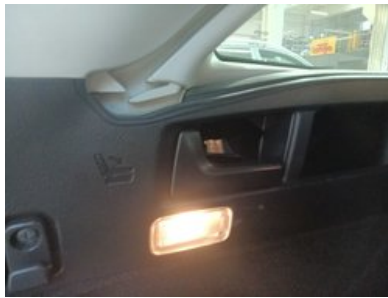
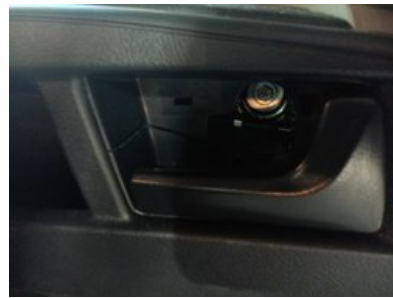
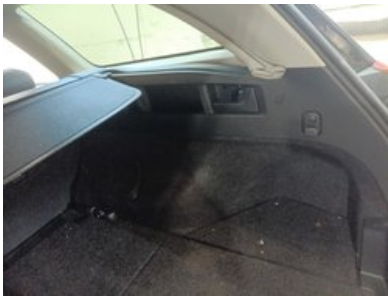
✓ **2. Seats:** Seat Adjustment Mechanisms - Functioning

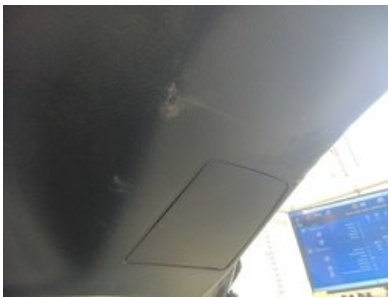
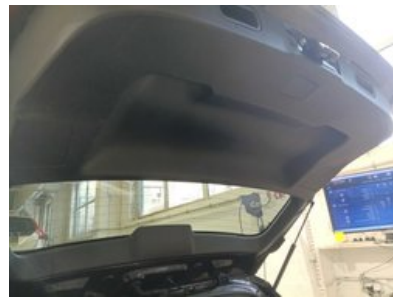
✓ **3. Inside:** Trims - Condition

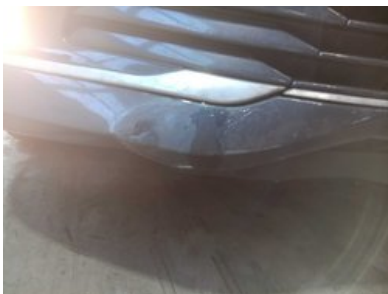
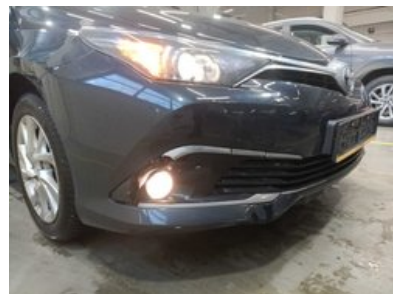
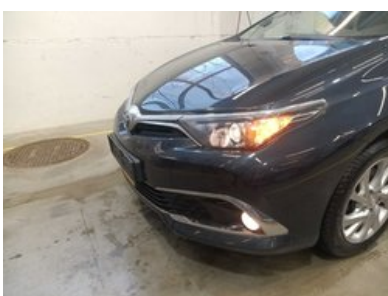
✓ **1. Front:** Front Bumper - Condition and Alignment

- ✓ 1. Other: Trim Around Right Fog Light with Chrome

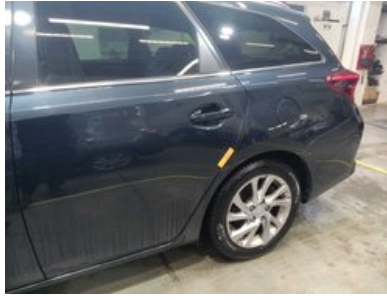
✓ **2. Side:** Left and Right Side - Visual Damage and Scratches

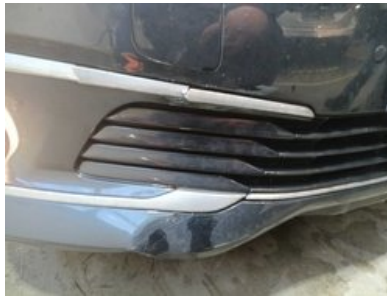
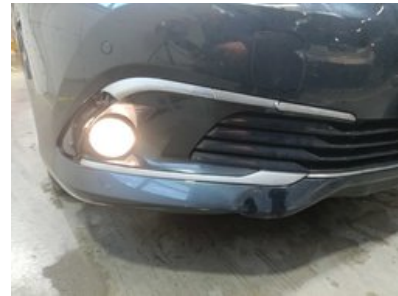
✓ **3. Other:** Audible Signs (Loose Parts, Rattling, Etc.)

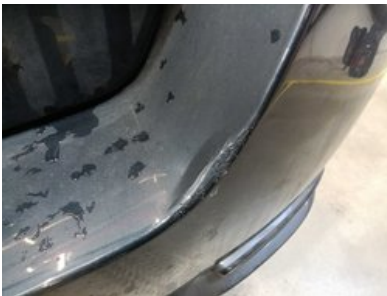
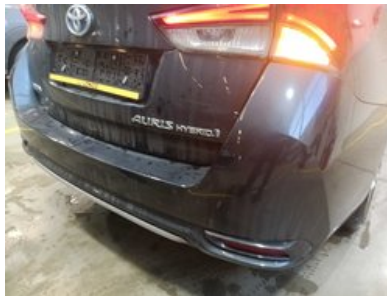
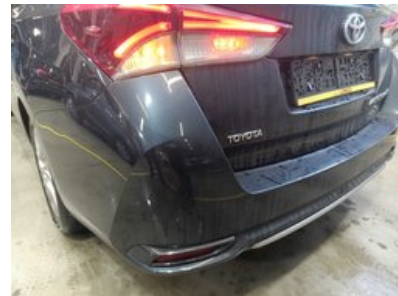
✓ **4. Rear:** Rear Bumper - Condition and Alignment

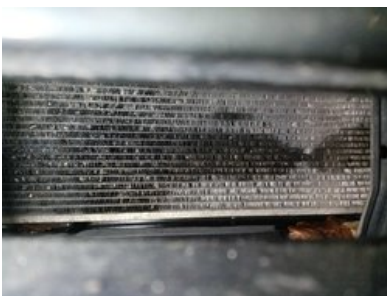
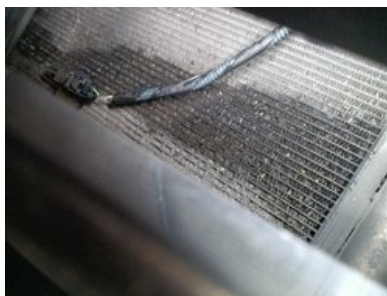
✓ **4. AIR CONDITIONING AND HEATING:** Condenser

- ✓ 1. Condenser
- ✓ 2. Engine Oil & Filter Change
- ✓ 3. Charge Battery
- ✓ 4. System Evacuation/Recharging
