# Diagnosis report of 2021 PEUGEOT 3008 Allure

# Preparation and repair report of 2021 PEUGEOT 3008 Allure

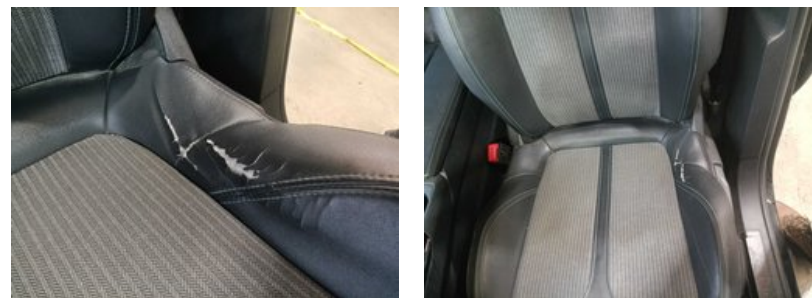
- ✔ 1. Seats: All Seats - Condition

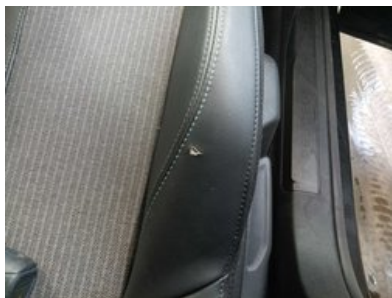
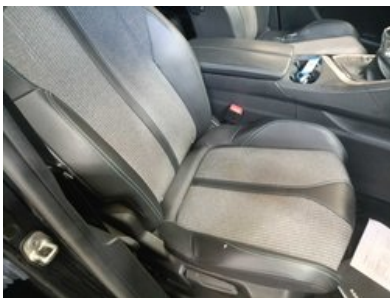
✓ **2. Seats:** All Seats - Condition

- ✓ 1. Change Rear Wiper Arm
- ✓ 2. Sew Front Seat

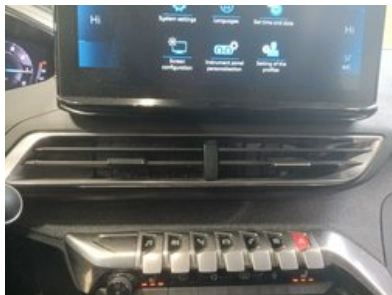
✓ **3. Front:** Trims - Condition

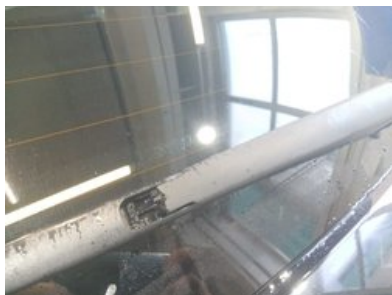
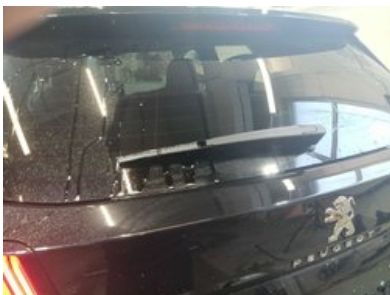
✓ **4. Front:** Window Wiper Rubber and Handle (Front and Rear) - Condition

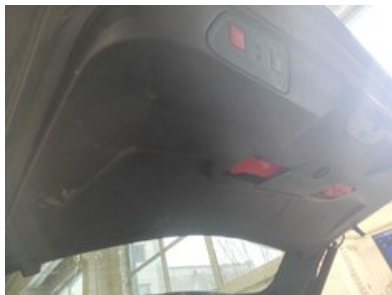
✓ **5. Inside:** Trims - Condition

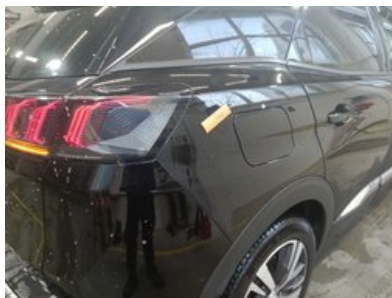
### ✓ 1. Side: Left and Right Side - Visual Damage and Scratches

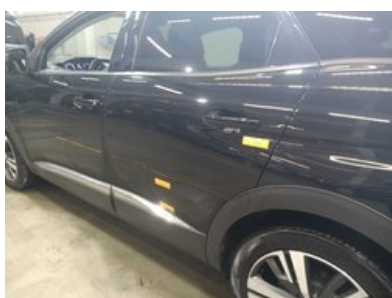
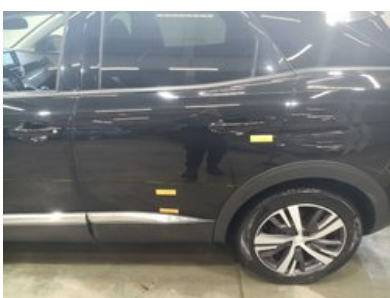
### ✓ 2. Side: Left and Right Side - Visual Damage and Scratches

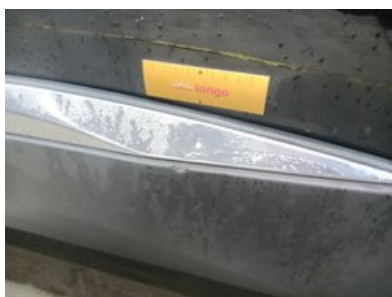
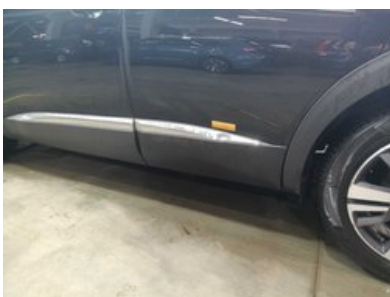
### ✓ 3. Side: Left and Right Side - Visual Damage and Scratches

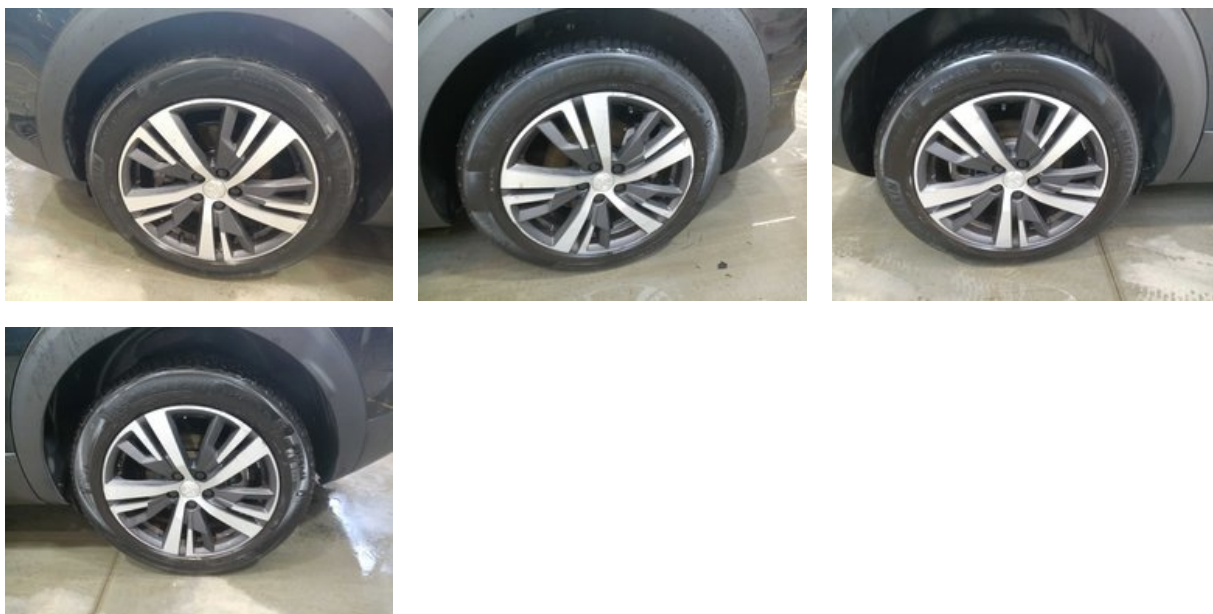
✓ **4. Side:** Wheels - Condition

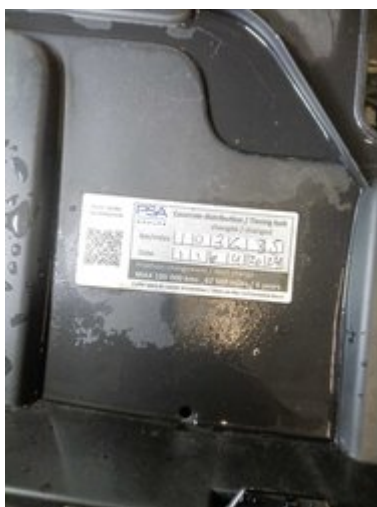
✓ **2. ENGINE:** Camshaft Drive Belt
