# Diagnosis report of

## 2015 PEUGEOT 308 Executive

# Diagnosis report of 2015 PEUGEOT 308 Executive

## Summary of diagnosed issues

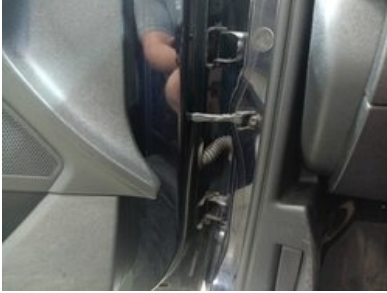
- ✓ **1. Doors:** All Four Doors - Opening, Closing, and Handle Operation

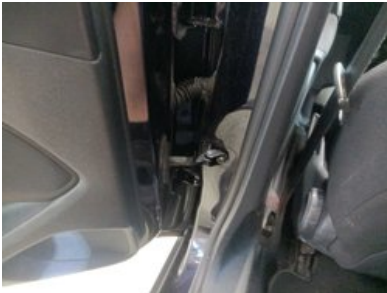
- ✓ **2. Doors:** All Four Doors - Opening, Closing, and Handle Operation

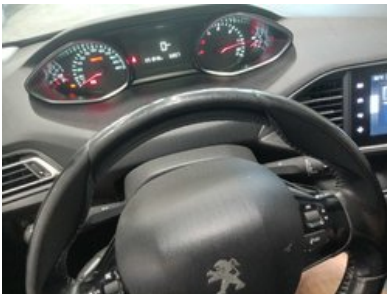
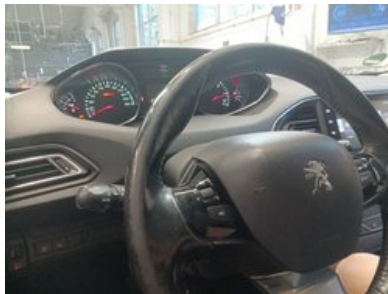
- ✓ **3. Front:** Steering Wheel - Condition

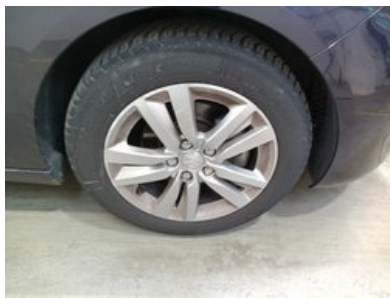
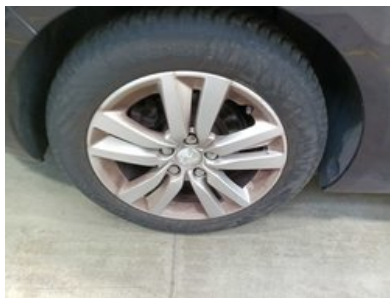
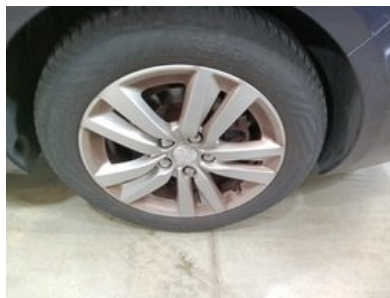
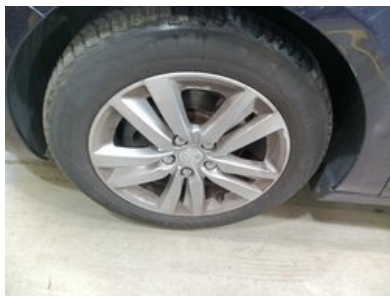
✓ **2. Side: Wheels - Condition**

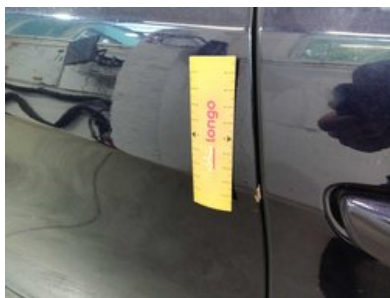
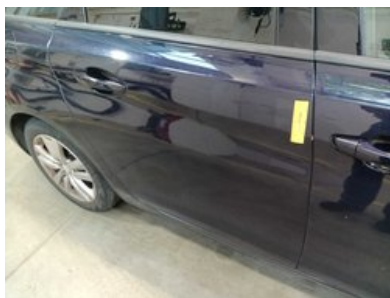
✓ **3. Side: Left and Right Side - Visual Damage and Scratches**

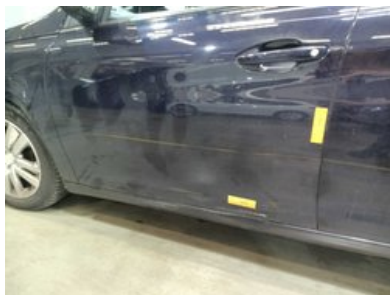
✓ **4. Side: Left and Right Side - Visual Damage and Scratches**

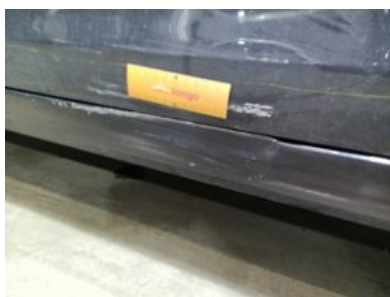
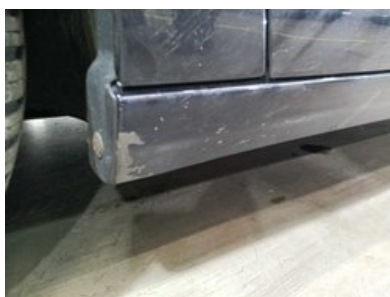
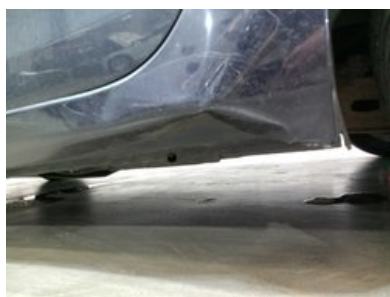
✓ **5. Side: Left and Right Side - Visual Damage and Scratches**

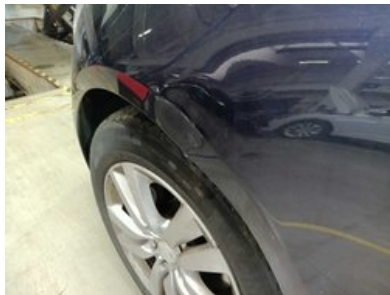
✓ **6. Side:** Left and Right Side - Visual Damage and Scratches

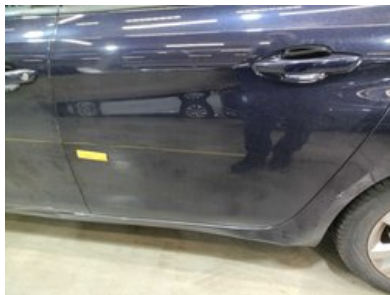
✓ **7. Side:** Left and Right Side - Visual Damage and Scratches

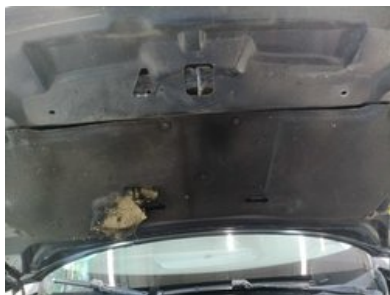
✓ **8. Front:** Hood Sound Insulation - Condition

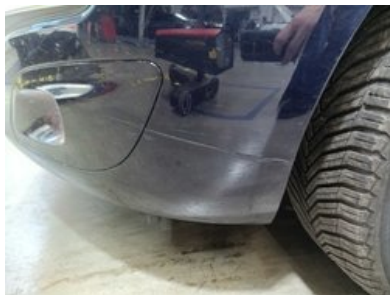
✓ **9. Front:** Front Bumper - Condition and Alignment

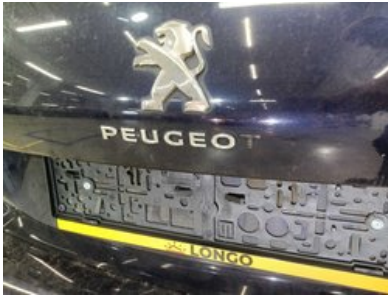
✓ **10. Rear:** Trunk - Visual Damage

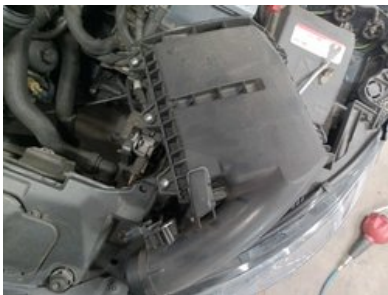
✓ **1. ENGINE:** Air Filter Box

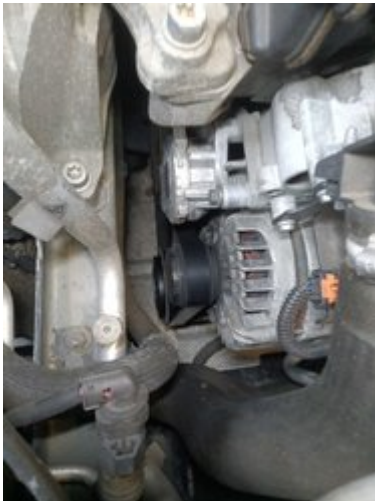
✓ **2. ENGINE:** Camshaft Drive Belt

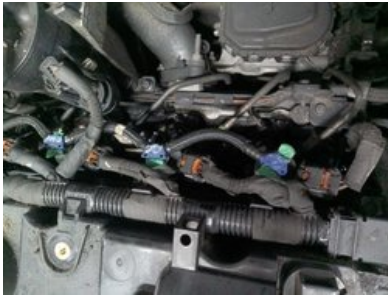
✓ **3. ENGINE MANAGEMENT - FUEL:** Fuel Injector Backfeed

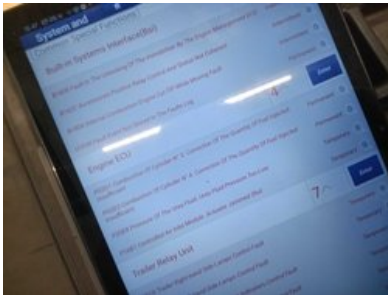
✓ **4. ENGINE MANAGEMENT - FUEL:** Injectors (All)

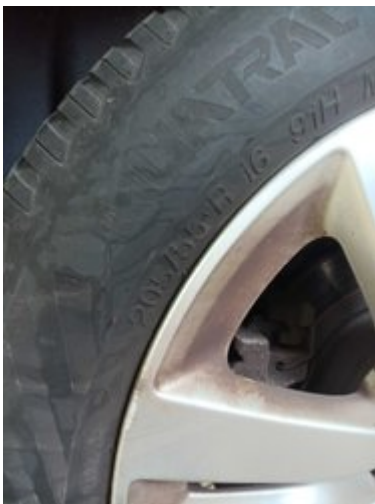
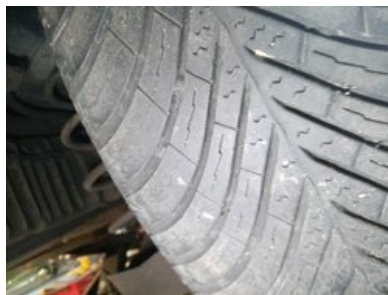
✓ **6. OTHER:** Change Tires

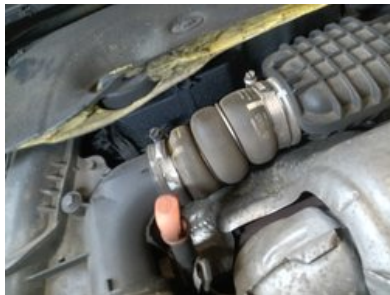
✓ **8. OTHER:** Engine Camshaft Repair "Sandwich"

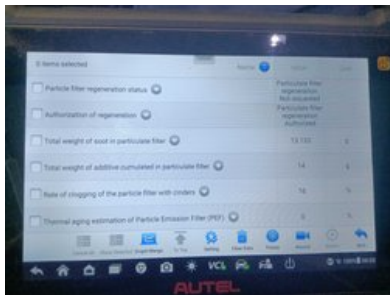
✓ **9. OTHER:** DPF Filter Regeneration/Cleaning

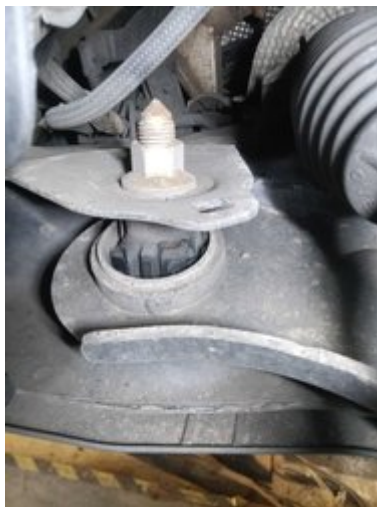
✓ **10. SUSPENSION:** Suspension Lower Arm Both

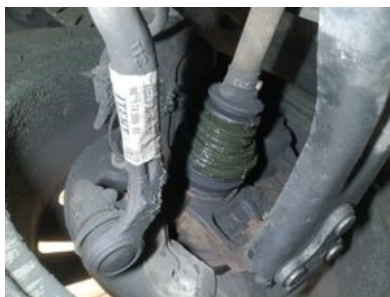
✓ **11. FINAL DRIVE, SHAFT & AXLES:** Driveshaft - Left
