# Diagnosis report of 2014 TOYOTA AURIS Sports Aspiration

## Summary of diagnosed issues

During the comprehensive diagnosis conducted by Longo, 17 issues were identified in the vehicle.

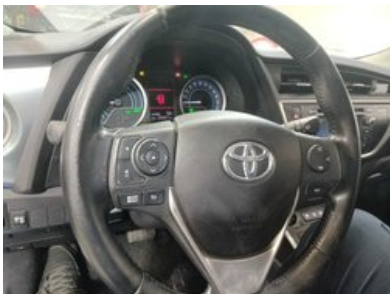
✔ **1. Front:** Steering Wheel - Condition

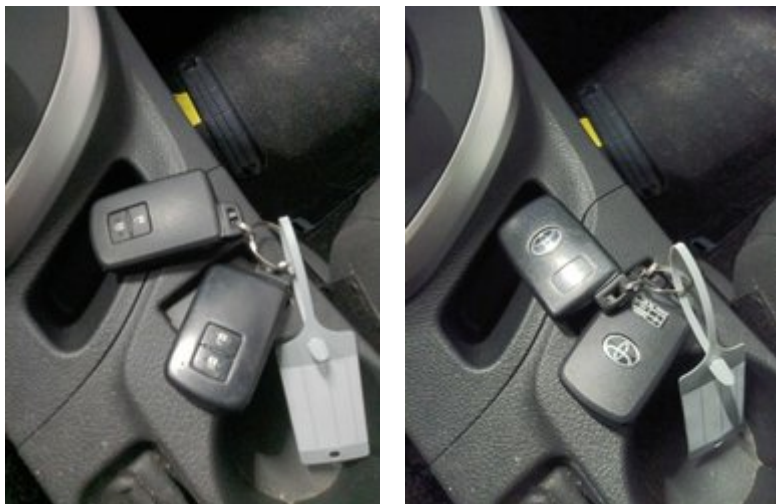
✔ **2. Inside:** Accessories - Functioning and Condition

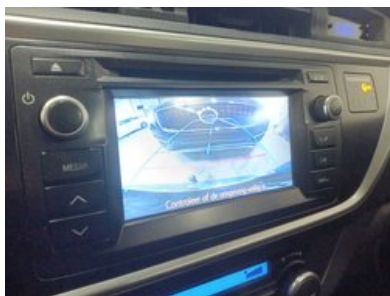
✔ **3. Inside:** Accessories - Functioning and Condition

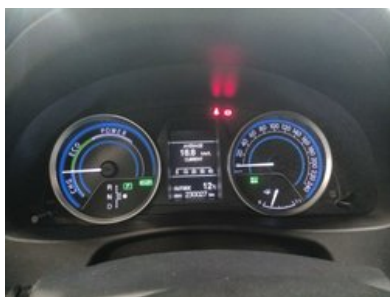
✔ **4. Inside:** Accessories - Functioning and Condition

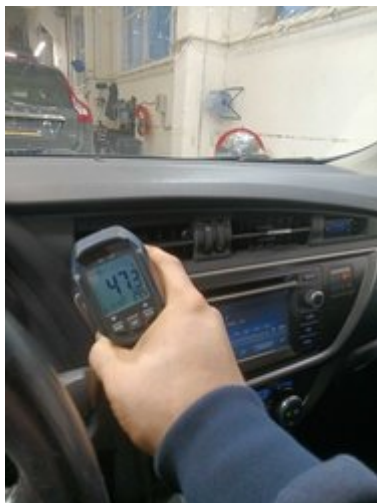
✓ **5. Inside:** Accessories - Functioning and Condition

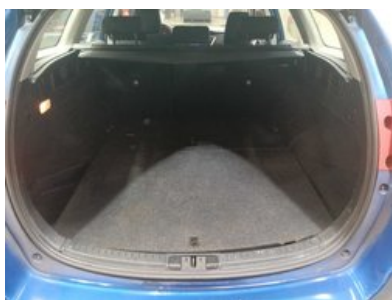
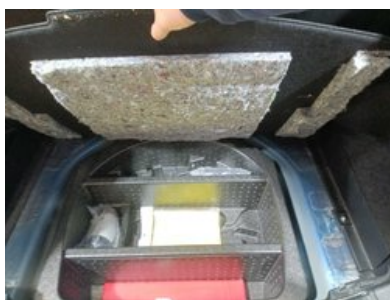
✓ **6. Inside:** Accessories - Functioning and Condition

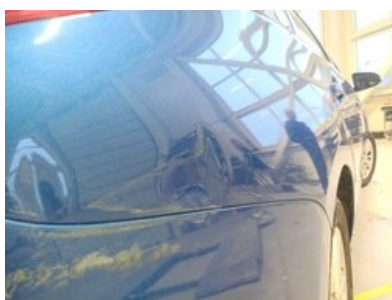
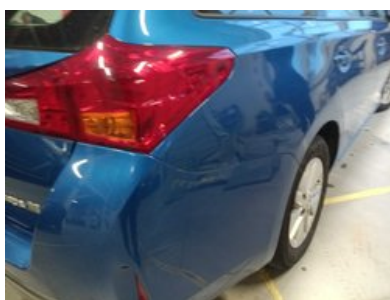
✓ **1. Side:** Left and Right Side - Visual Damage and Scratches

- ✓ 1. Paint Rear Fender
- ✓ 2. Paint Rear Bumper
- ✓ 3. Rear Bumper Chrome

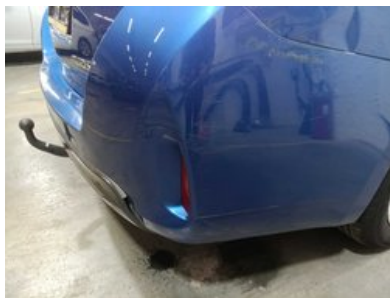
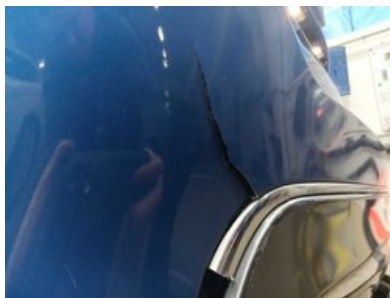
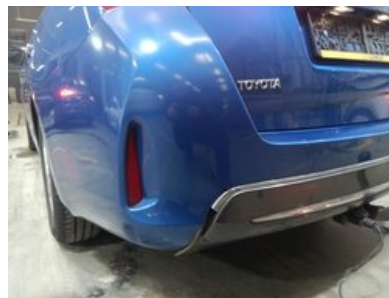
✓ **2. Rear:** Rear Bumper - Condition and Alignment

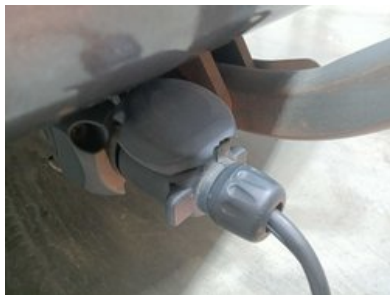
✓ **3. Rear:** Tow Hitch (Attachment, Removal Mechanism, External Light Connector, Connector Thickness)

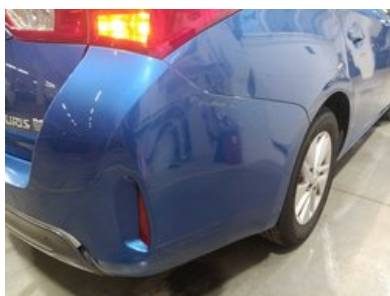
✓ **4. Other:** Additional Polishing Tasks

- ✓ 1. Body wet wash
- ✓ 2. Full interior deep clean using only hypoallergenic cleaning products
- ✓ 3. Post cleaning body polish

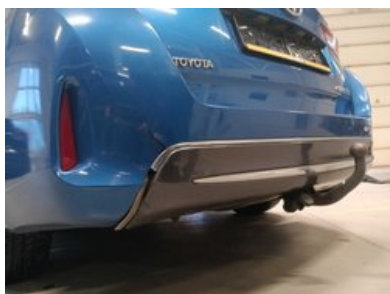
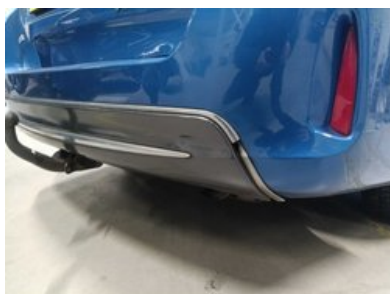
✓ **5. Other:** Audible Signs (Loose Parts, Rattling, Etc.)

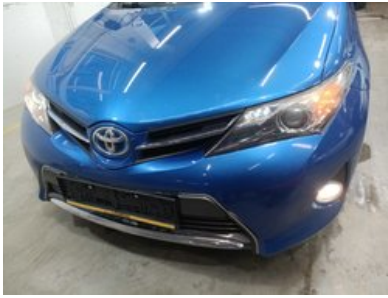
✔ **6. Lights:** Light Bulbs

- ✓ 1. Engine Oil & Filter Change
- ✓ 2. Change Bulb for Headlights

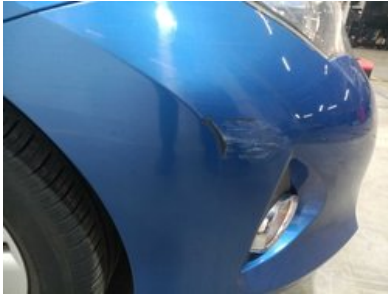
✔ **7. Front:** Front Bumper - Condition and Alignment

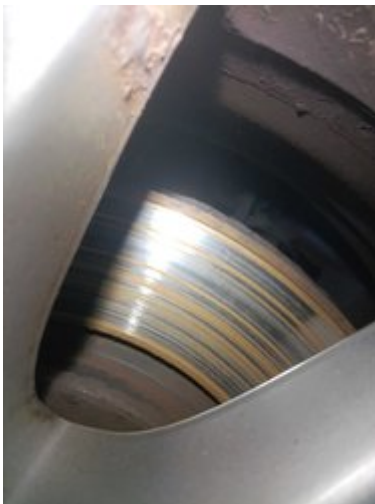
✔ **2. BRAKES:** Rear Brake Disc (Both)

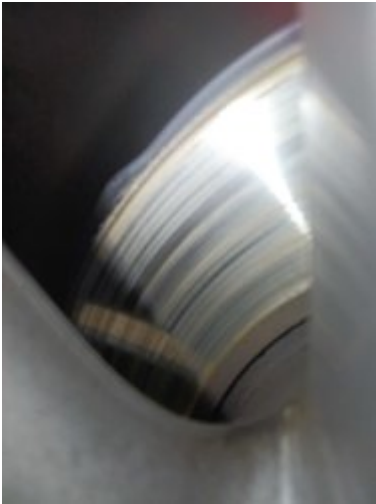
✓ **3. BRAKES:** Front Brake Discs Both

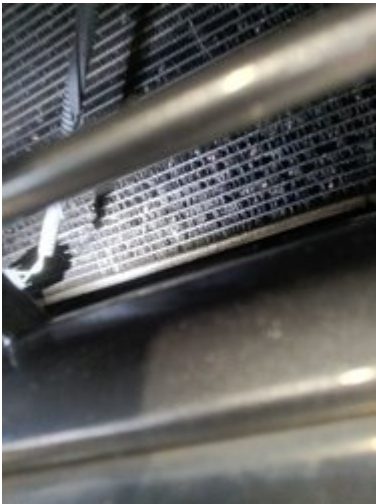
✓ **4. AIR CONDITIONING AND HEATING:** Condenser
