# Diagnosis report of 2015 TOYOTA AURIS Active

# Preparation and repair report of 2015 TOYOTA AURIS Active

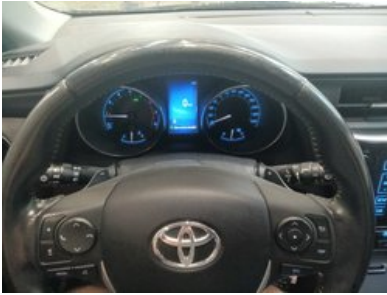
### ✓ 1. Front: Steering Wheel - Condition

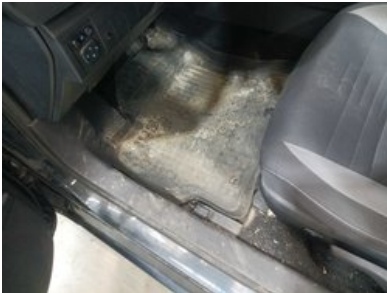
### ✓ 2. Inside: Additional Cleaning Tasks

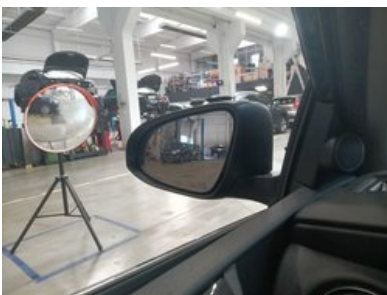
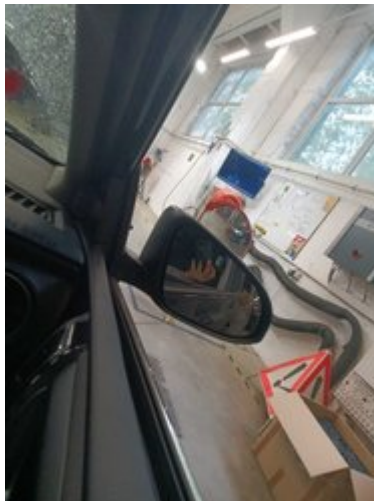
### ✓ 3. Doors: Exterior Side Mirrors - Electronic Controls, Folding, and Adjustment

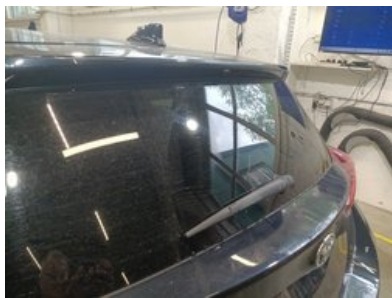
- ✓ **1. Rear:** Rear Window Integrity

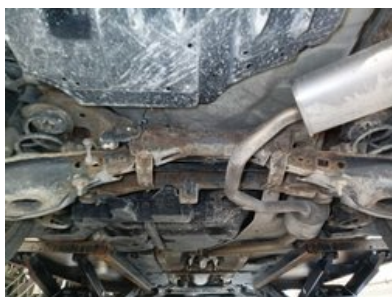
- ✓ **1. OTHER:** Engine Oil & Filter Change
- ✓ **2. OTHER:** Charge Battery
- ✓ **3. BODY - REAR SECTION:** Corrosion

- ✓ 1. Engine Oil & Filter Change
- ✓ 2. Charge Battery
