# Diagnosis report of 2015 MITSUBISHI OUTLANDER Executiv

Diagnosis report of

2015 MITSUBISHI OUTLANDER Executiv

Summary of diagnosed issues

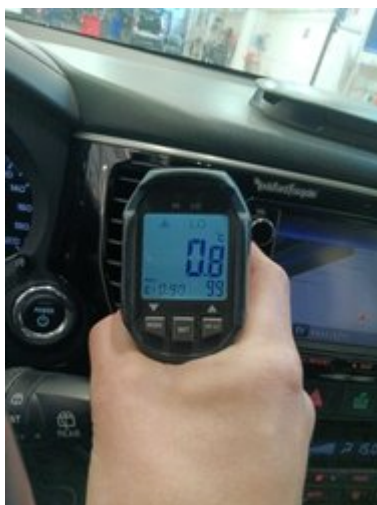
✓ **2. Air-Conditioning Measurement**
