# Diagnosis report of 2017 HONDA CR-V Elegance Plus

Diagnosis report of

2017 HONDA CR-V Elegance Plus

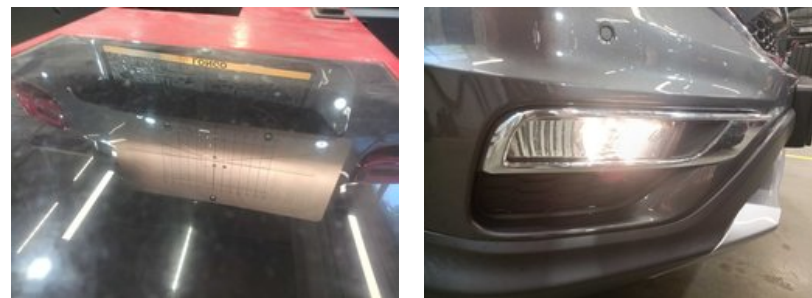
- ✔ 1. Lights: Front Lights (City, Regular, Full Headlight, Fog, Indicator) - Basic Functioning, Damage, and Color

- ✓ 1. Change Front Fog Lights

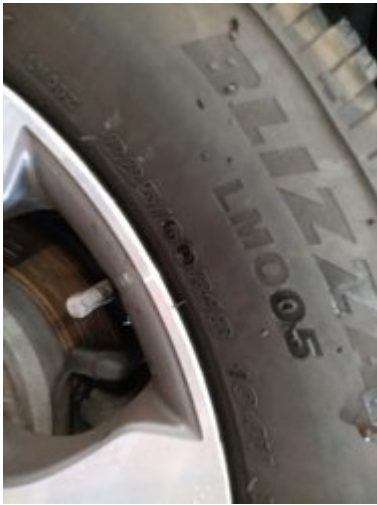
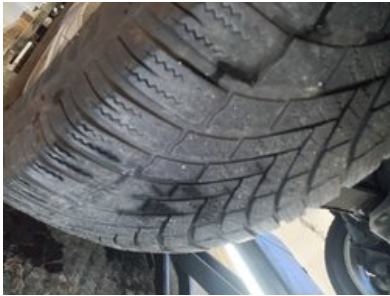
✓ 1. OTHER: Change Tires

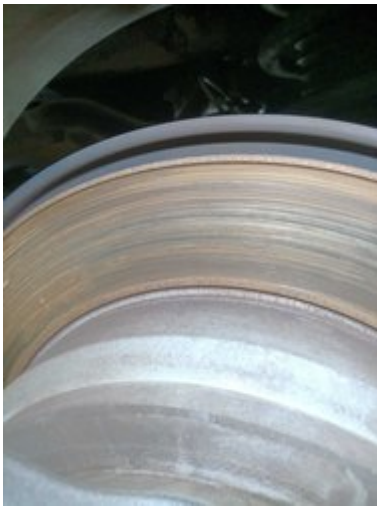
✓ 2. OTHER: Engine Oil & Filter Change

✓ 3. BRAKES: Rear Brake Disc (Both)

- ✓ 1. Engine Oil & Filter Change

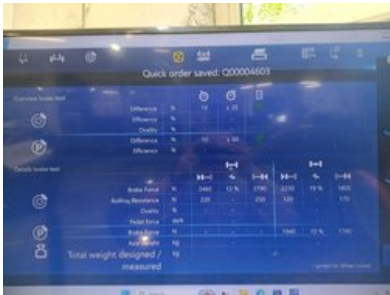
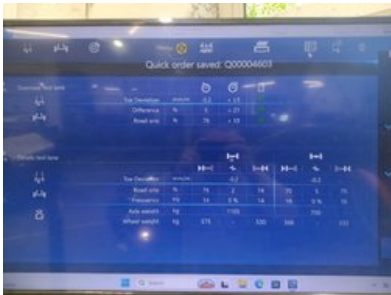
✓ 1. Brake Test Line Results

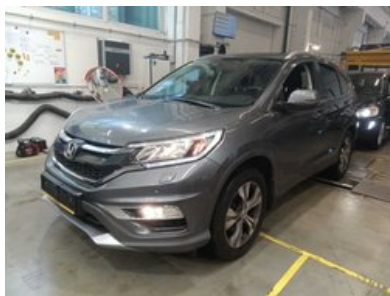
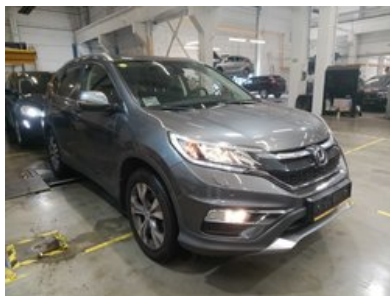
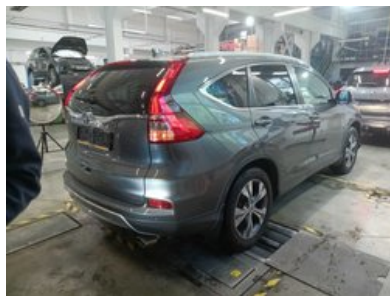
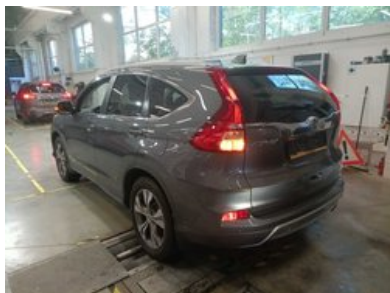
✓ 2. Diagnostic Photo

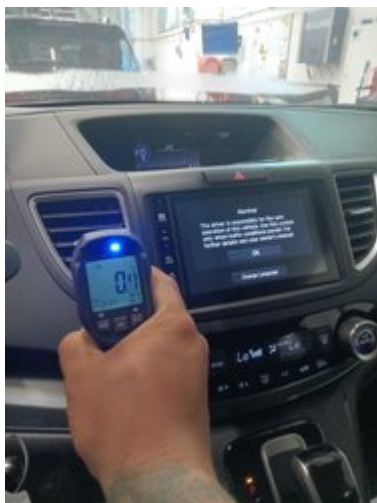
✓ 3. Air-Conditioning Measurement
