Diagnosis report of 2014 TOYOTA AURIS Aspiration

During the comprehensive diagnosis conducted by Longo, 7 issues were identified in the vehicle.

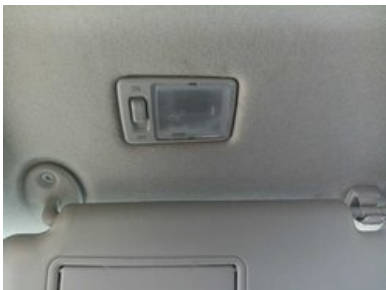
- ✔ **1. Front:** Sun Visors - Operation and Condition

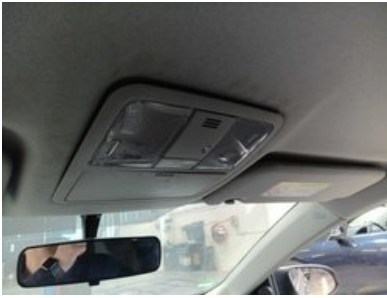
✓ **2. Inside:** Interior Lighting - Basic Functioning and Damage

- ✓ 1. Interior Lighting Panel

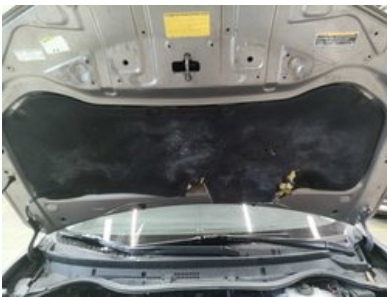
✓ **1. Front:** Hood Sound Insulation - Condition

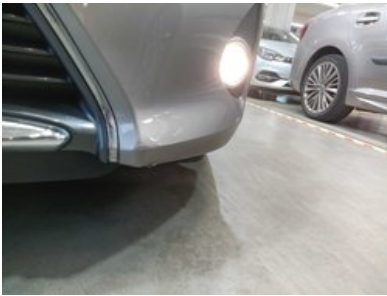
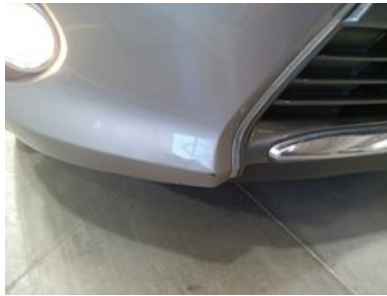
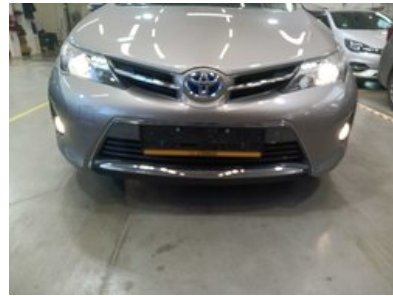
✓ **2. Front:** Front Bumper - Condition and Alignment

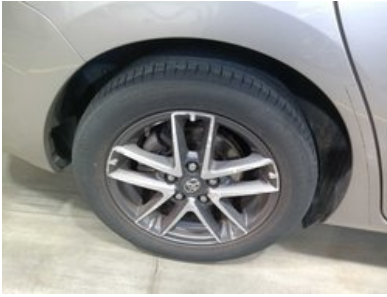
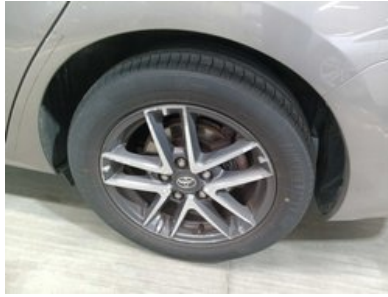
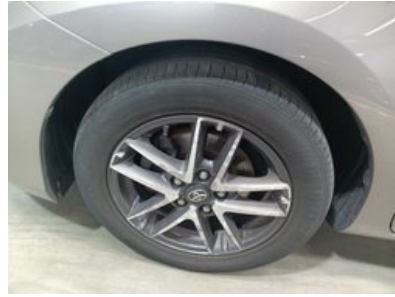
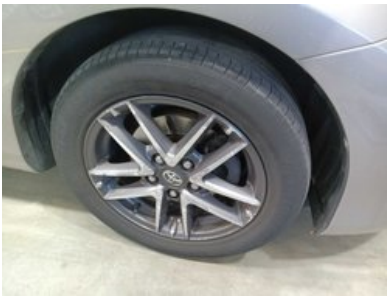
✓ **3. Side:** Wheels - Condition

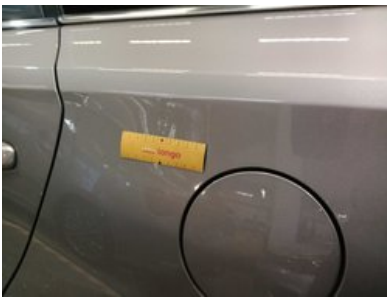
✓ **4. Side:** Left and Right Side - Visual Damage and Scratches

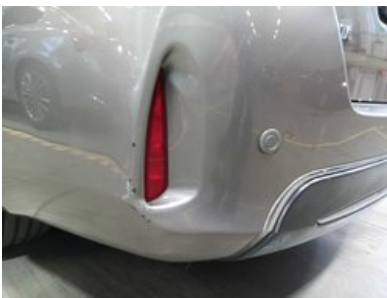
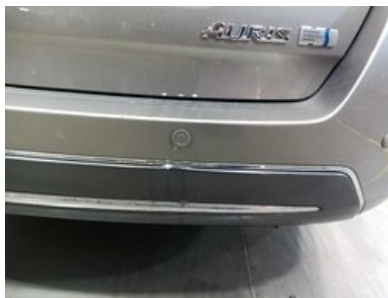
✓ **5. Rear:** Rear Bumper - Condition and Alignment

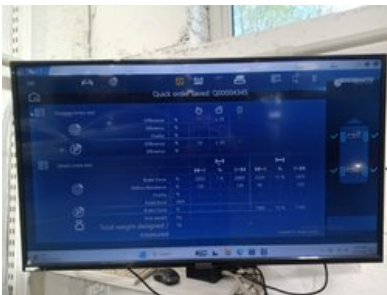
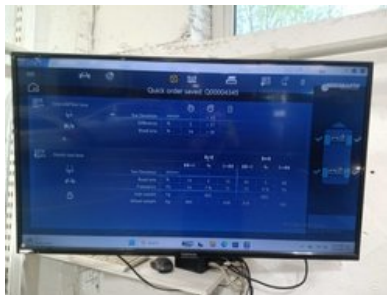
✓ 2. Brake Test Line Results

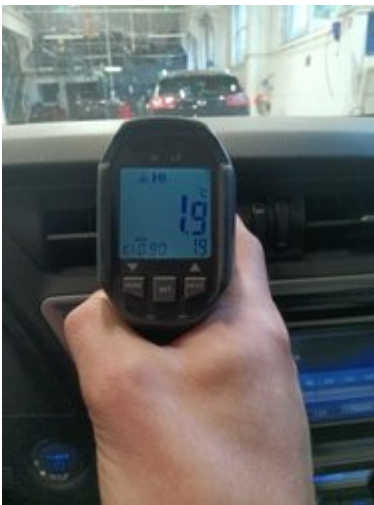
✓ 3. Air-Conditioning Measurement
