# Diagnosis report of 2016 TOYOTA AURIS Business

# Preparation and repair report of 2016 TOYOTA AURIS Business

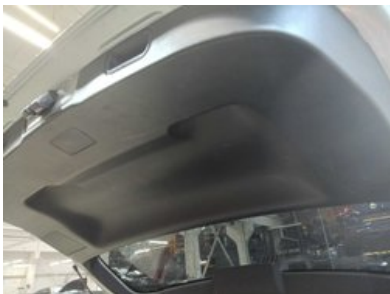
- ✔ 1. Inside: Trims - Condition

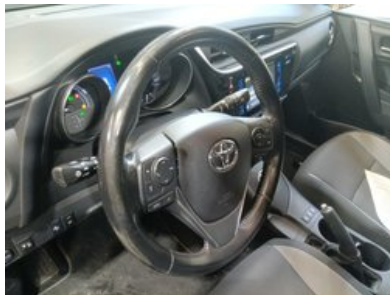
✓ **2. Front:** Steering Wheel - Condition

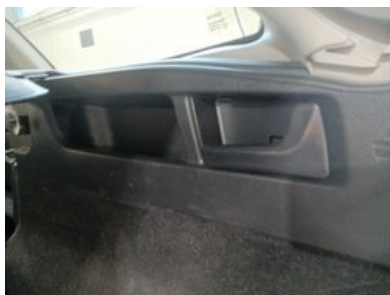
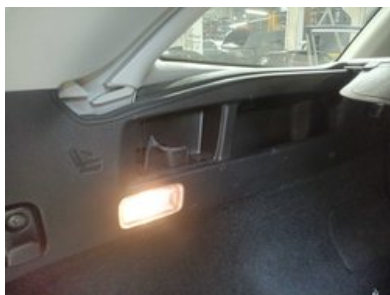
✓ **3. Seats:** Seat Adjustment Mechanisms - Functioning

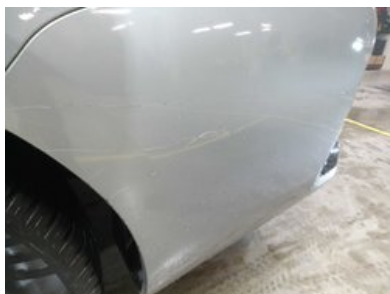
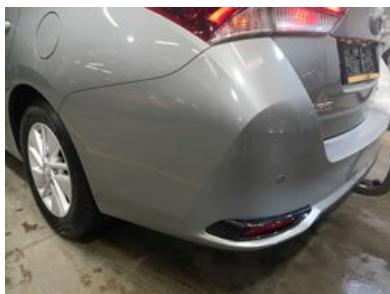
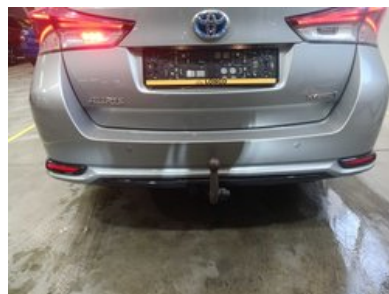
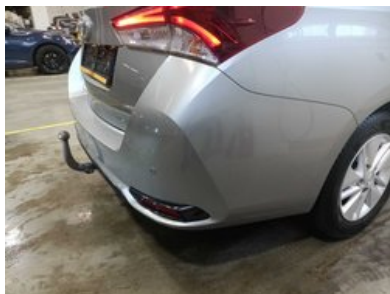
✓ **1. Rear:** Rear Bumper - Condition and Alignment

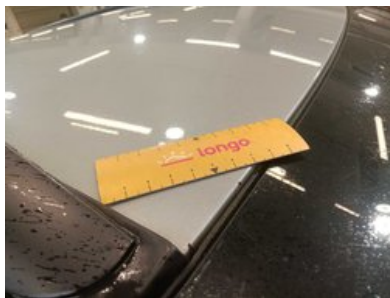
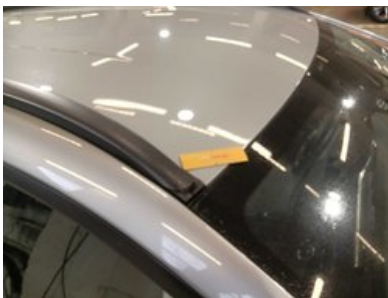
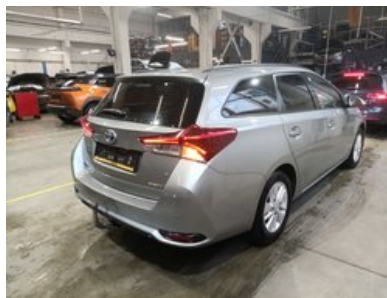
✔ **2. Other:** Roof - Visual Damage (e.g., Hail Damage)

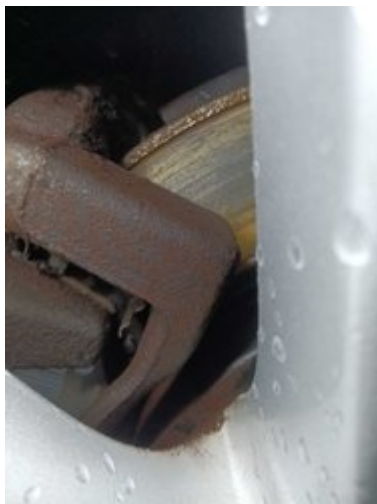
✔ **2. BRAKES:** Rear Brake Disc (Both)

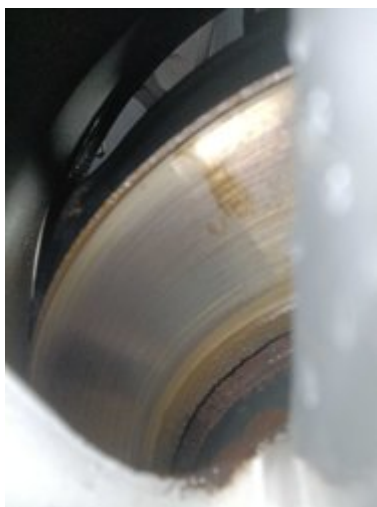
✔ **3. BRAKES:** Front Brake Discs Both

- ✓ 1. System Evacuation/Recharging
- ✓ 2. Front Brake Discs (Both)
- ✓ 3. Anti-Roll Bar Bush - Outer
- ✓ 4. Engine Oil & Filter Change

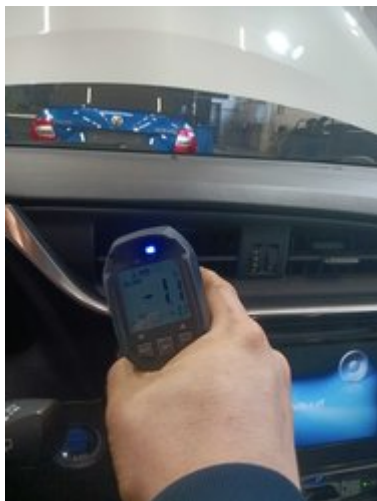
✓ 4. Air-Conditioning Measurement
