Diagnosis report of 2021 PEUGEOT 2008 Allure

During the comprehensive diagnosis conducted by Longo, 7 issues were identified in the vehicle.

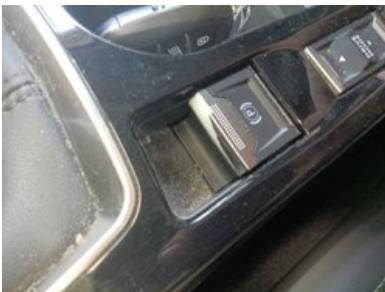
- ✔ 1. Inside: Trims - Condition

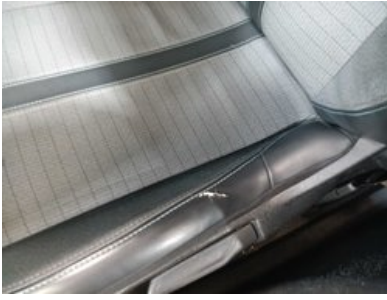
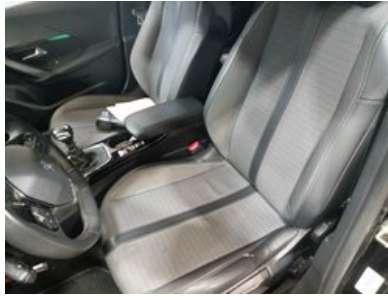
✔ **2. Seats:** All Seats - Condition

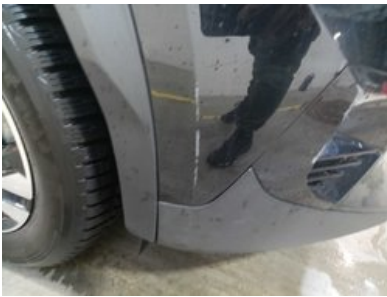
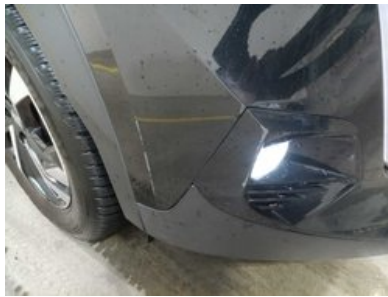
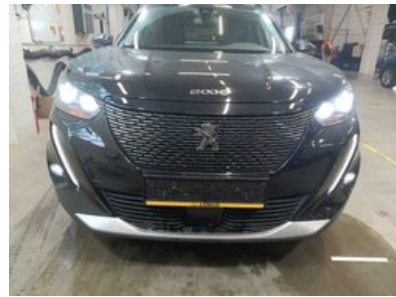
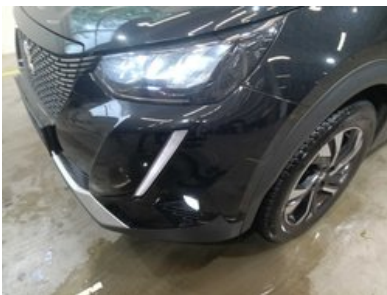
✔ **1. Front:** Front Bumper - Condition and Alignment

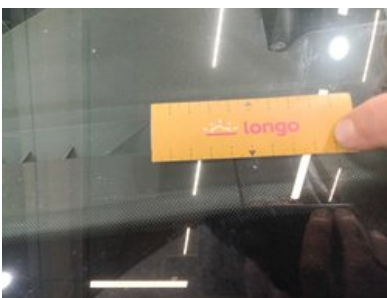
✔ **2. Front:** Windscreen Integrity - Free from MOT-Excluding Damage

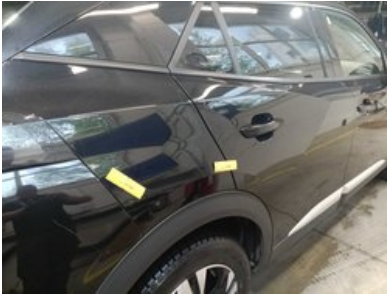
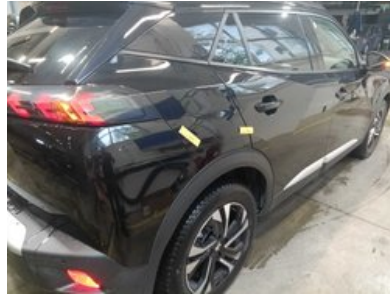
✔ **3. Side:** Left and Right Side - Visual Damage and Scratches

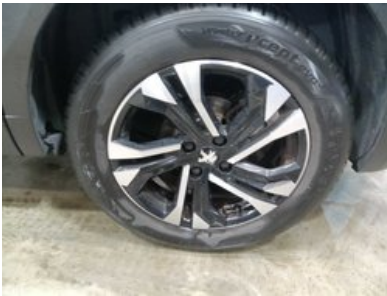
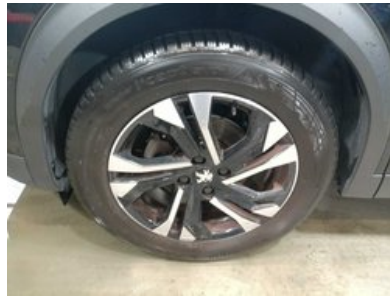
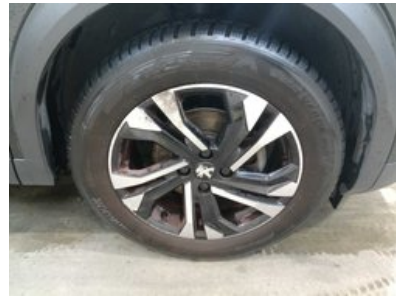
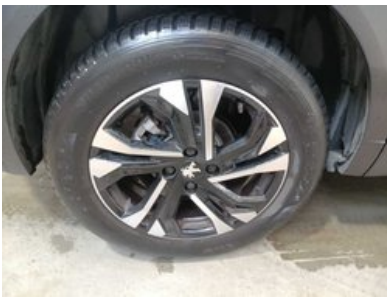
✔ **4. Side:** Wheels - Condition

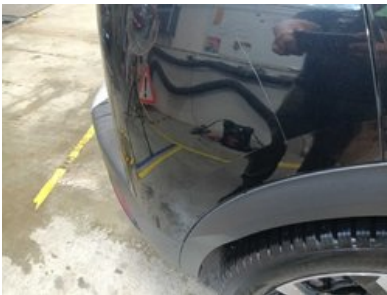
✔ **5. Other:** Additional Polishing Tasks
