# Diagnosis report of 2015 TOYOTA YARIS Aspiration

Checked by Longo Shared Service certified diagnostics team: Mindaugas G., Arnas S.

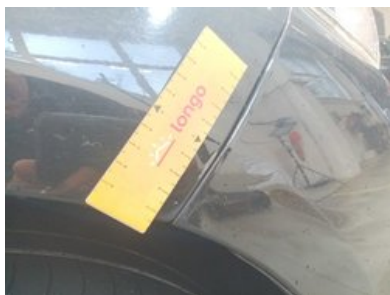
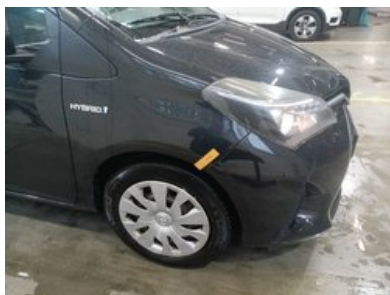
### ✓ 1. Side: Left and Right Side - Visual Damage and Scratches
