# Diagnosis report of 2016 OPEL MOKKA Business+

## Summary of diagnosed issues

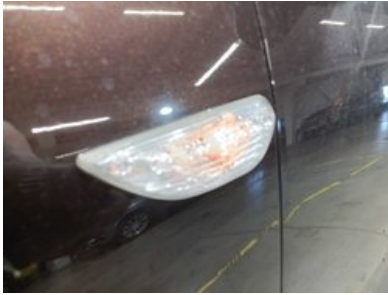
- ✓ **1. Lights:** Car Side Lights - Basic Functioning, Damage, and Color

- ✓ 1. Change Lights on Car Side

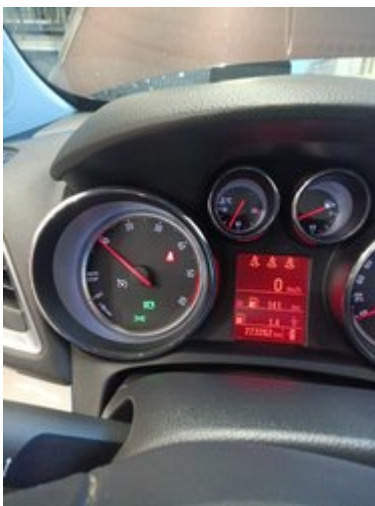
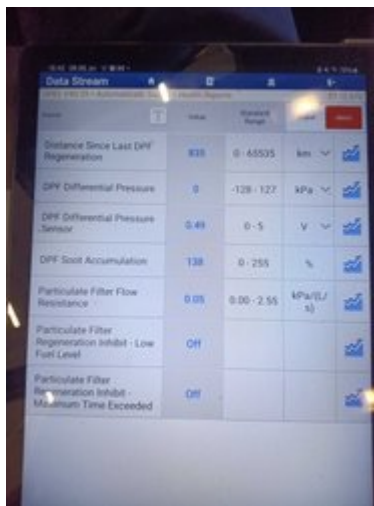
- ✓ **1. OTHER:** Engine Oil & Filter Change
- ✓ **2. OTHER:** DPF Filter Regeneration/Cleaning

| Parameter | Value | Unit | Target |
|---|---|---|---|
| Distance Since Last DPF Regeneration | 835 | km | 0 - 45535 |
| DPF Soot Accumulation | 138 | % | 0 - 255 |

- ✓ 1. DPF Filter Regeneration/Cleaning
- ✓ 2. Engine Oil & Filter Change

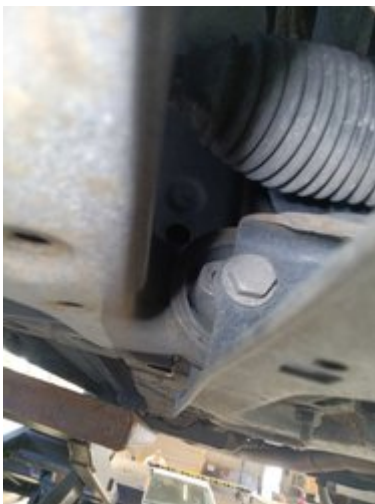
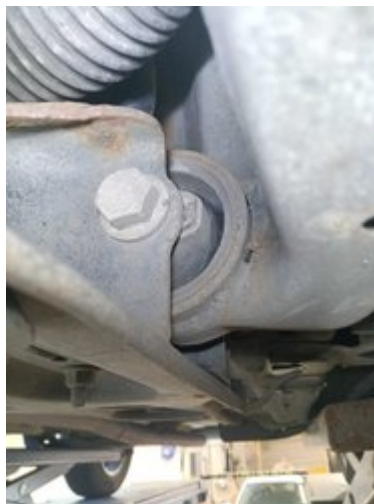
- ✓ **3. SUSPENSION:** Suspension Lower Arm
