Diagnosis report of 2017 TOYOTA C-HR Executive

Preparation and repair report of 2017 TOYOTA C-HR Executive

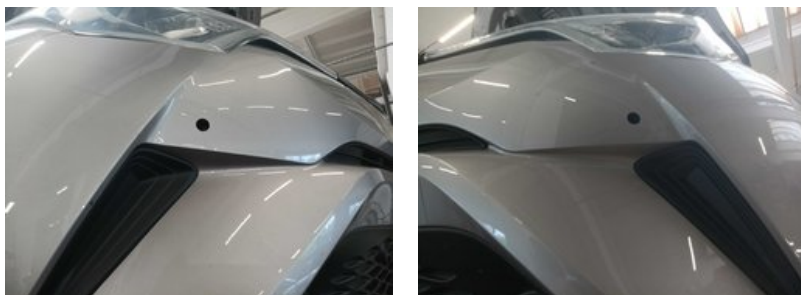
- ✔ **1. Operation:** Parking Assistance Systems - Functioning

- ✓ 1. Change Parking Assistance System

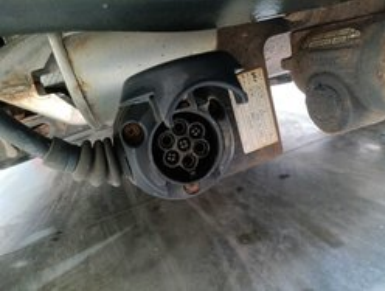
- ✔ **1. Rear:** Tow Hitch (Attachment, Removal Mechanism, External Light Connector, Connector Thickness)

- ✓ 1. Remove External Light Connector System
- ✓ 2. Engine Oil & Filter Change

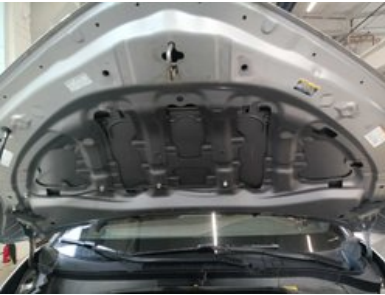
-
- ✔ **2. Front:** Hood Sound Insulation - Condition

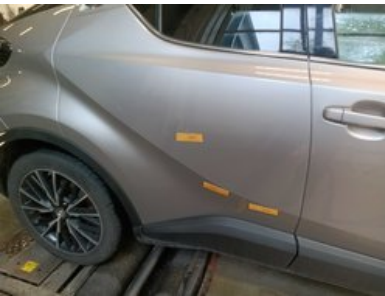
-
- ✔ **3. Side:** Left and Right Side - Visual Damage and Scratches

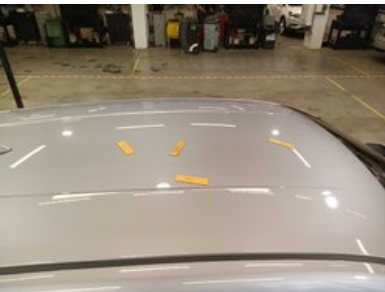
-
- ✔ **4. Other:** Roof - Visual Damage (e.g., Hail Damage)

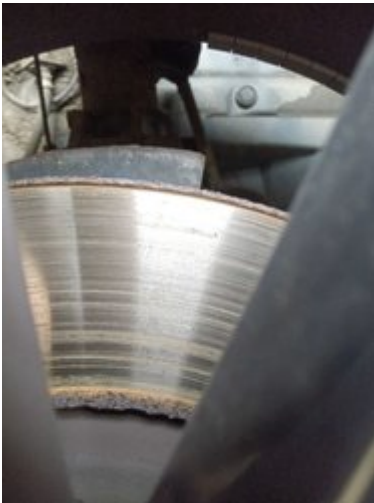
-
- ✓ **2. BRAKES:** Front Brake Discs Both

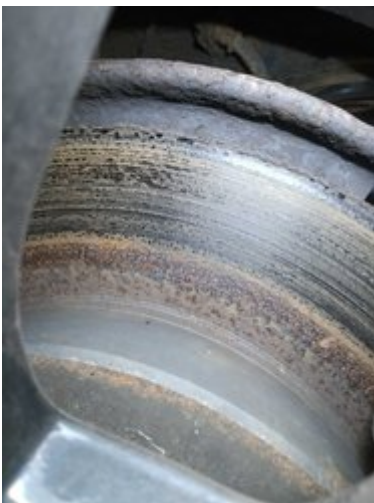
-
- ✓ **3. BRAKES:** Rear Brake Disc (Both)
