# Diagnosis report of 2017 PEUGEOT 3008 Premium

During the comprehensive diagnosis conducted by Longo, 12 issues were identified in the vehicle.

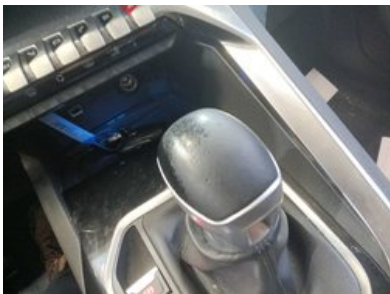
- ✔ **1. Inside:** Gear Shift Boot and Gear Shift Knob - Condition

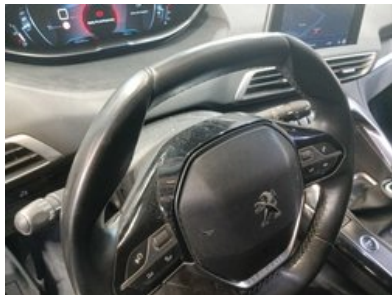
✓ **2. Front:** Steering Wheel - Condition

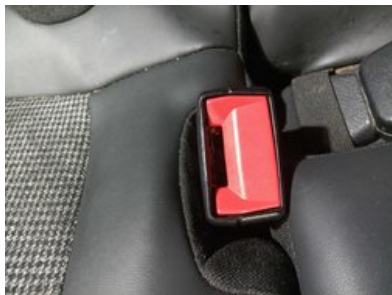
✓ **3. Seats:** Seatbelts - Functioning and Locking Mechanism

- ✓ 1. Change Seatbelts / Mountings

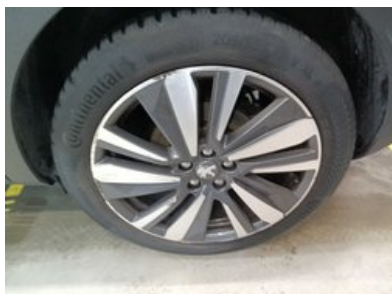
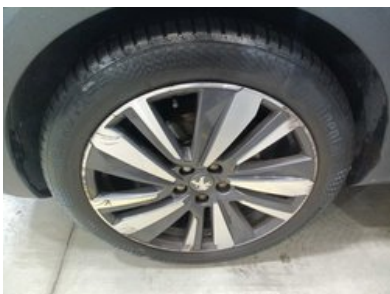
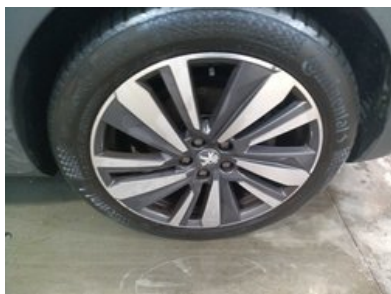
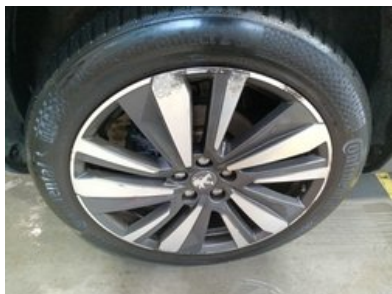
✓ **1. Side:** Wheels - Condition

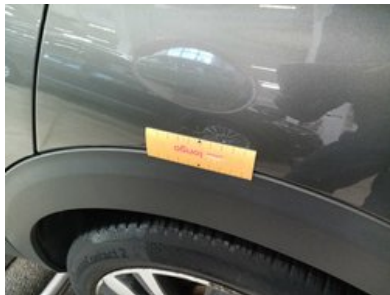
✓ **2. Side:** Left and Right Side - Visual Damage and Scratches

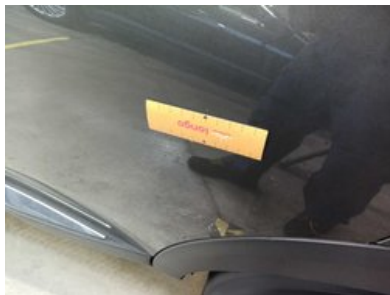
✓ **3. Side:** Left and Right Side - Visual Damage and Scratches

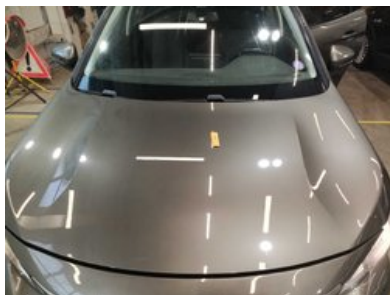
✓ **4. Front:** Hood - Visual Damage

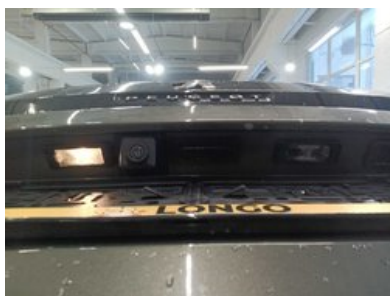
✓ **5. Lights:** Light Bulbs

- ✓ 1. Change Bulb for License Plate Lights
- ✓ 2. Engine Oil & Filter Change
- ✓ 3. Suspension Lower Arm Bushes (Both)

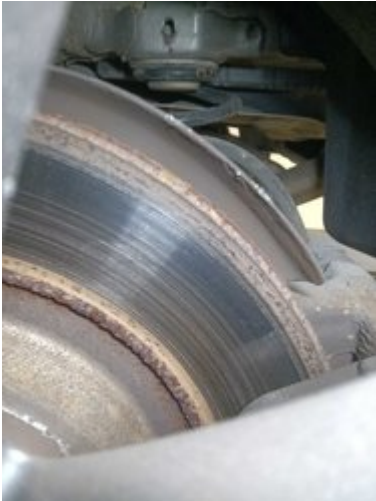
1. BRAKES: Rear Brake Disc (Both)

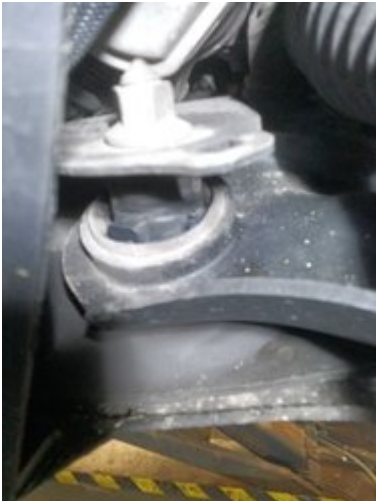
4. SUSPENSION: Suspension Lower Arm Bushes Both
