# Diagnosis report of 2019 PEUGEOT 3008 Access

| VIN Code: VF3MRHNSMK5333410 | Fuel consumption: 5.10 l/100km |

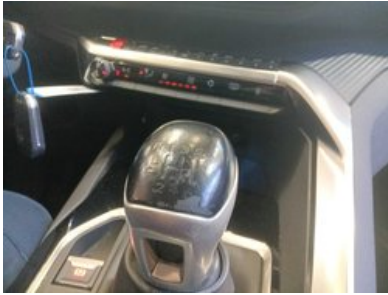
- ✓ **1. Inside:** Gear Shift Boot and Gear Shift Knob - Condition

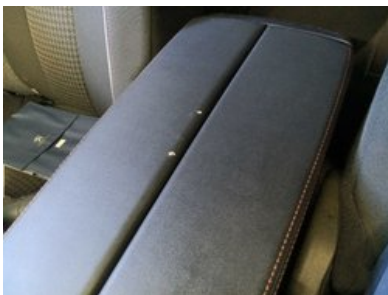
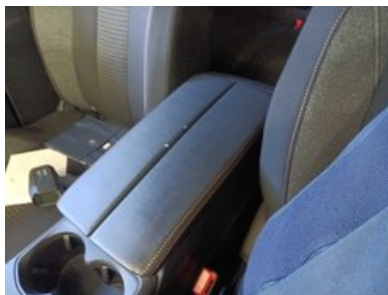
- ✓ **2. Inside:** Armrest - Operation and Condition

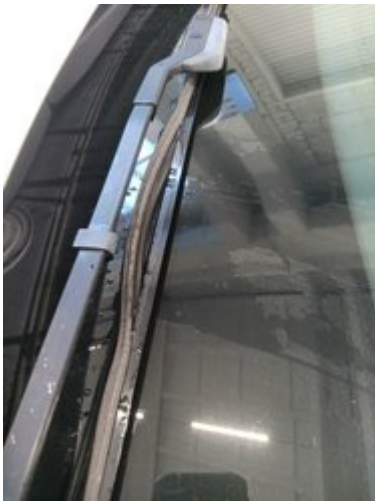
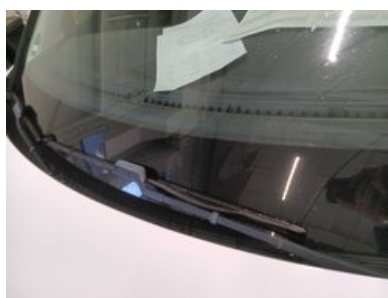
- ✓ **3. Front:** Window Wiper Rubber and Handle (Front and Rear) - Condition

- ✓ 1. Change Bulb for License Plate Lights
- ✓ 2. Front Brake Pads (All)
- ✓ 3. Battery
- ✓ 4. Engine Oil & Filter Change
- ✓ 5. Change Front Wiper (Mechanical)

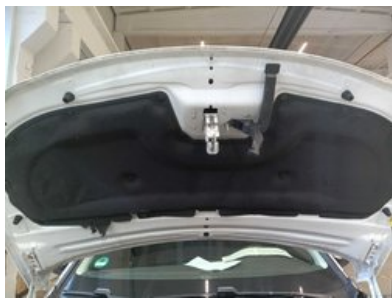
### ✓ 1. Front: Hood Sound Insulation - Condition

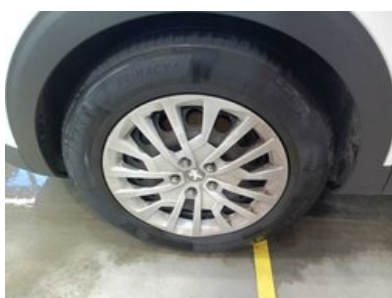
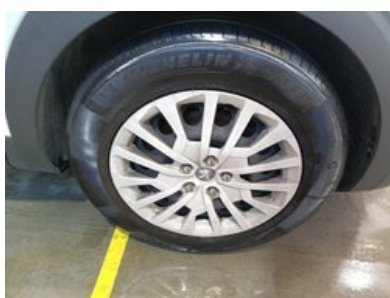
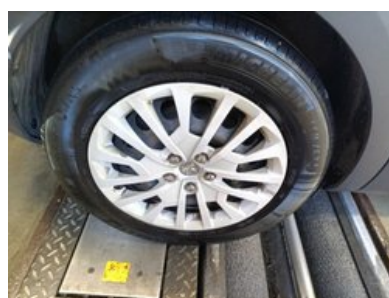
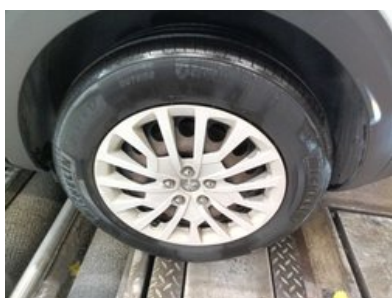
### ✓ 2. Side: Wheels - Condition

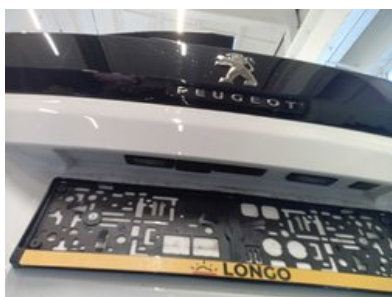
### ✓ 3. Lights: Light Bulbs

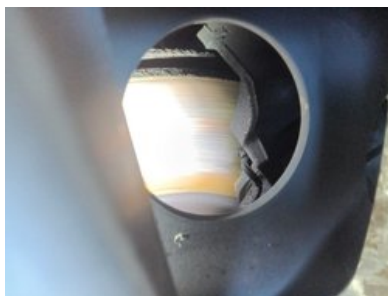
✓ **4. BRAKES:** Front Brake Pads (All)
