# Diagnosis report of 2022 PEUGEOT 2008 Allure

# Preparation and repair report of 2022 PEUGEOT 2008 Allure

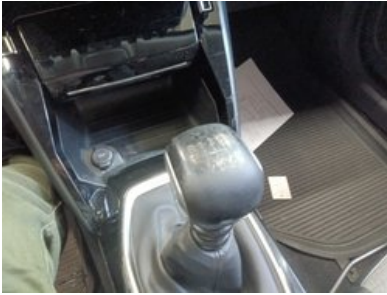
- ✓ **1. Inside:** Gear Shift Boot and Gear Shift Knob - Condition

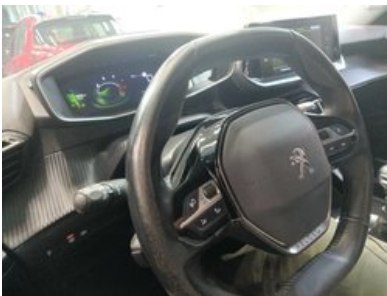
- ✓ **2. Front:** Steering Wheel - Condition

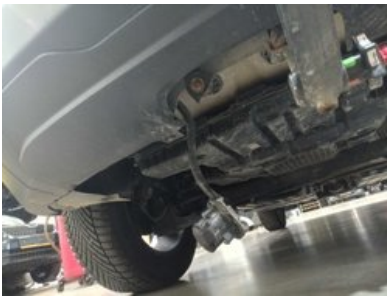
- ✓ **1. Rear:** Tow Hitch (Attachment, Removal Mechanism, External Light Connector, Connector Thickness)

- ✓ 1. Repair Socket Holder

- 1. AdBlue 3L
- 2. Engine Oil 4L
- 3. Oil Filter (OE667/6)
- 4. Oil Pan Gasket (834.823)
- 5. Tow Hitch Bracket (ORIS026-244)

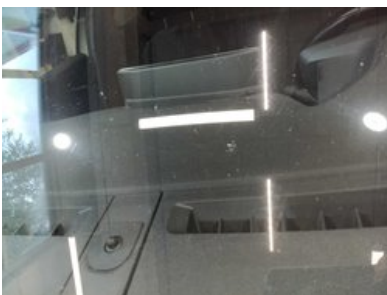
- ✓ **2. Front:** Windscreen Integrity - Free from MOT-Excluding Damage

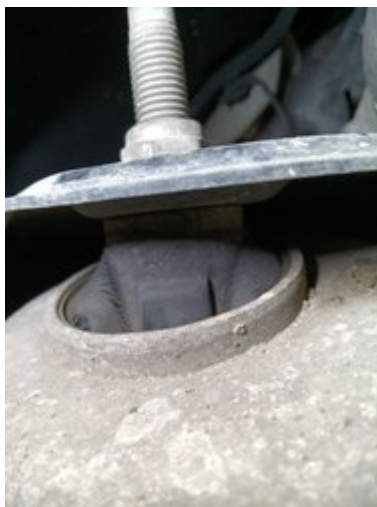
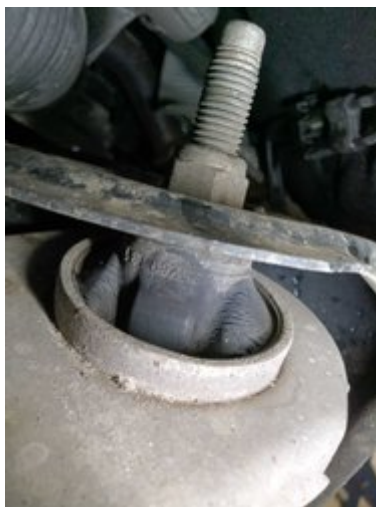
- ✓ **1. OTHER:** Engine Oil & Filter Change
- ✓ **2. SUSPENSION:** Suspension Lower Arm Both

- ✓ 1. Engine Oil & Filter Change

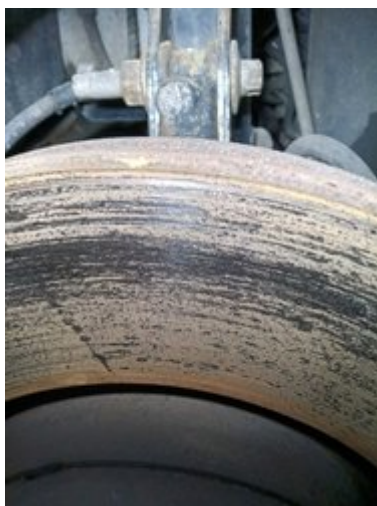
- ✓ **3. BRAKES:** Front Brake Discs Both

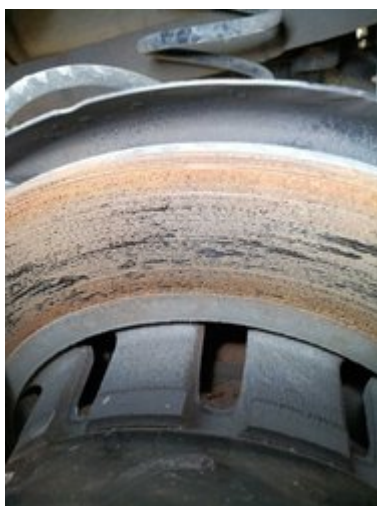
- ✓ **4. BRAKES:** Rear Brake Disc (Both)
