Diagnosis report of 2018 PEUGEOT 3008 Executive

Preparation and repair report of 2018 PEUGEOT 3008 Executive

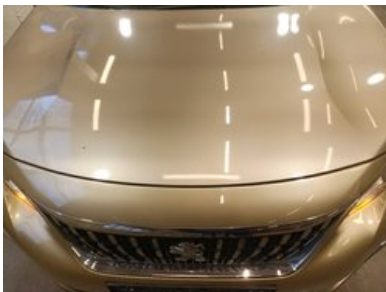
- ✔ **1. Front:** Front Bumper - Condition and Alignment

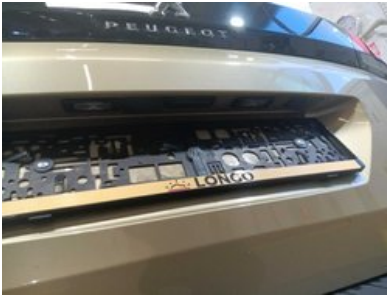
✔ **2. Lights:** Light Bulbs

- ✓ 1. Stabilizer Link
- ✓ 2. Change Bulb for License Plate Lights
- ✓ 3. Cabin Heater Core

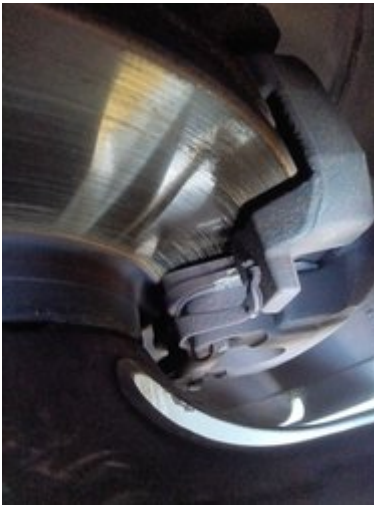
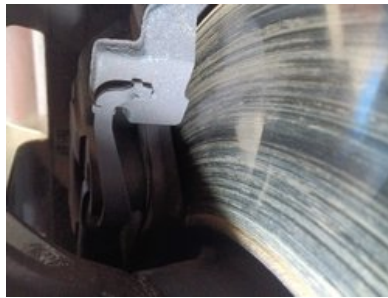
✔ **2. OTHER:** Front Brake Discs Including Pads

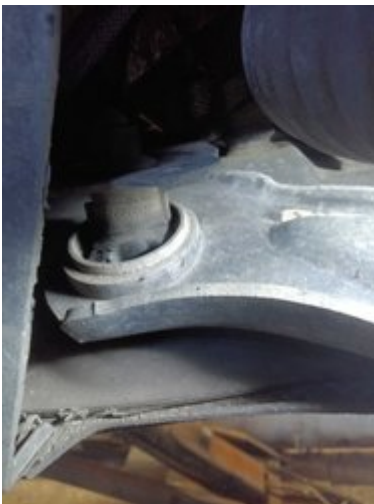
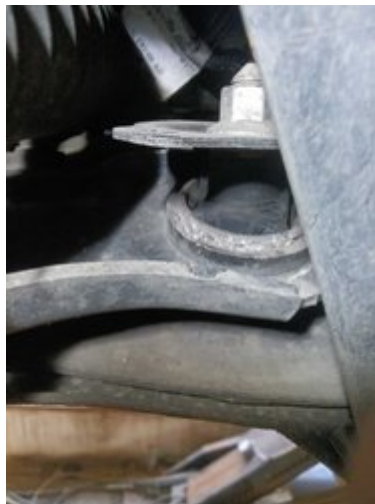
✔ **3. OTHER:** Suspension Lower Arm

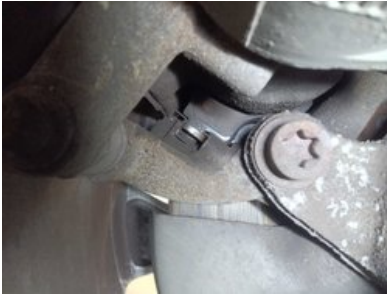
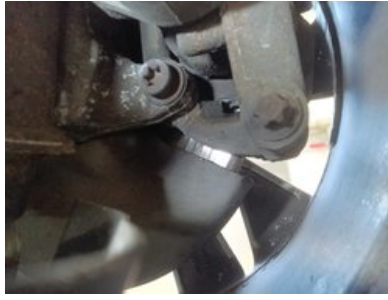
✔ 4. OTHER: Rear Brake Disc and Pads

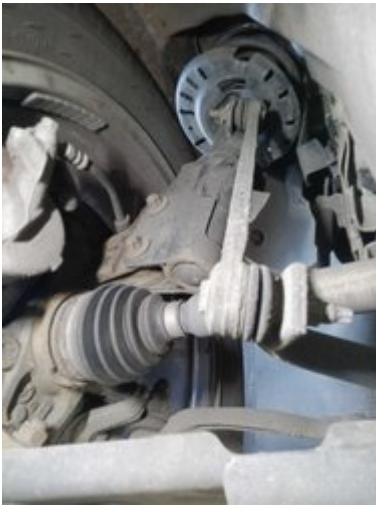
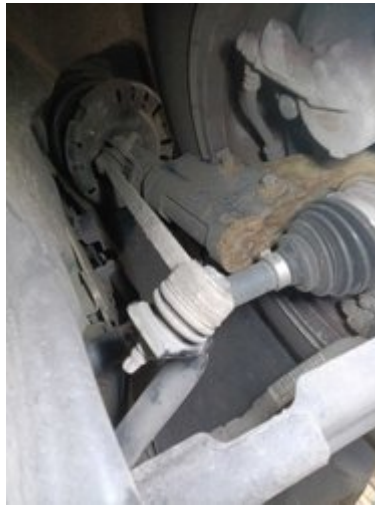
✔ 5. OTHER: Stabilizer Link

- 1. Stabilizer (FE19397)
- 2. Heat Exchanger, Interior Heating (NRF54422)
