# Diagnosis report of 2018 TOYOTA AURIS Aspiration

During the comprehensive diagnosis conducted by Longo, 15 issues were identified in the vehicle.

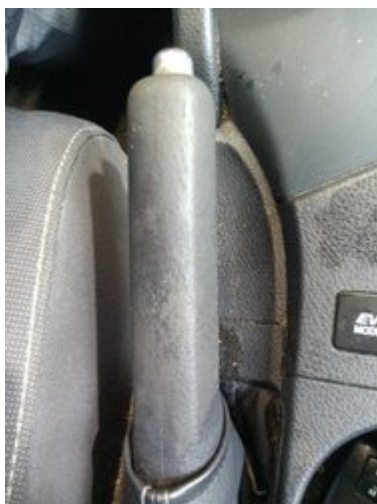
### ✔ 1. Inside: Trims - Condition

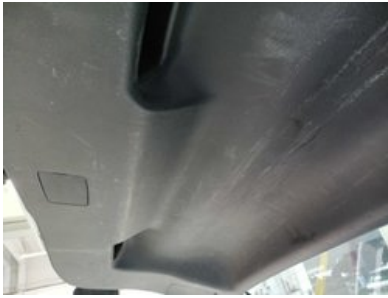
✓ **2. Inside:** Trims - Condition

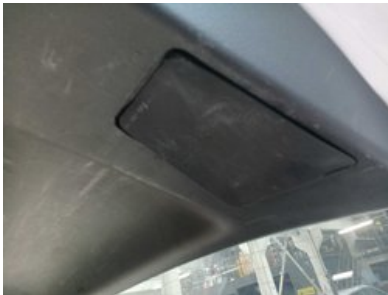
✓ **3. Inside:** Trims - Condition

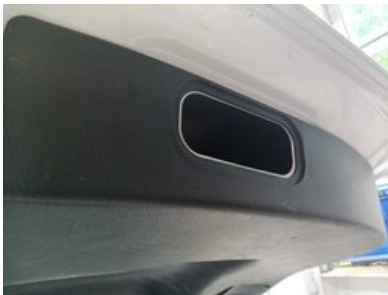
✓ **4. Inside:** Trims - Condition

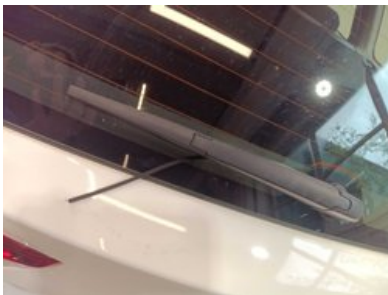
✓ **5. Front:** Window Wiper Rubber and Handle (Front and Rear) - Condition

- ✓ 1. Change Rear Wiper (Mechanical)
- ✓ 2. Charge Battery
- ✓ 3. Engine Oil & Filter Change

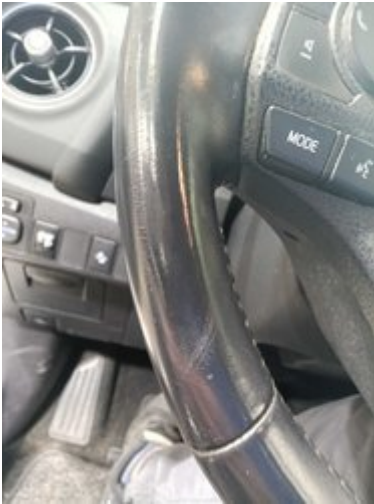
✓ **6. Front:** Steering Wheel - Condition

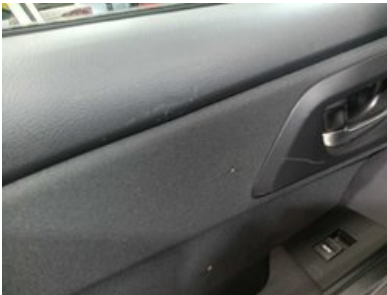
✓ **7. Doors:** Trims - Condition

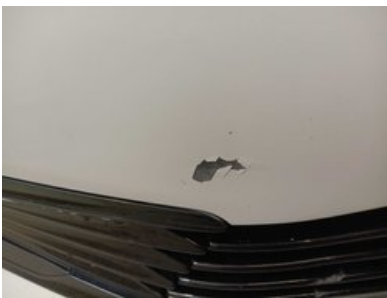
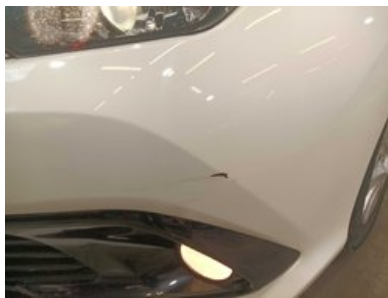
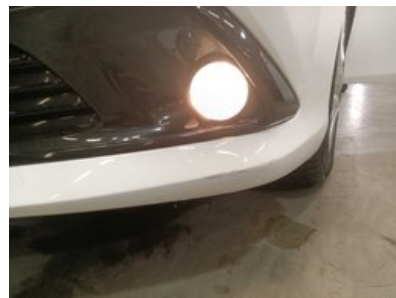
✓ **1. Front:** Front Bumper - Condition and Alignment

- ✓ 1. Paint Door
- ✓ 2. Paint Front Bumper

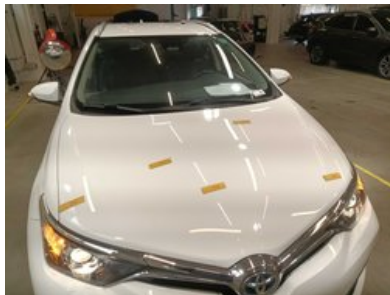
✓ **2. Front:** Hood - Visual Damage

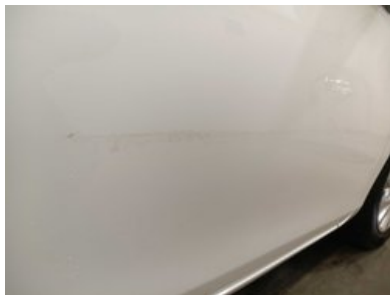
✓ **3. Other:** Additional Polishing Tasks

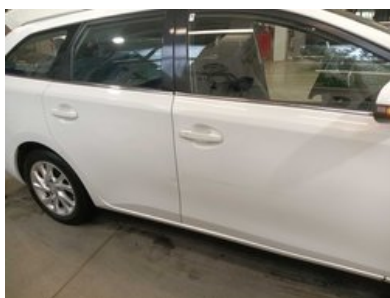
✓ **4. Other:** Additional Polishing Tasks

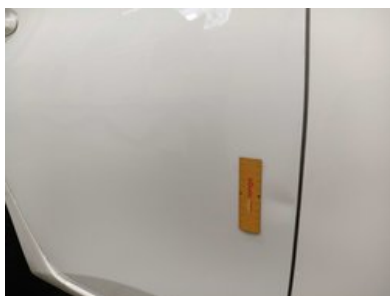
✓ **5. Side:** Left and Right Side - Visual Damage and Scratches

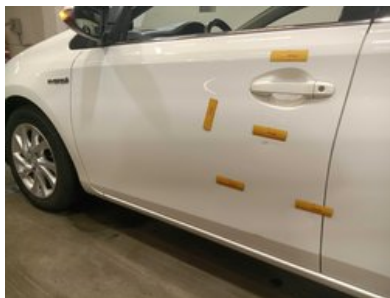
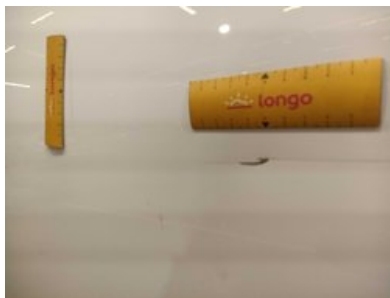
✓ **6. Side:** Left and Right Side - Visual Damage and Scratches
