# Diagnosis report of 2017 TOYOTA AVENSIS Active Plus

# Preparation and repair report of 2017 TOYOTA AVENSIS Active Plus

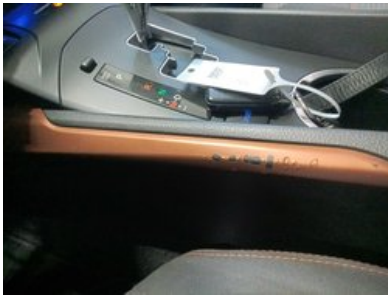
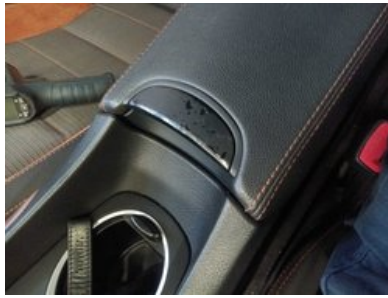
### ✓ 1. Inside: Trims - Condition

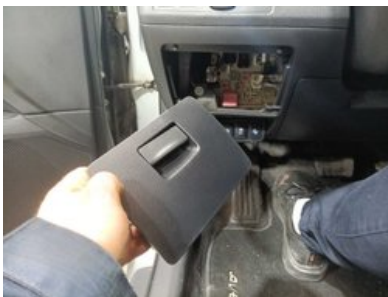
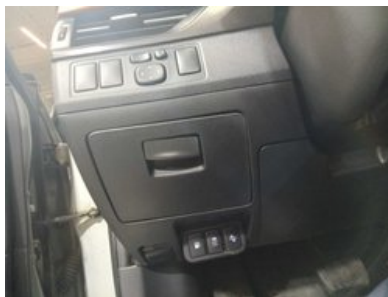
### ✓ 2. Front: Trims - Condition

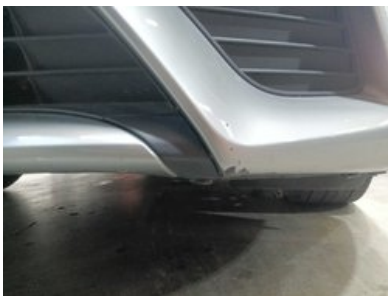
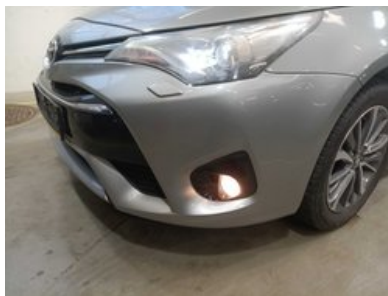
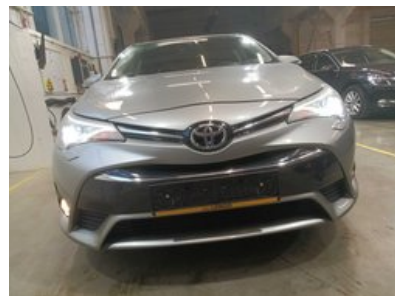
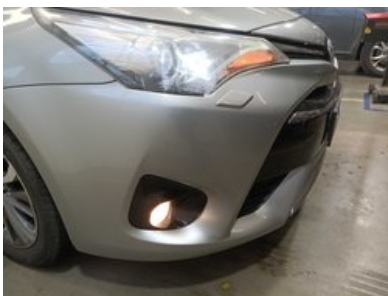
### ✓ 1. Front: Front Bumper - Condition and Alignment

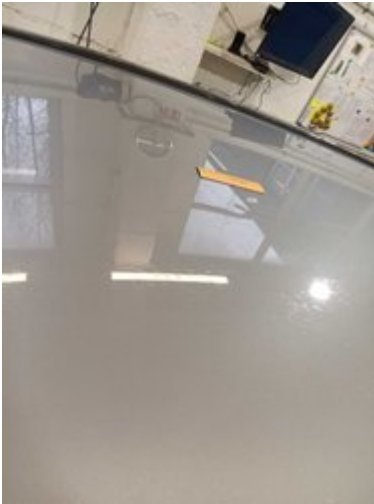
✓ **2. Other:** Roof - Visual Damage (e.g., Hail Damage)

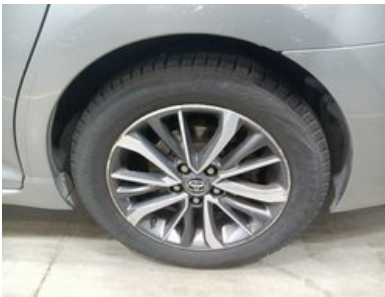
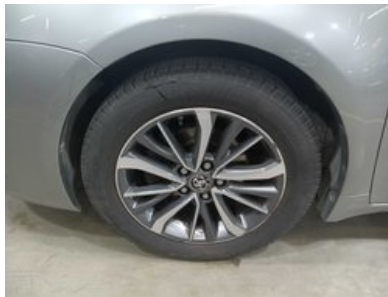
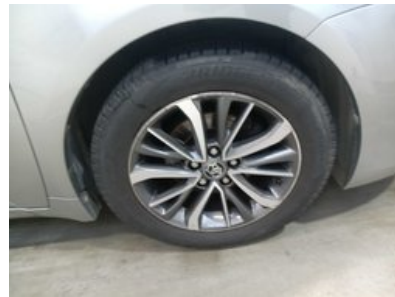
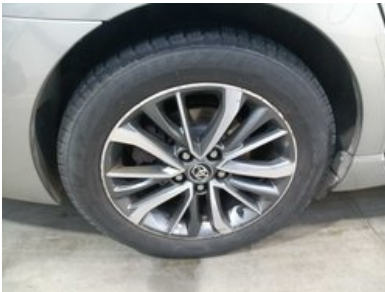
✓ **3. Side:** Wheels - Condition

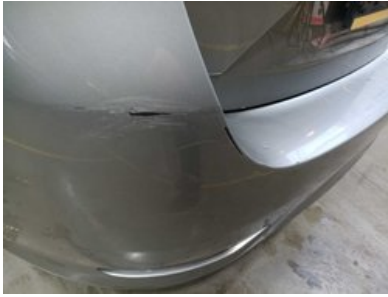
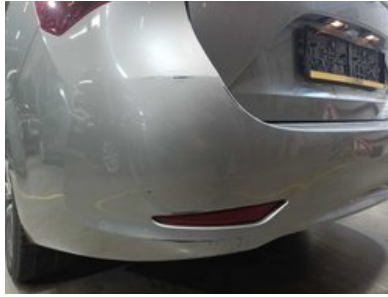
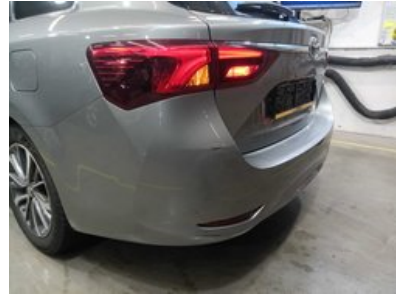
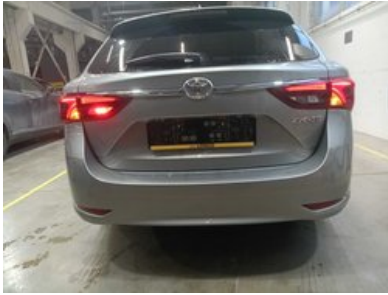
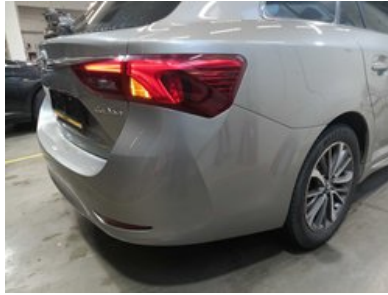
✓ **4. Rear:** Rear Bumper - Condition and Alignment

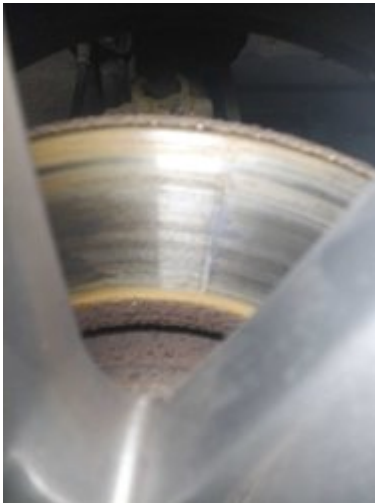
✓ **2. BRAKES:** Front Brake Discs Both

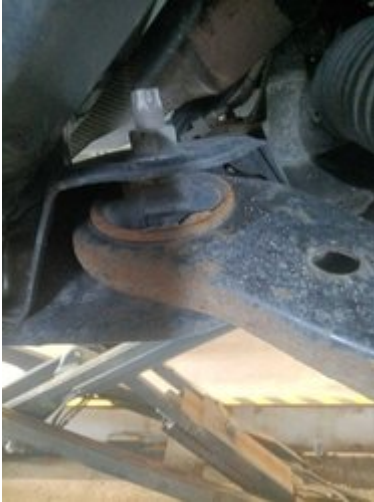
✓ **3. SUSPENSION:** Suspension Lower Arm Both

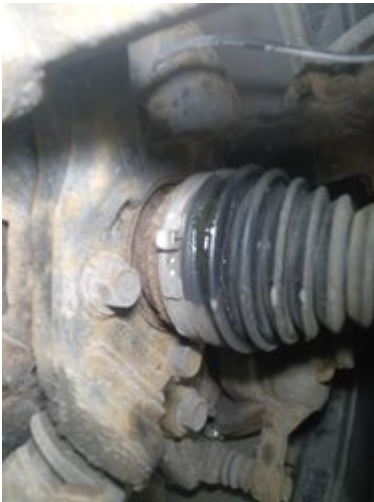
✓ **4. FINAL DRIVE, SHAFT & AXLES:** Driveshaft - Left

- ✓ 1. Driveshaft - Left
- ✓ 2. Engine Oil & Filter Change
- ✓ 3. Battery
- ✓ 4. Driveshaft Left

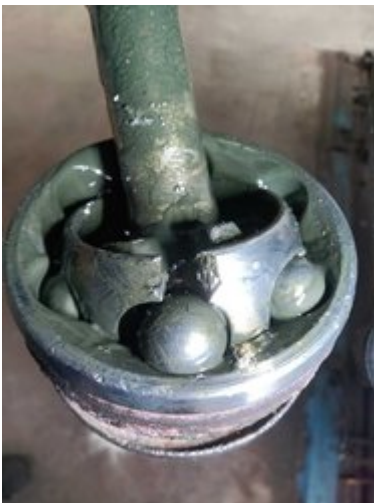
✓ **5. FINAL DRIVE, SHAFT & AXLES:** Driveshaft Left

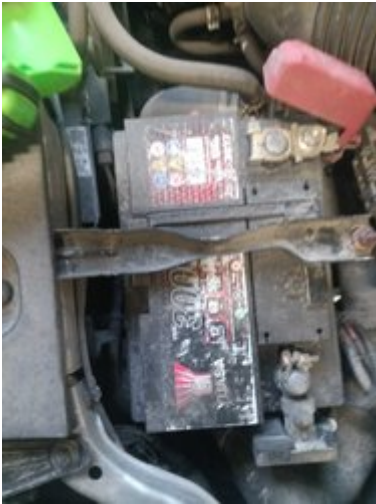
6. GENERAL ELECTRICS: Battery
