# Diagnosis report of 2019 PEUGEOT 308 Allure

During the comprehensive diagnosis conducted by Longo, 9 issues were identified in the vehicle.

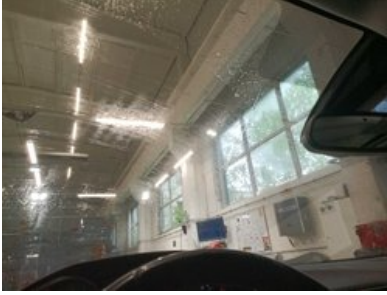
- ✓ **1. Front:** Window Wiper Rubber and Handle (Front and Rear) - Condition

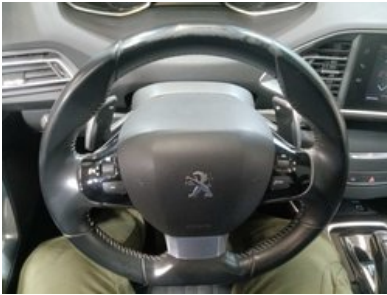
- ✓ **2. Front:** Steering Wheel - Condition

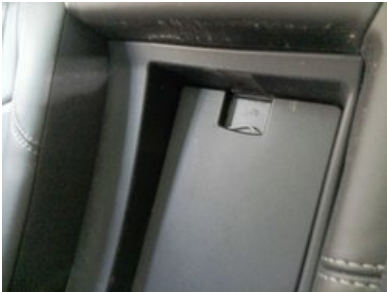
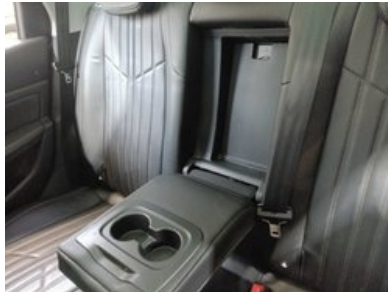
- ✓ **3. Inside:** Armrest - Operation and Condition

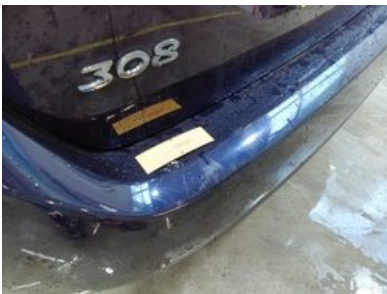
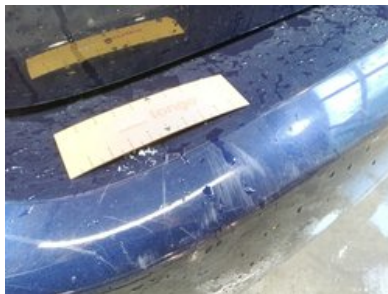
- ✓ **1. Rear:** Rear Bumper - Condition and Alignment

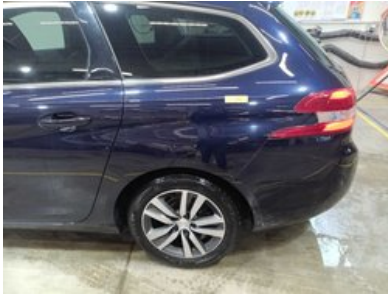
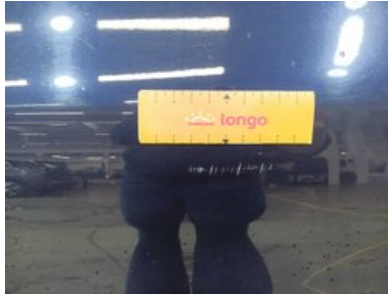
✔ **2. Side:** Left and Right Side - Visual Damage and Scratches

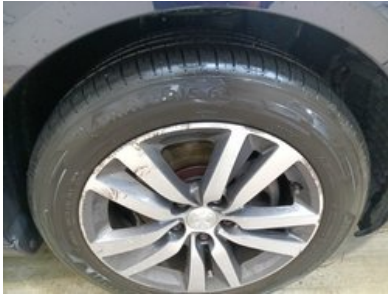
✔ **3. Side:** Wheels - Condition

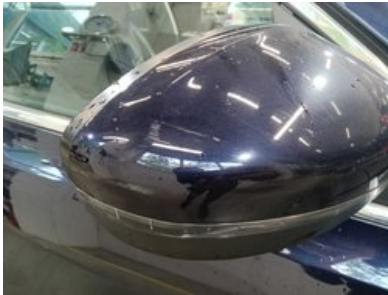
✔ **4. Side:** Exterior Mirrors - Mirror Integrity and Car Attachment
