# Diagnosis report of 2018 TOYOTA AVENSIS Business Edition

Diagnosis report of

2018 TOYOTA AVENSIS Business Edition

Diagnosis details

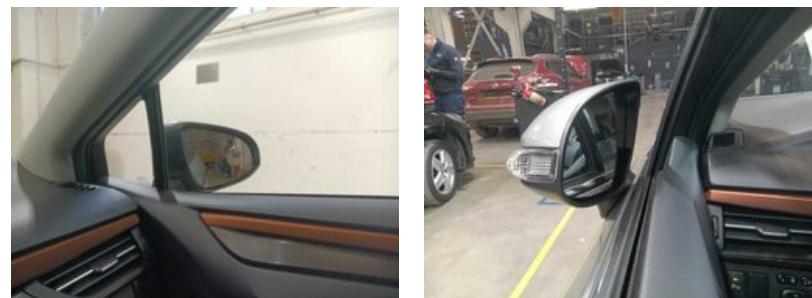
- ✔ 1. Doors: Exterior Side Mirrors - Electronic Controls, Folding, and Adjustment

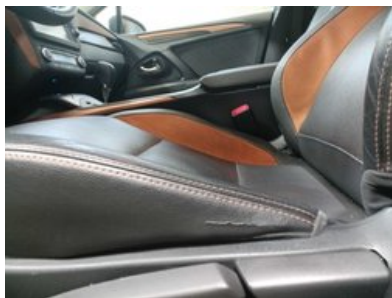
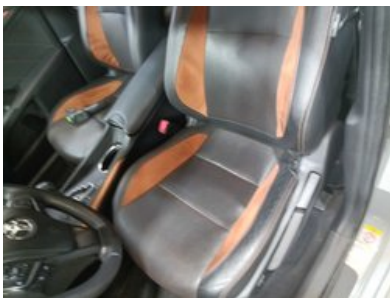
✓ **2. Seats:** All Seats - Condition

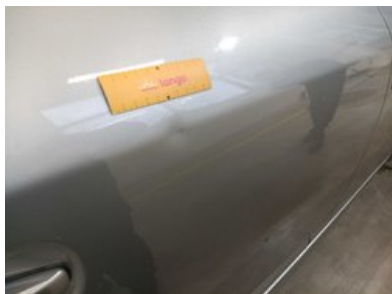
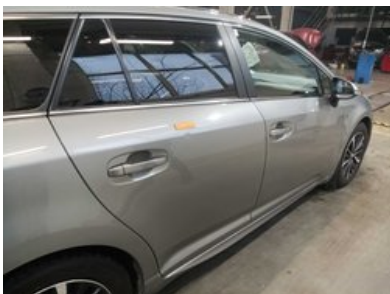
✓ **1. Side:** Left and Right Side - Visual Damage and Scratches

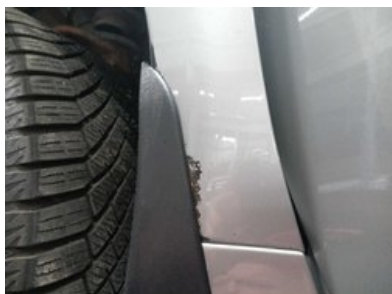
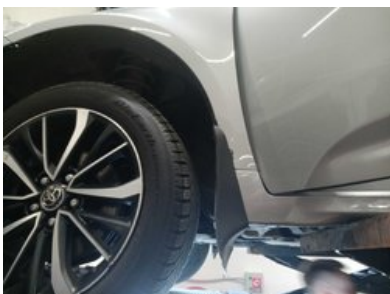
✓ **2. Side:** Left and Right Side - Visual Damage and Scratches

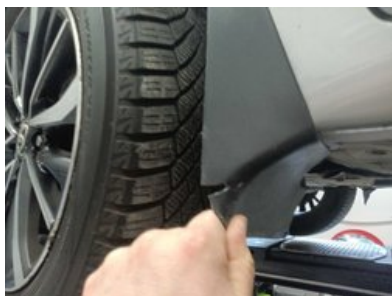
✓ **3. Side:** Left and Right Side - Visual Damage and Scratches

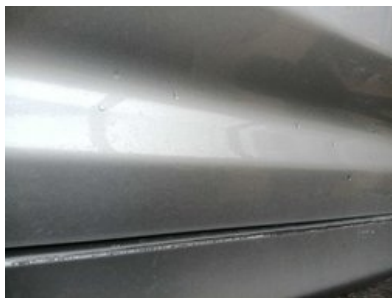
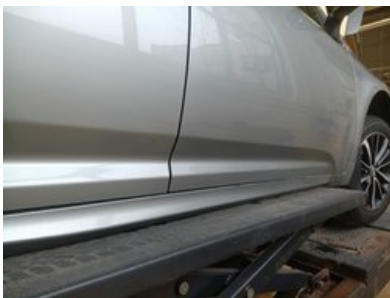
✓ **4. Side:** Left and Right Side - Visual Damage and Scratches

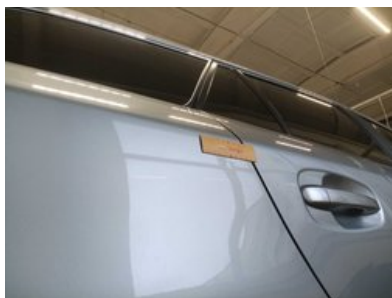
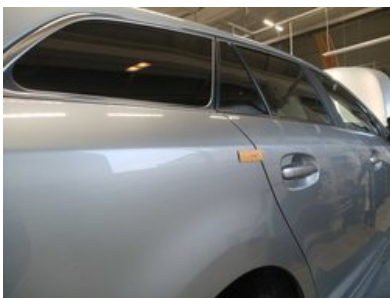
✓ **5. Side:** Left and Right Side - Visual Damage and Scratches

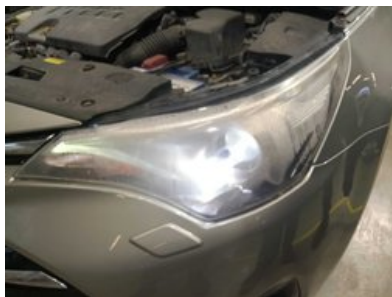
✓ **6. Lights:** Front Lights (City, Regular, Full Headlight, Fog, Indicator) - Basic Functioning, Damage, and Color

- ✓ 1. Repair Front Lights (External)
- ✓ 2. Headlamp Alignment

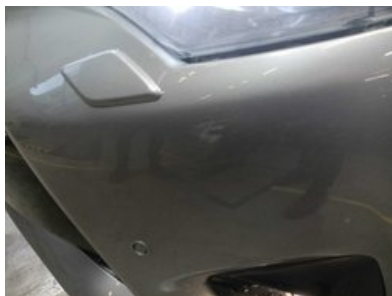
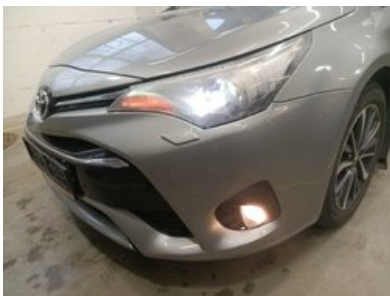
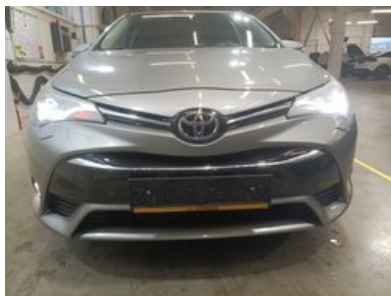
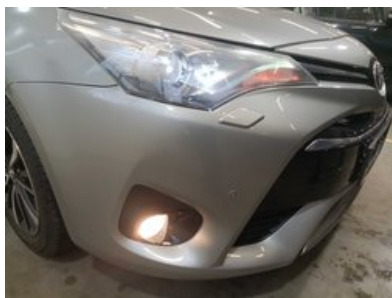
✓ **7. Front:** Front Bumper - Condition and Alignment

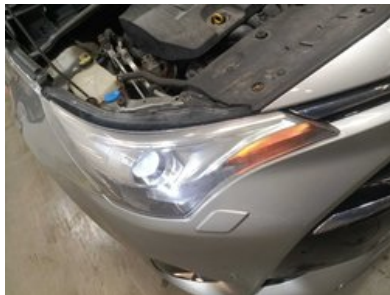
✓ **8. Other:** Additional Polishing Tasks

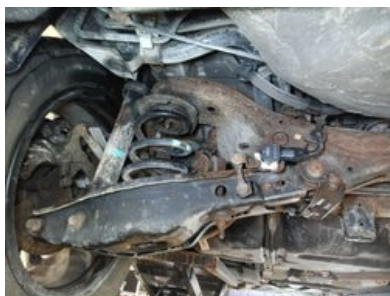
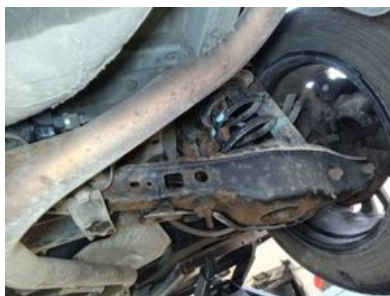
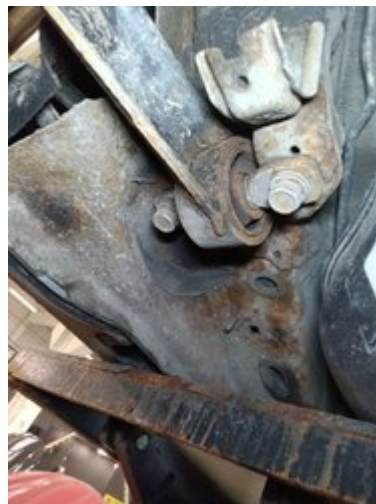
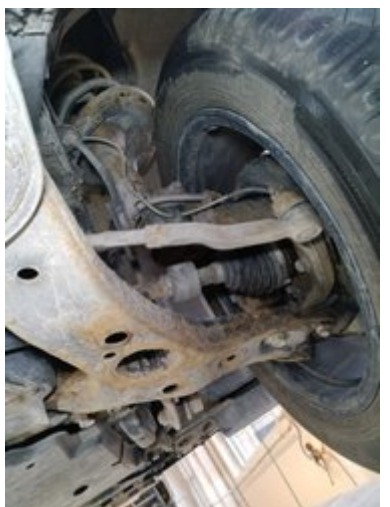
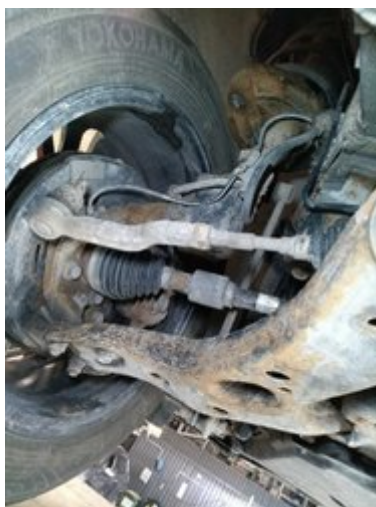
✓ **3. BODY - CENTRE SECTION:** Corrosion

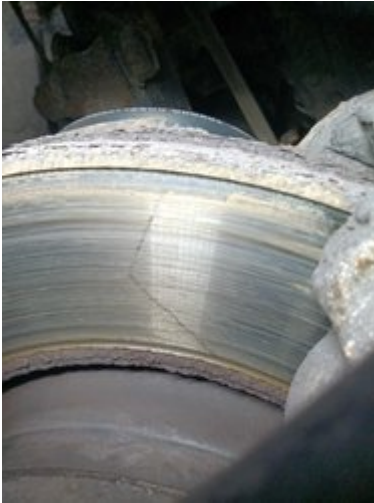
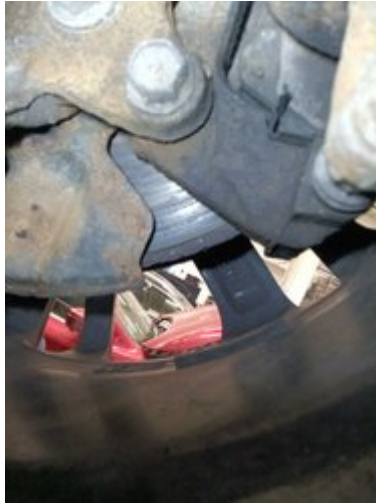
✓ **4. BRAKES:** Front Brake Discs Both

- ✓ 1. Front Anti-Roll Bar Link Both Sides
- ✓ 2. Engine Oil & Filter Change
- ✓ 3. Front Brake Discs (Both)
- ✓ 4. Charge Battery

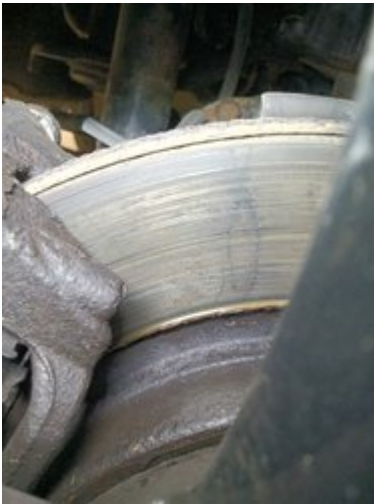
✓ **5. BRAKES:** Rear Brake Disc (Both)

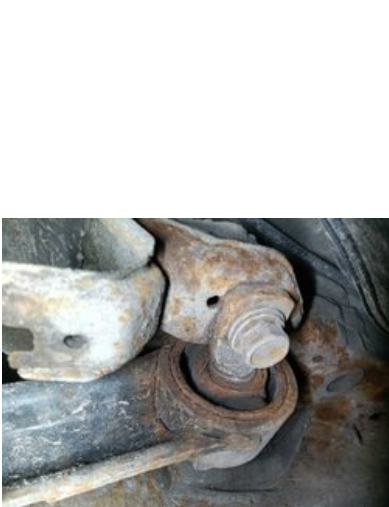
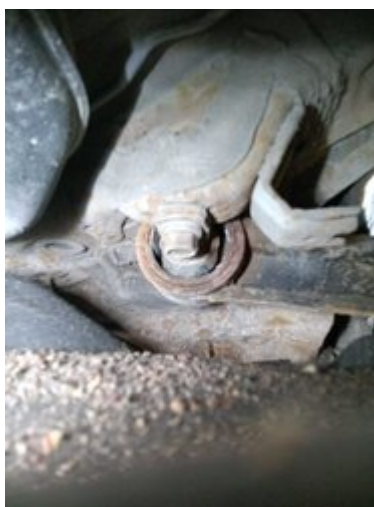
✓ **6. SUSPENSION:** Rear Suspension Trailing Arm Bushings

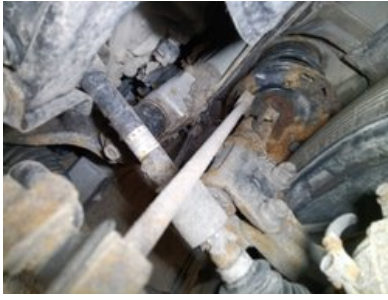
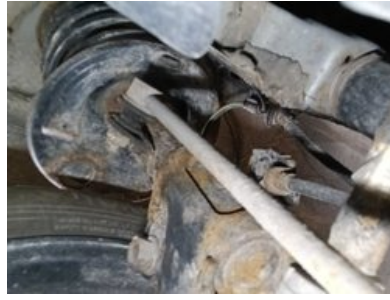
✔ **7. SUSPENSION:** Front Anti-Roll Bar Links Both Sides

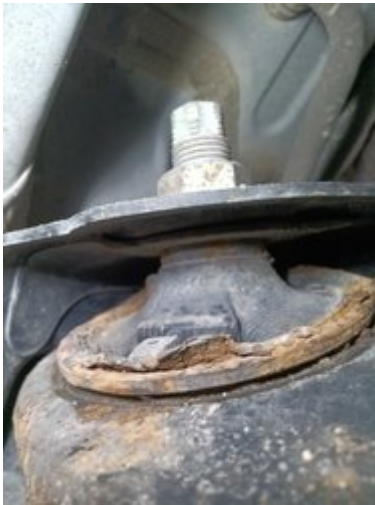
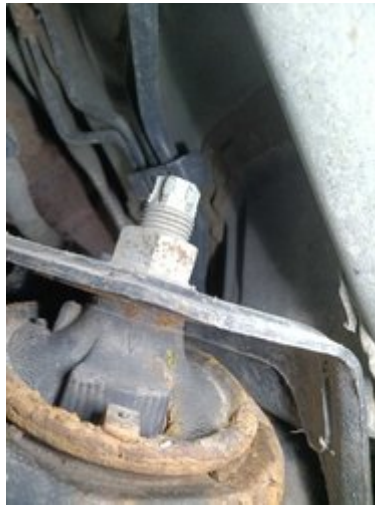
✔ **8. SUSPENSION:** Suspension Lower Arm Both
