# Diagnosis report of 2018 PEUGEOT RIFTER Allure

# Preparation and repair report of 2018 PEUGEOT RIFTER Allure

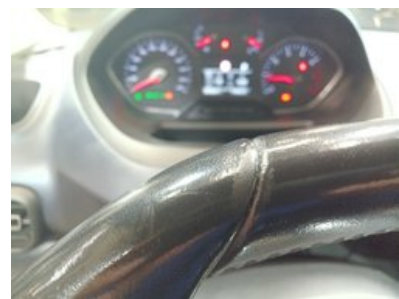
- ✔ 1. Front: Steering Wheel - Condition

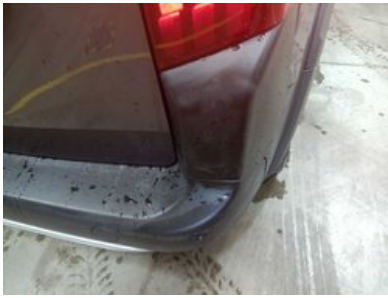
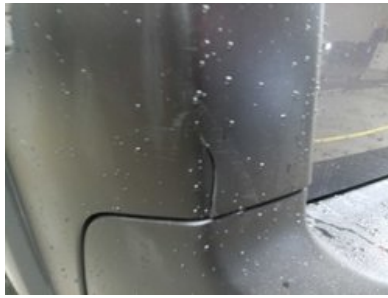
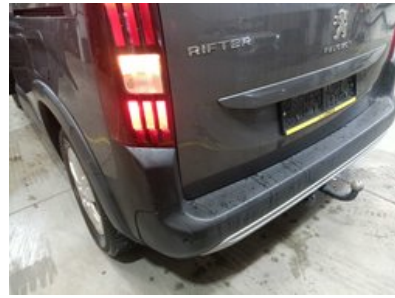
- ✓ **1. Rear:** Rear Bumper - Condition and Alignment

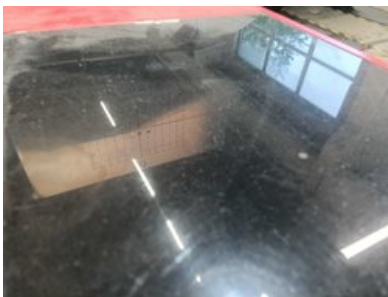
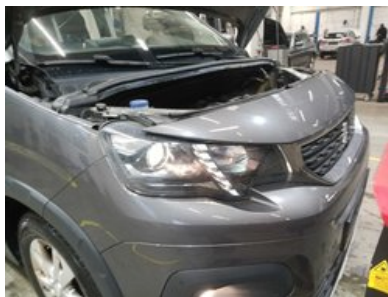
- ✓ **2. Lights:** Light Bulbs

- ✓ 1. Change Bulb for Headlights
- ✓ 2. Charge Battery
- ✓ 3. Engine Oil & Filter Change

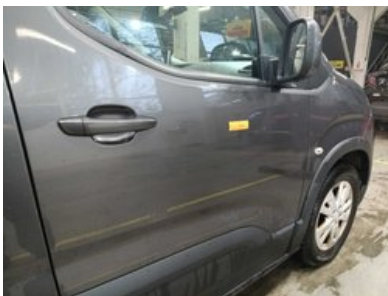
- ✓ **3. Side:** Left and Right Side - Visual Damage and Scratches
