# Diagnosis report of 2017 FORD KUGA ST Line

This vehicle has been inspected in accordance with the Longo 150-point checklist, covering the body exterior, interior, and mechanical condition. Based on the inspection performed and the information available at the time of assessment, no indications of involvement in major accidents were identified. Information regarding maintenance history and mandatory roadworthiness inspections is based on available documentation and records from the country of export. Please note that certain general wear and tear issues are considered acceptable and may not be repaired.

During the comprehensive diagnosis conducted by Longo, 11 issues were identified in the vehicle.

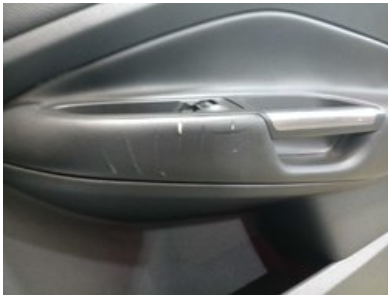
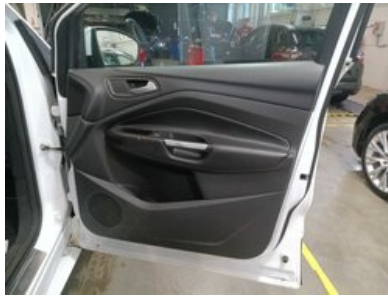
### ✓ 1. Doors: Trims - Condition

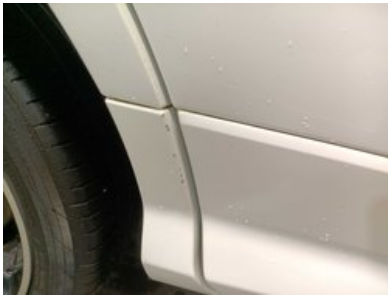
### ✓ 1. Side: Left and Right Side - Visual Damage and Scratches

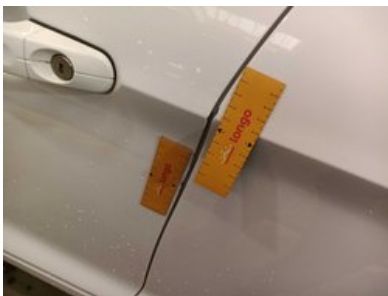
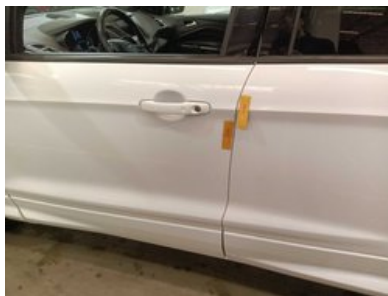
### ✓ 2. Side: Left and Right Side - Visual Damage and Scratches

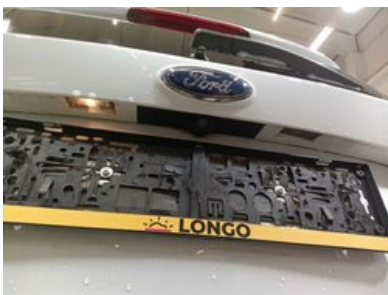
### ✓ 3. Lights: Light Bulbs

- ✓ 1. System Evacuation/Recharging
- ✓ 2. Other: Engine Mount
- ✓ 3. Change Bulb for License Plate Lights

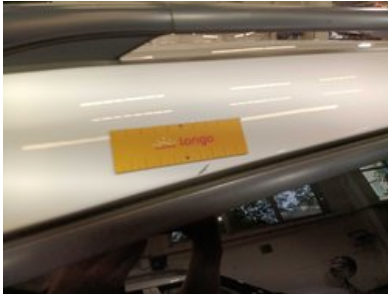
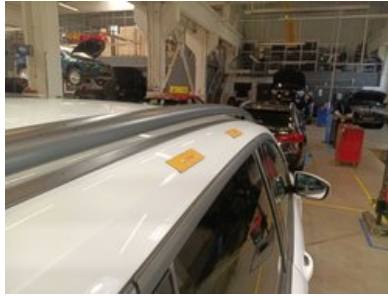
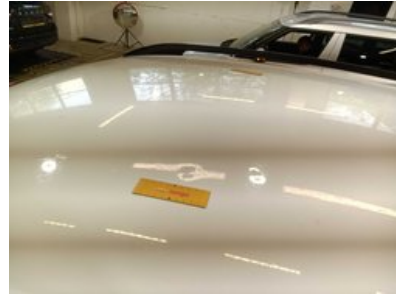
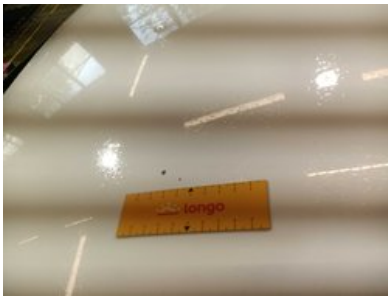
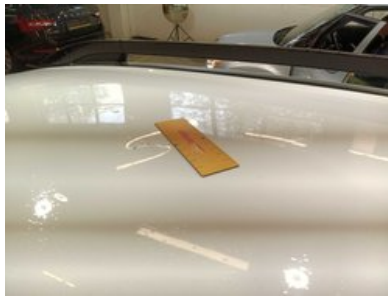
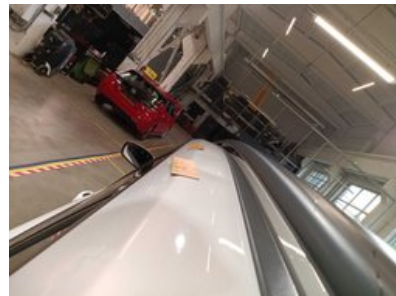
✓ **4. Other:** Roof - Visual Damage (e.g., Hail Damage)

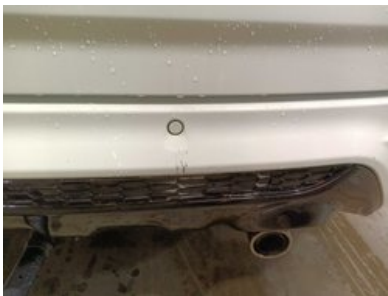
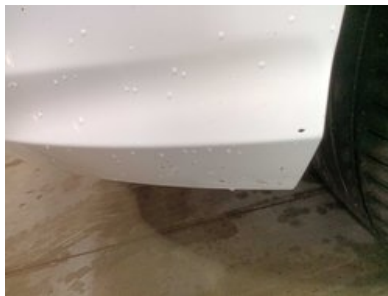
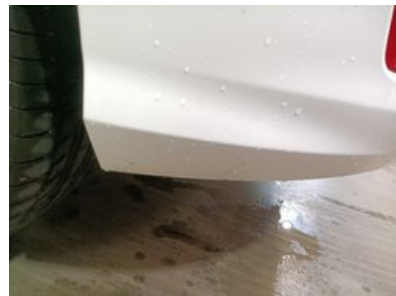
✓ **5. Rear:** Rear Bumper - Condition and Alignment

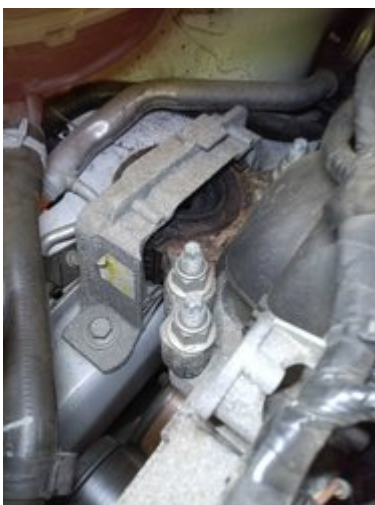
✓ **1. ENGINE:** Engine Mount

- 1. Refrigerant R1234YF (R1234YF)
- 2. Engine Mounting (RH11-4060)

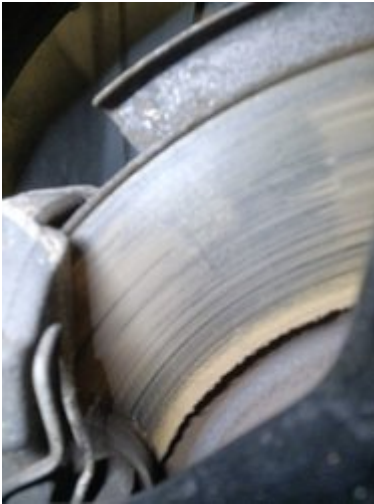
✓ **2. BRAKES:** Front Brake Discs Both

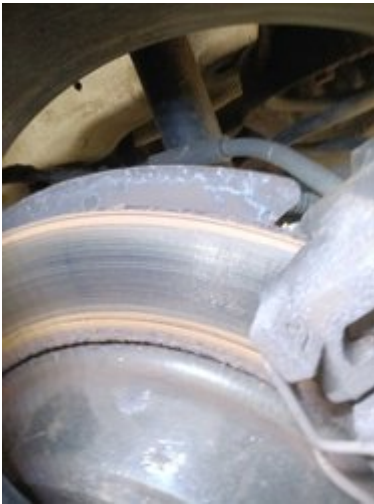
✓ **3. BRAKES:** Rear Brake Disc (Both)

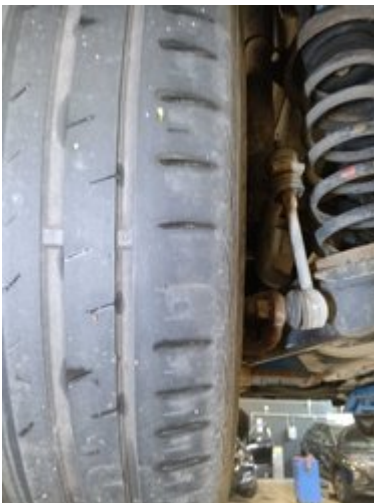
✓ **4. OTHER:** Change Tires

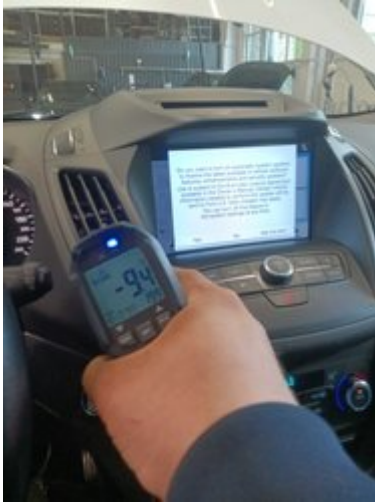
✓ **5. AIR CONDITIONING AND HEATING:** System Evacuation/Recharging
