# Diagnosis report of 2016 KIA CARENS Dream Team

# Preparation and repair report of 2016 KIA CARENS Dream Team

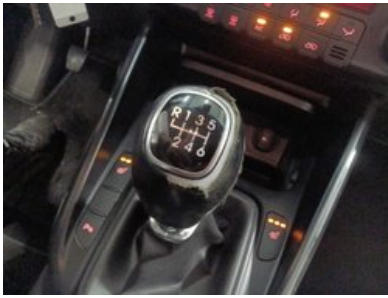
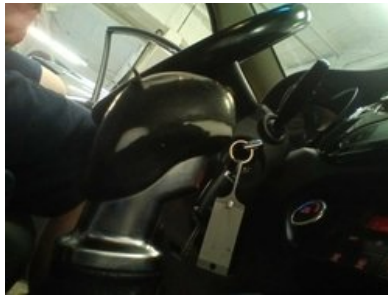
- ✓ **1. Inside:** Gear Shift Boot and Gear Shift Knob - Condition

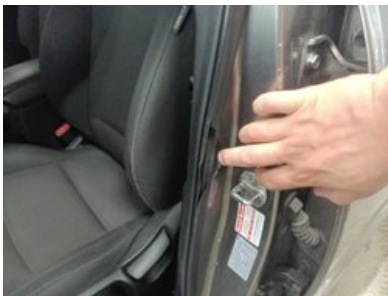
- ✓ **2. Doors:** Door Rubber Seals

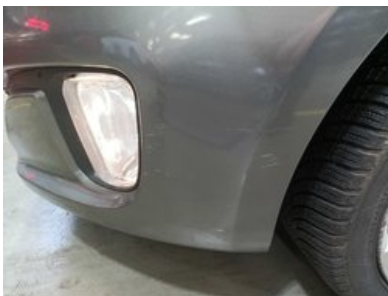
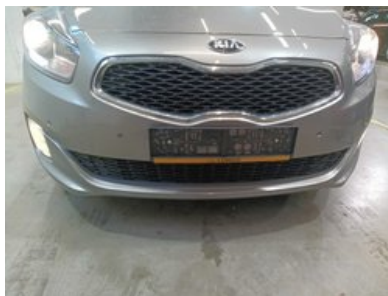
- ✓ **1. Front:** Front Bumper - Condition and Alignment

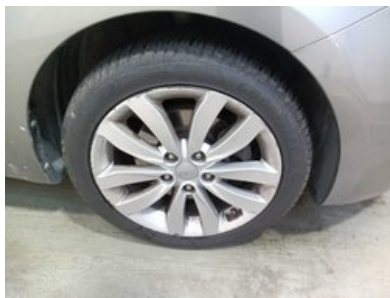
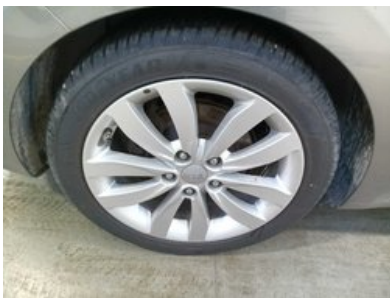
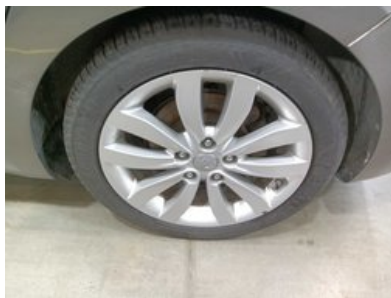
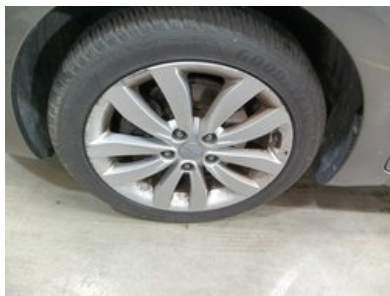
✓ **2. Side:** Wheels - Condition

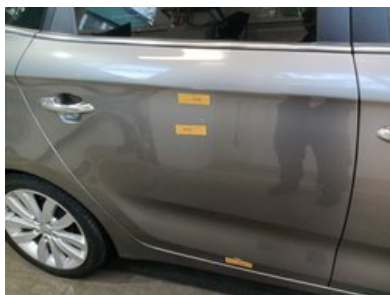
✓ **3. Side:** Left and Right Side - Visual Damage and Scratches

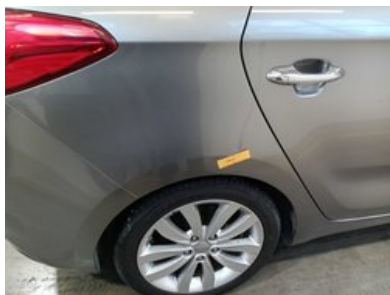
✓ **4. Side:** Left and Right Side - Visual Damage and Scratches

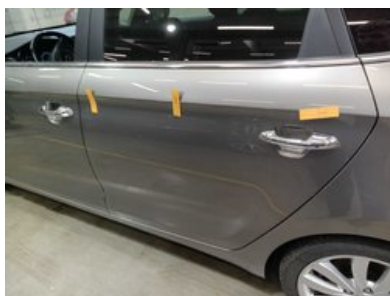
✓ **5. Side:** Left and Right Side - Visual Damage and Scratches

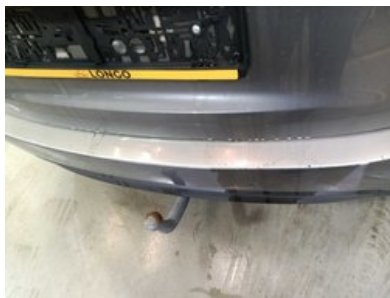
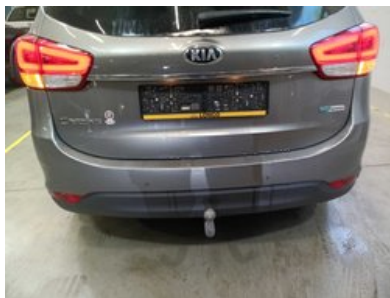
✓ **6. Rear:** Rear Bumper - Condition and Alignment

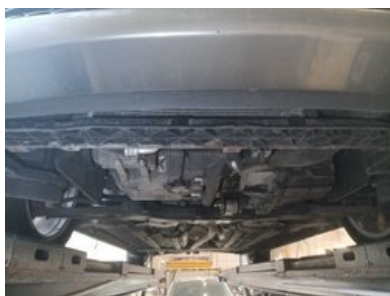
✓ **1. BODY - FRONT SECTION:** Missing Engine Cover

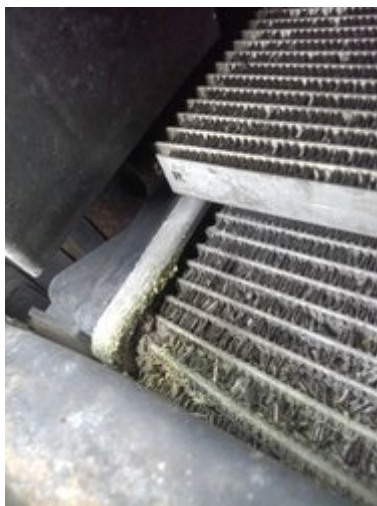
✓ **3. COOLING SYSTEM:** Radiator

- ✓ 1. Engine Oil & Filter Change
- ✓ 2. Radiator

- 1. Oil Filter (OE674/5)
- 2. Total Ineo First OW30 208L 5.3L
- 3. Oil Drain Plug (EL726760)
- 4. Engine Radiator (D70320TT)
