# Diagnosis report of 2014 TOYOTA AURIS Executive

During the comprehensive diagnosis conducted by Longo, 9 issues were identified in the vehicle.

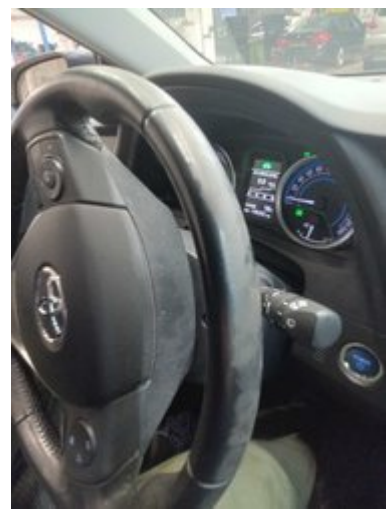
- ✔ 1. Inside: Additional Cleaning Tasks

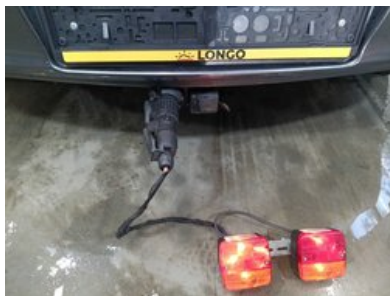
- ✓ **1. Rear:** Tow Hitch (Attachment, Removal Mechanism, External Light Connector, Connector Thickness)

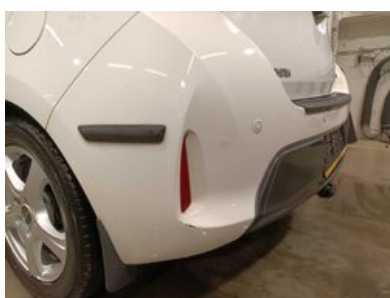
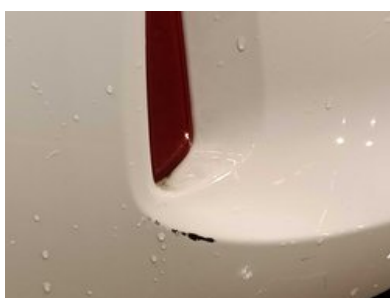
- ✓ **2. Rear:** Rear Bumper - Condition and Alignment

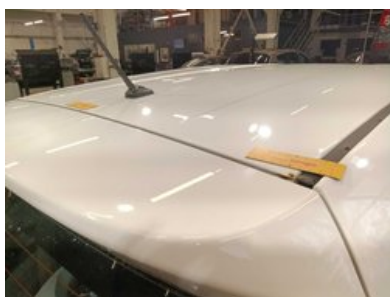
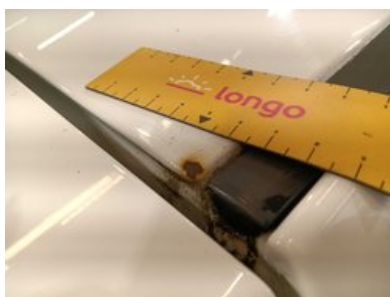
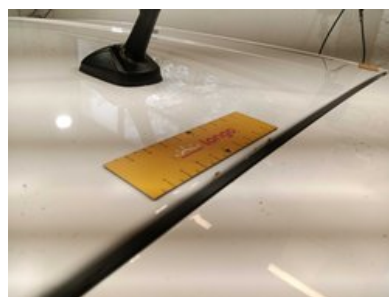
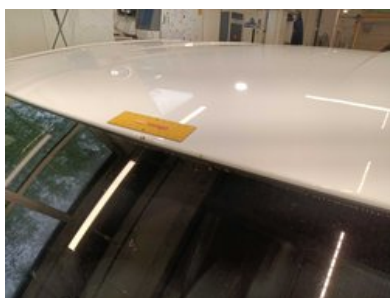
- ✓ **3. Other:** Roof - Visual Damage (e.g., Hail Damage)

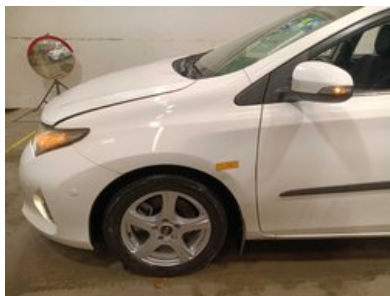
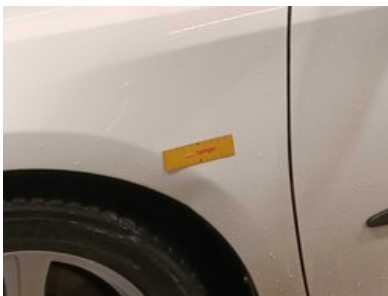
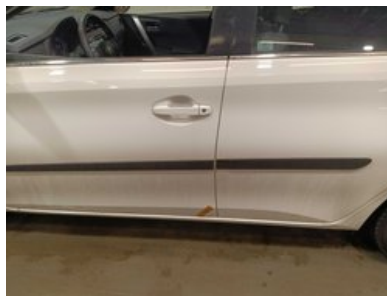
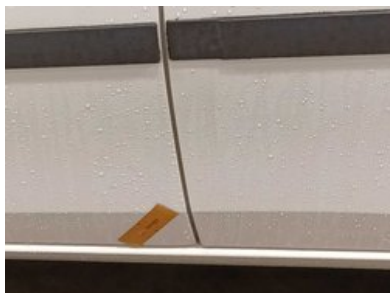
✓ **4. Side:** Left and Right Side - Visual Damage and Scratches

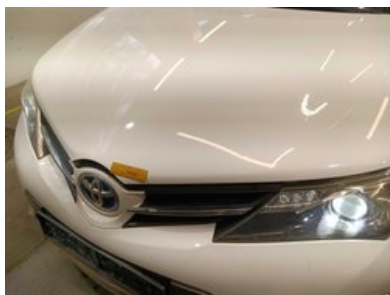
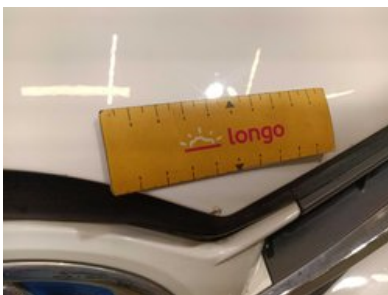
✓ **5. Front:** Hood - Visual Damage
