# Diagnosis report of 2020 PEUGEOT 3008 Executive

During the comprehensive diagnosis conducted by Longo, 4 issues were identified in the vehicle.

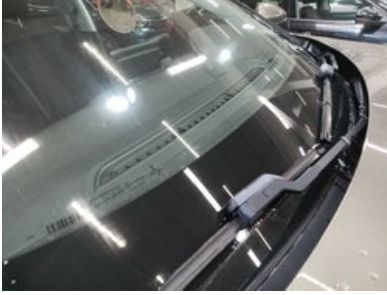
- ✓ **1. Front:** Window Wiper Rubber and Handle (Front and Rear) - Condition

- ✓ 1. Change Front Wiper (Mechanical)

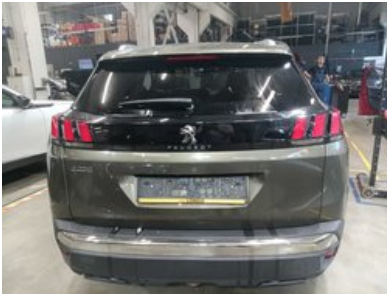
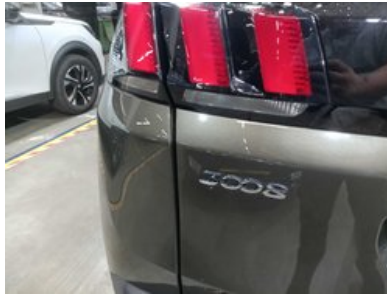
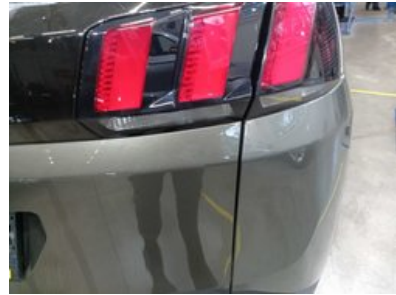
- ✓ **1. Rear:** Trunk - Visual Damage

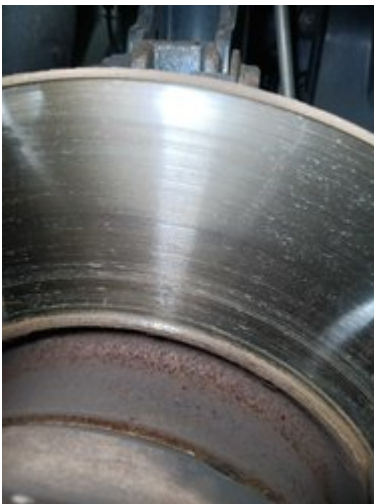
- ✓ **1. BRAKES:** Front Brake Discs Both

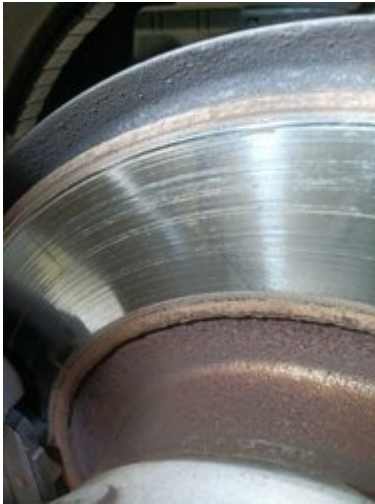
✓ **2. BRAKES:** Rear Brake Disc (Both)
