# Diagnosis report of 2015 TOYOTA AURIS Aspiration

Mileage on completion date: 183 122 km

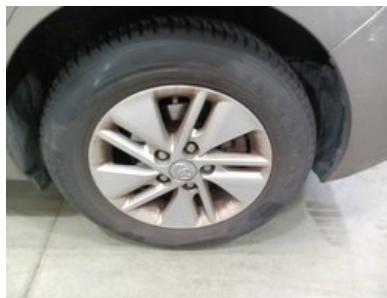
✓ **4. Side:** Wheels - Condition

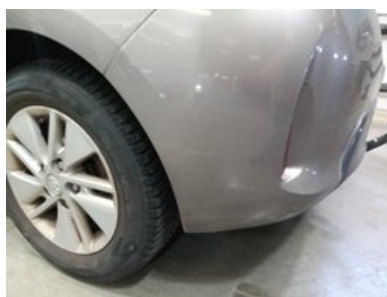
✓ **7. Rear:** Rear Bumper - Condition and Alignment
