# Diagnosis report of 2019 PEUGEOT 3008 Access

# Preparation and repair report of 2019 PEUGEOT 3008 Access

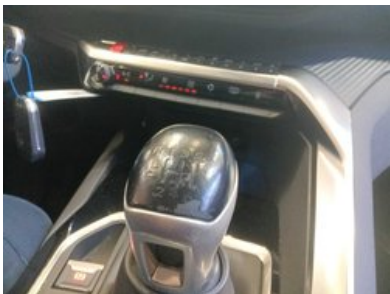
- ✔ **1. Inside:** Gear Shift Boot and Gear Shift Knob - Condition

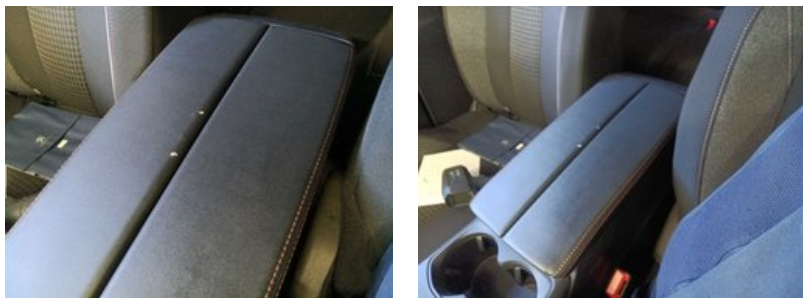
✔ **2. Inside:** Armrest - Operation and Condition

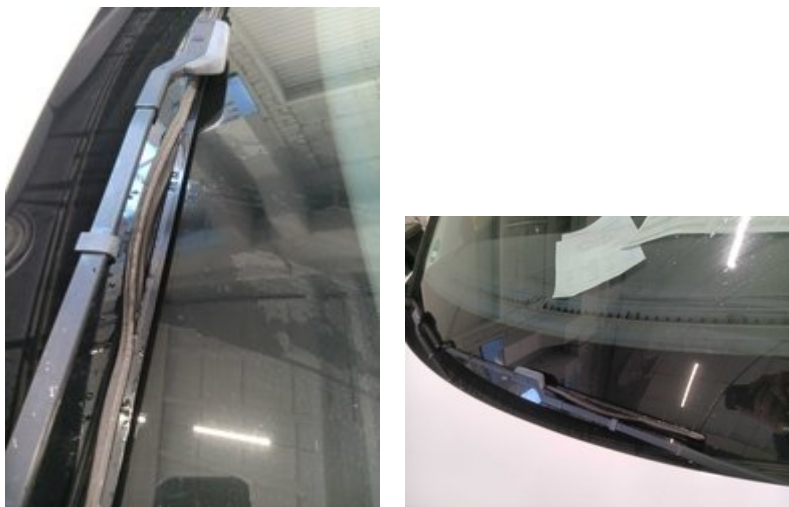
✔ **3. Front:** Window Wiper Rubber and Handle (Front and Rear) - Condition

- ✓ 1. Change Bulb for License Plate Lights
- ✓ 2. Front Brake Pads (All)
- ✓ 3. Battery
- ✓ 4. Engine Oil & Filter Change
- ✓ 5. Change Front Wiper (Mechanical)

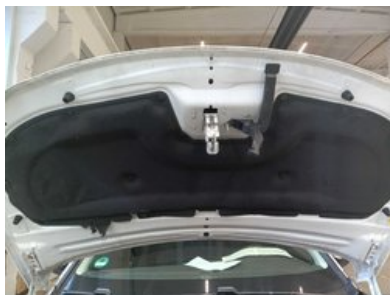
✔ **1. Front:** Hood Sound Insulation - Condition

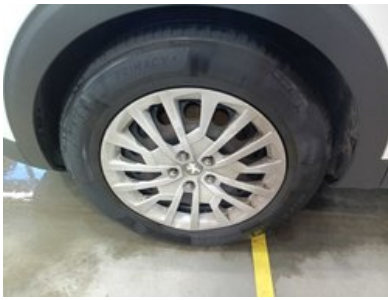
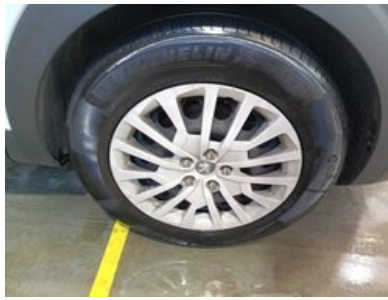
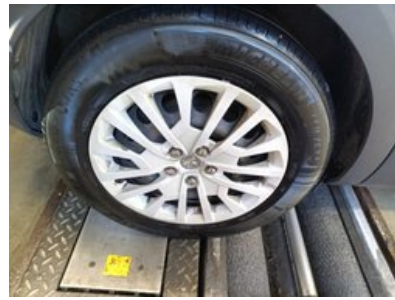
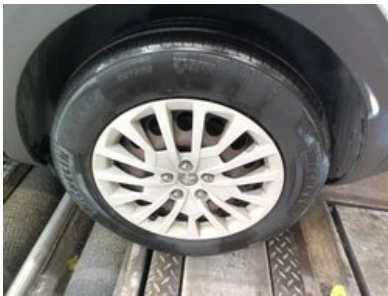
✓ **2. Side:** Wheels - Condition

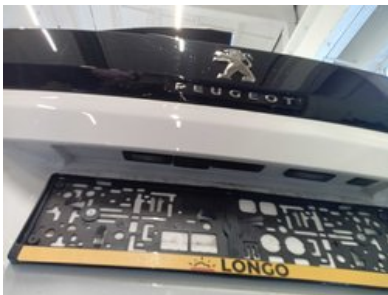
✓ **3. Lights:** Light Bulbs

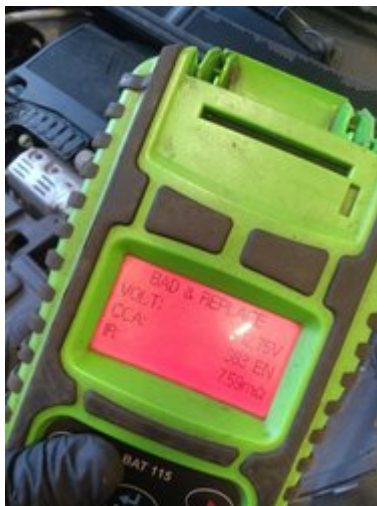
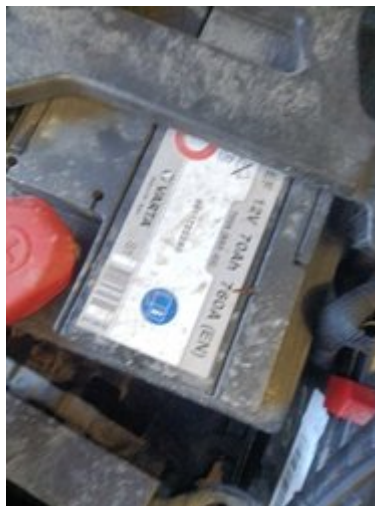
✓ **3. GENERAL ELECTRICS:** Battery

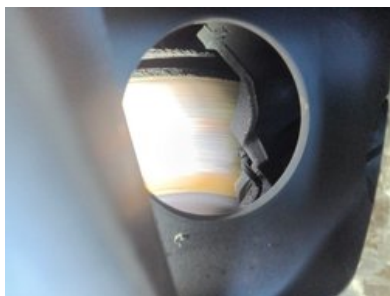
✓ **4. BRAKES:** Front Brake Pads (All)
