Diagnosis report of 2017 PEUGEOT 3008 Première

Preparation and repair report of 2017 PEUGEOT 3008 Première

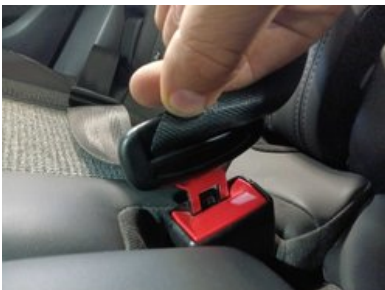
- ✔ **1. Seats:** Seatbelts - Functioning and Locking Mechanism

- ✓ 1. Change Seatbelts / Mountings

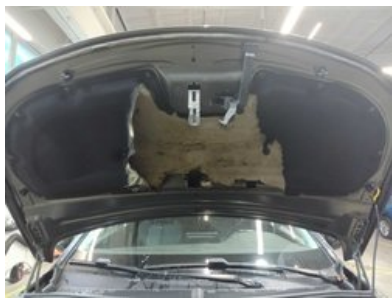
✔ 1. Front: Hood Sound Insulation - Condition

- ✓ 1. Change Hood Sound Insulation
- ✓ 2. Camshaft Drive Belt
- ✓ 3. Change Bulb for Headlights
- ✓ 4. Engine Oil & Filter Change
- ✓ 5. Anti-Roll Bar Link - Outer (Both)

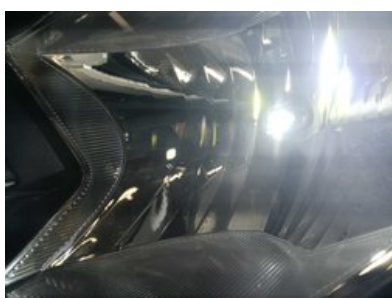
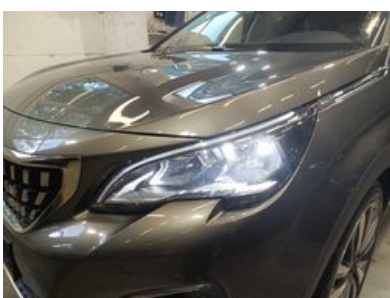
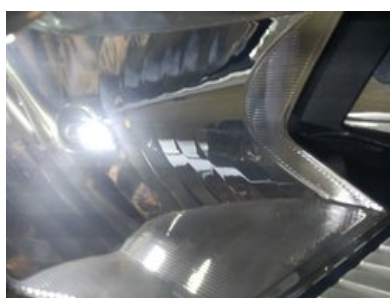
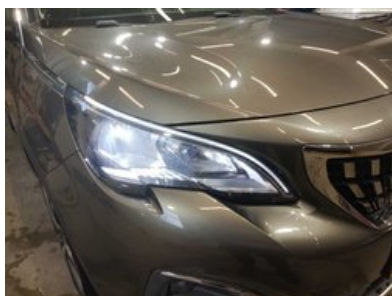
✔ 2. Lights: Light Bulbs

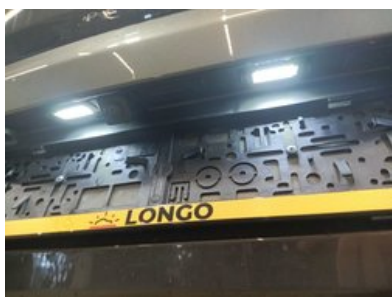
✔ 3. Lights: License Plate Lighting System - Functioning

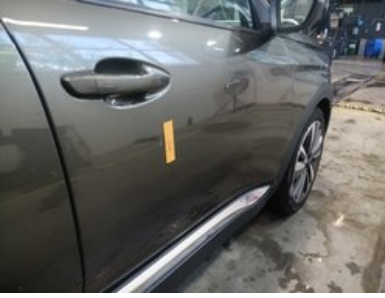
✓ **4. Side:** Left and Right Side - Visual Damage and Scratches

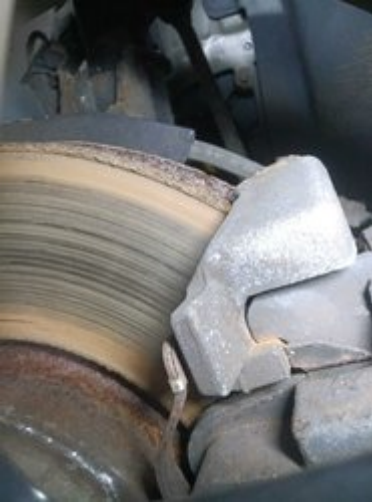
✔ **3. BRAKES:** Front Brake Discs Both

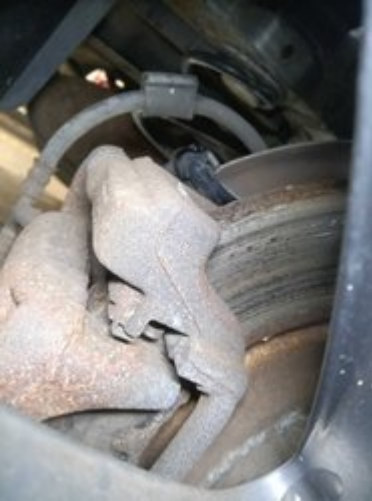
✔ **4. BRAKES:** Rear Brake Disc (Both)

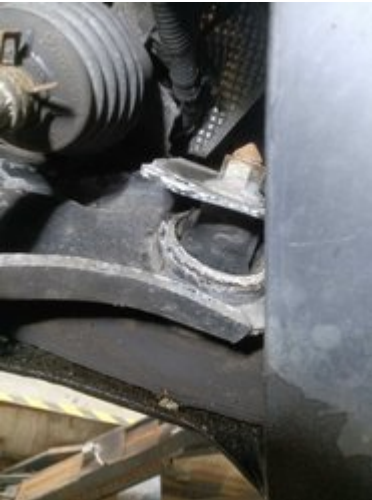
✔ **5. SUSPENSION:** Suspension Lower Arm Bushes Both
