# Diagnosis report of 2020 PEUGEOT 5008 GT-Line

| VIN Code: VF3MRHNSMKL131339 | Fuel consumption: 5.10 l/100km |

During the comprehensive diagnosis conducted by Longo, 12 issues were identified in the vehicle.

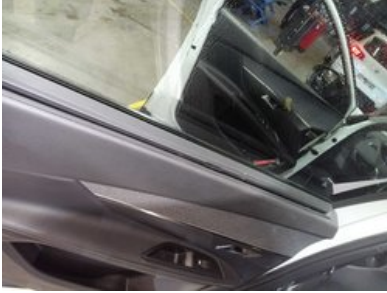
### ✓ 1. Doors: Electronic Window Operation - All Windows

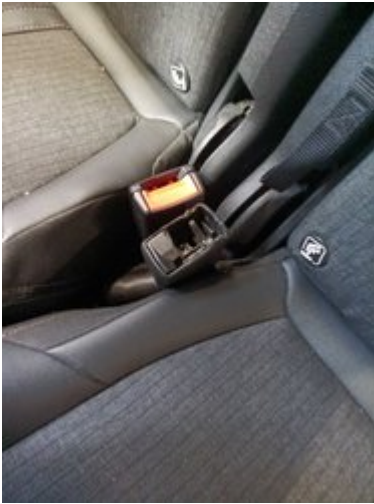
### ✓ 2. Seats: Seatbelts - Functioning and Locking Mechanism

- ✓ 1. Change Seatbelts / Mountings
- ✓ 2. Paintless Dent Repair

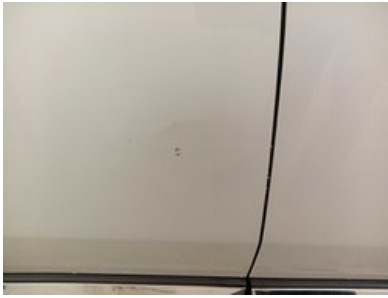
✓ **2. Side:** Left and Right Side - Visual Damage and Scratches

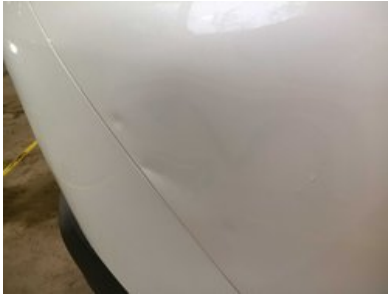
✓ **3. Side:** Left and Right Side - Visual Damage and Scratches

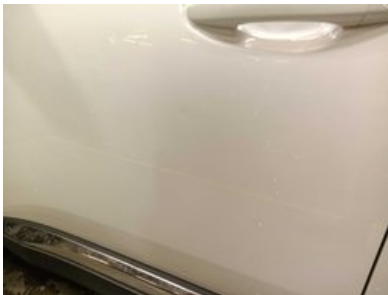
✓ **4. Side:** Left and Right Side - Visual Damage and Scratches

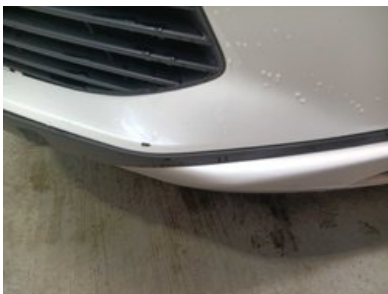
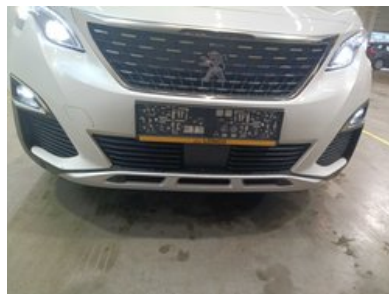
✓ **5. Front:** Front Bumper - Condition and Alignment

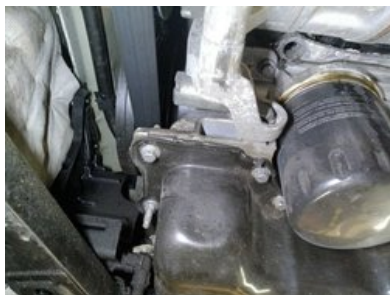
### ✓ 3. OTHER: Oil Pan

- 1. Oil Filter (OP540/1)
- 2. Oil Pan Gasket (834.823)
- 3. 5W30 Quartz Ineo RCP 208L (5W30 QUARTZ INEO RCP 208L)
- 4. Rear Seatbelt Buckle 5008 II 9828112777 9809500380 (VYG26636)

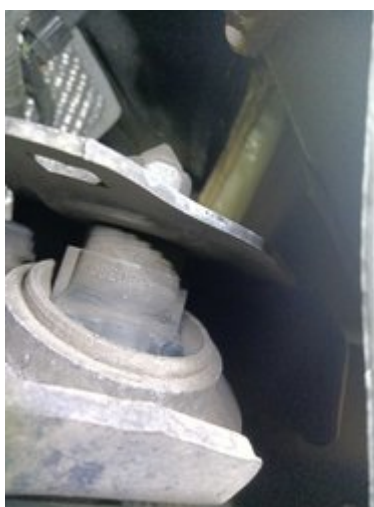
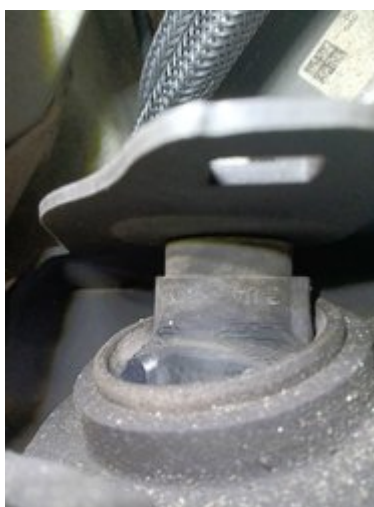
### ✓ 5. OTHER: Suspension Lower Arm
