# Diagnosis report of 2019 OPEL Grandland X Business Edition

Diagnosis report of

2019 OPEL Grandland X Business Edition

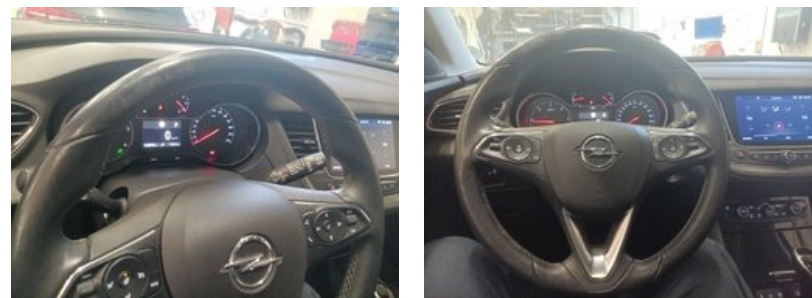
- ✔ 1. Front: Steering Wheel - Condition

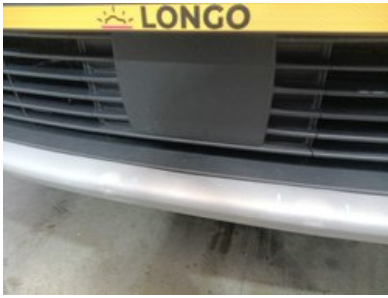
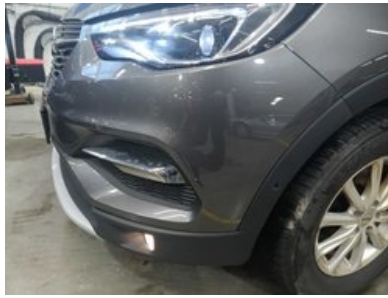
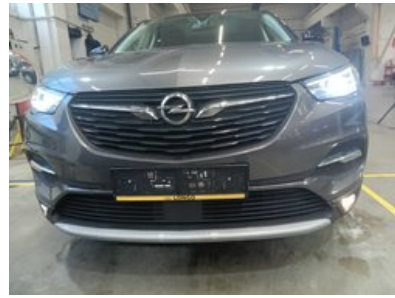
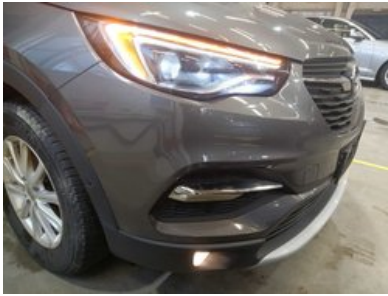
### ✓ 1. Front: Front Bumper - Condition and Alignment

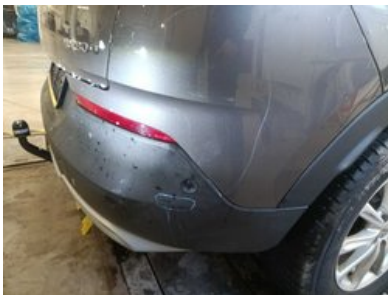
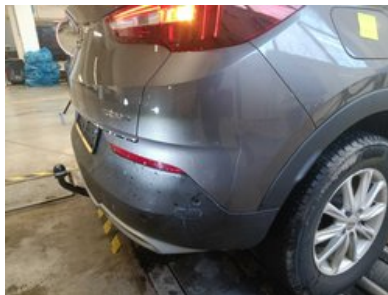
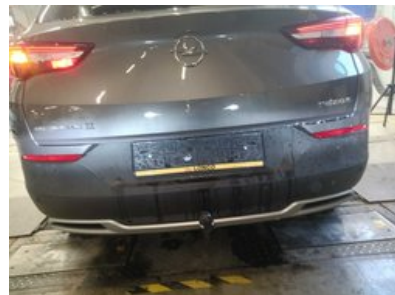
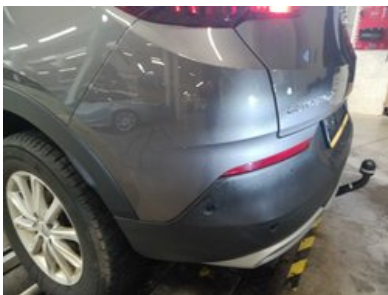
### ✓ 2. Rear: Rear Bumper - Condition and Alignment

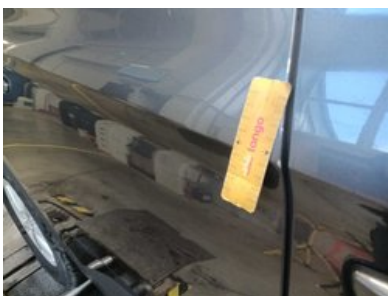
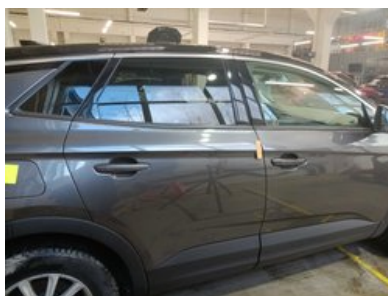
### ✓ 3. Side: Left and Right Side - Visual Damage and Scratches

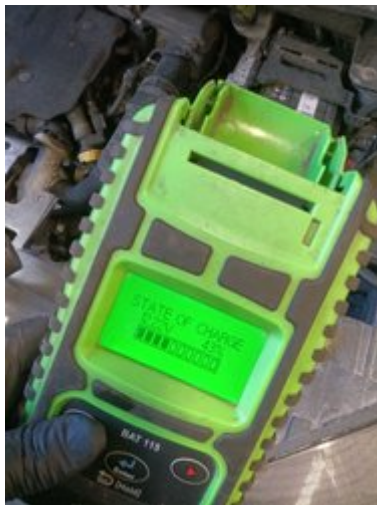
- ✓ 1. OTHER: Engine Oil & Filter Change
- ✓ 2. OTHER: Charge Battery

- ✓ 1. Charge Battery
- ✓ 2. Engine Oil & Filter Change

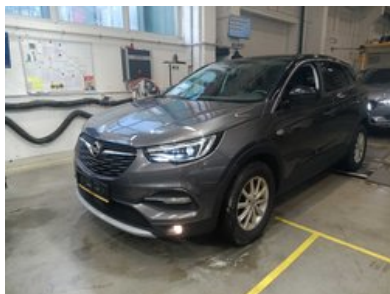
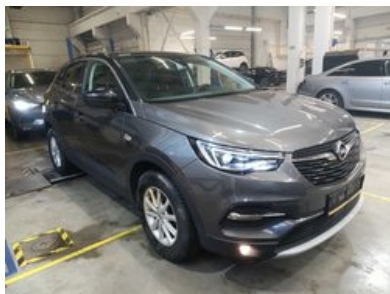
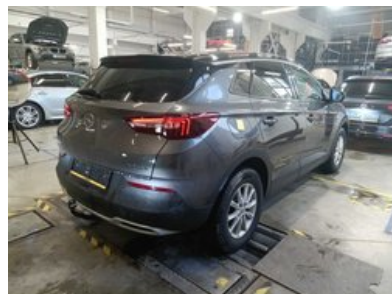
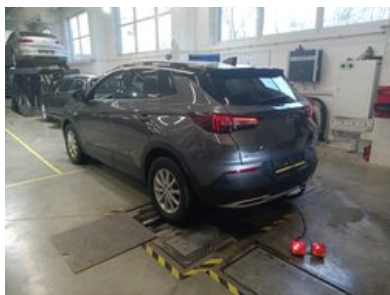
- ✓ 1. Add AdBlue
- ✓ 2. Diagnostic Photo
