# Diagnosis report of 2019 PEUGEOT 5008 Premium

During the comprehensive diagnosis conducted by Longo, 8 issues were identified in the vehicle.

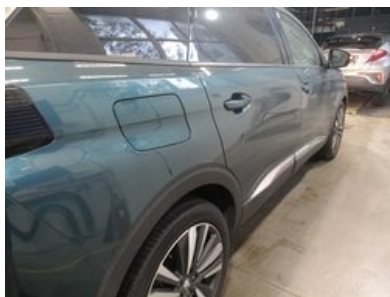
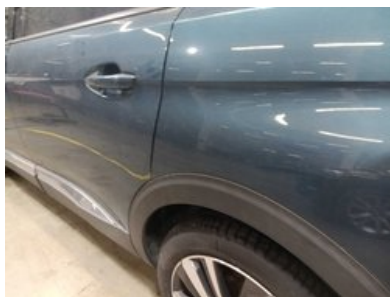
- ✓ **1. Side:** Left and Right Side - Visual Damage and Scratches

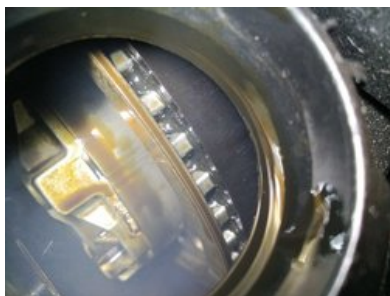
- ✓ **1. ENGINE:** Camshaft Drive Belt

- ✓ 1. Charge Battery
- ✓ 2. Camshaft Drive Belt
- ✓ 3. Auxiliary Drive Belt
- ✓ 4. Engine Oil & Filter Change

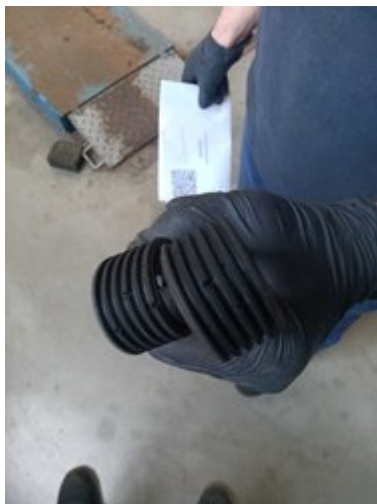
- ✓ **2. ENGINE:** Auxiliary Drive Belt

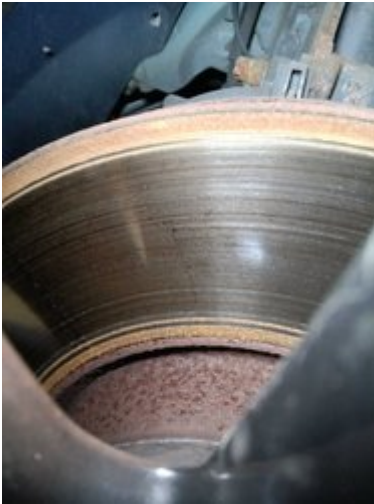
✓ **3. BRAKES:** Front Brake Discs Both

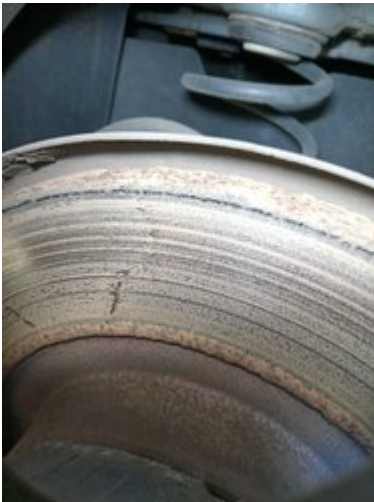
✓ **4. BRAKES:** Rear Brake Disc (Both)

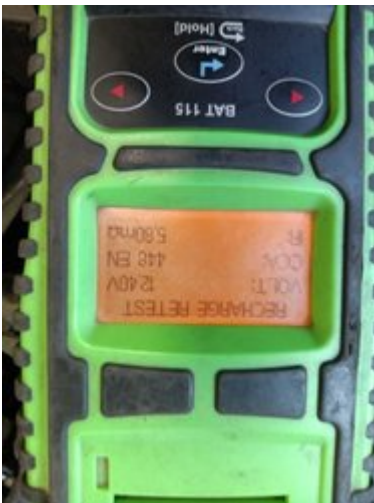
✓ **5. OTHER:** Charge Battery

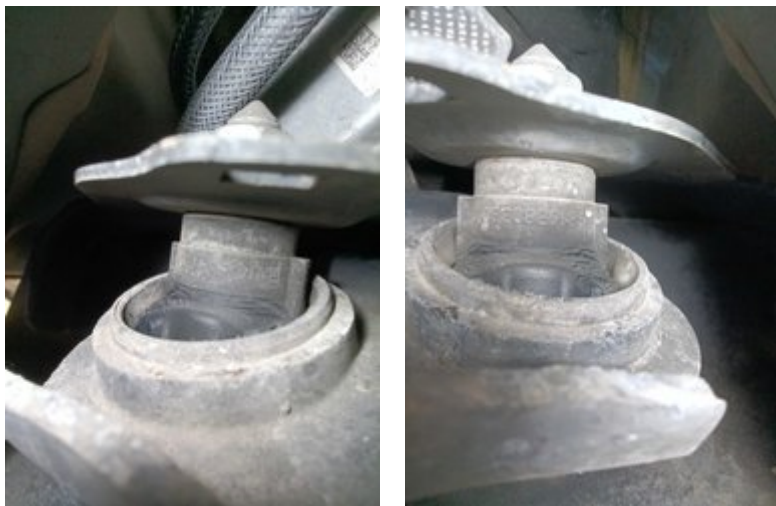
## ✓ 7. SUSPENSION: Suspension Lower Arm Both
