# Diagnosis report of 2021 NISSAN LEAF Acenta 40 kWh

## Diagnosis details

## Summary of diagnosed issues

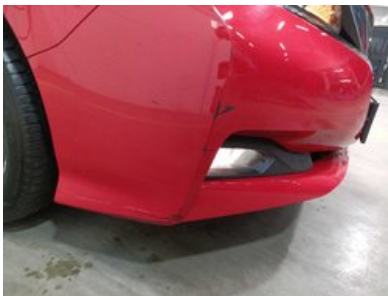
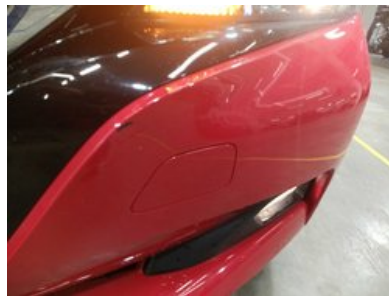
- ✔ **1. Front:** Front Bumper - Condition and Alignment

- ✓ 1. Paint Rear Fender
- ✓ 2. Paint Door
- ✓ 3. Paint Front Bumper
- ✓ 4. Paint Rear Bumper

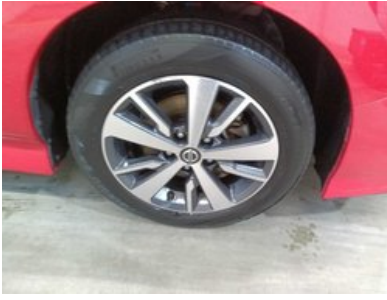
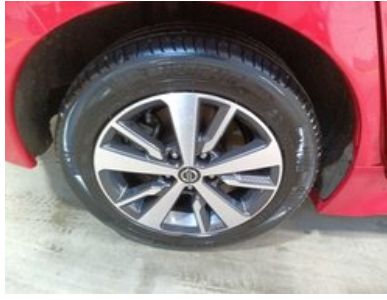
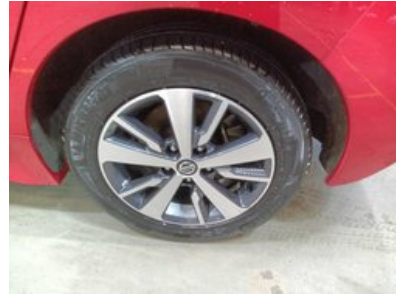
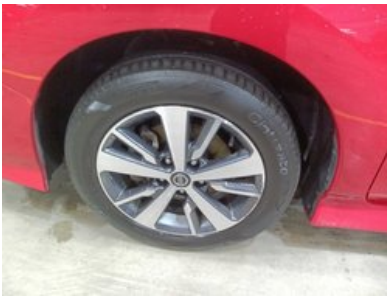
✔ **2. Side:** Wheels - Condition

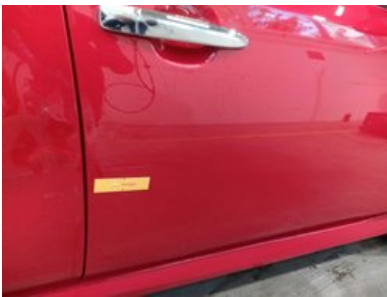
✔ **3. Side:** Left and Right Side - Visual Damage and Scratches

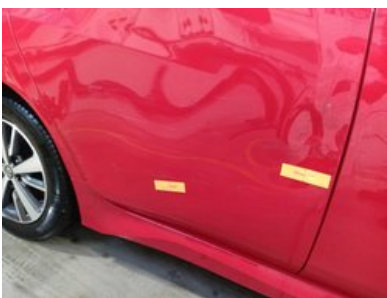
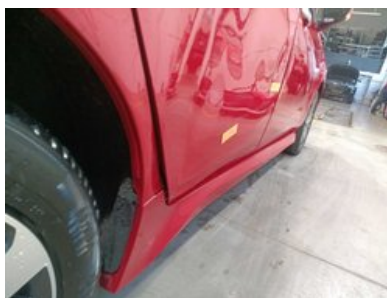
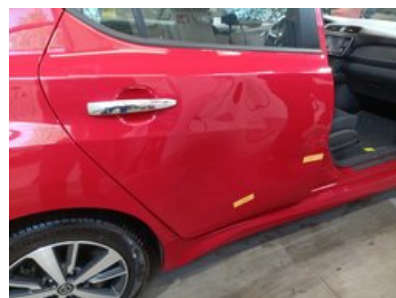
✔ **4. Side:** Left and Right Side - Visual Damage and Scratches

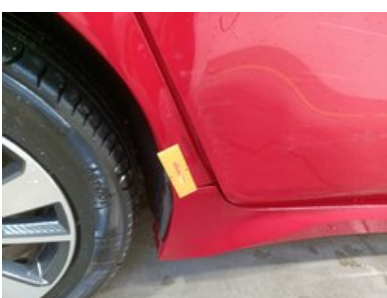
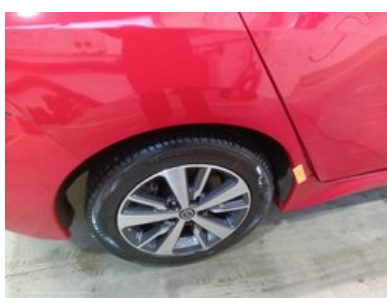
✔ **5. Side:** Left and Right Side - Visual Damage and Scratches

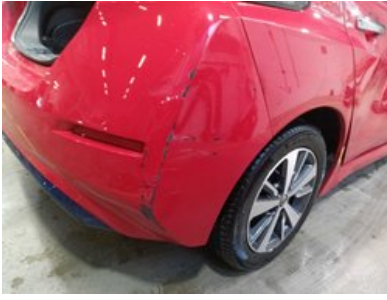
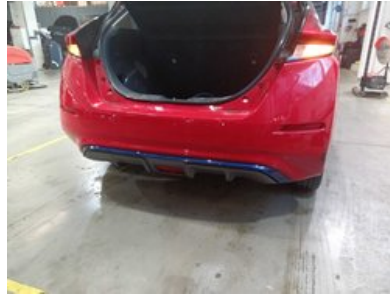
✔ **6. Rear:** Rear Bumper - Condition and Alignment

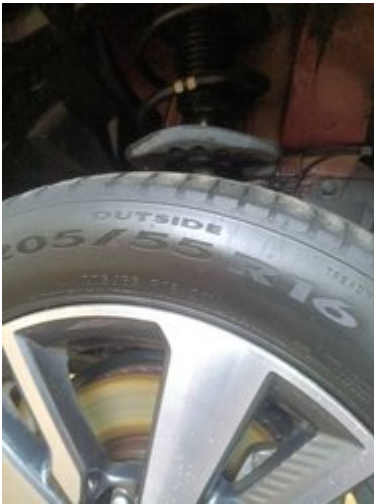
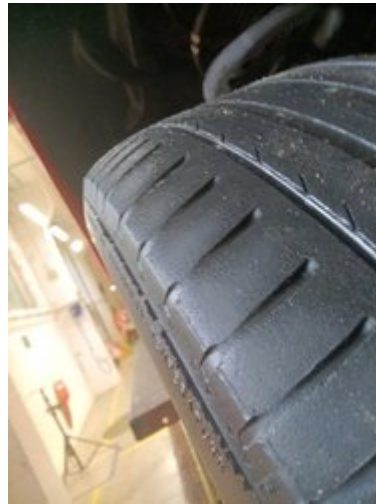
✔ **1. OTHER:** Change Tires

- ✓ 1. Change Tires
