# Diagnosis report of 2019 PEUGEOT 3008 GT Line

During the comprehensive diagnosis conducted by Longo, 7 issues were identified in the vehicle.

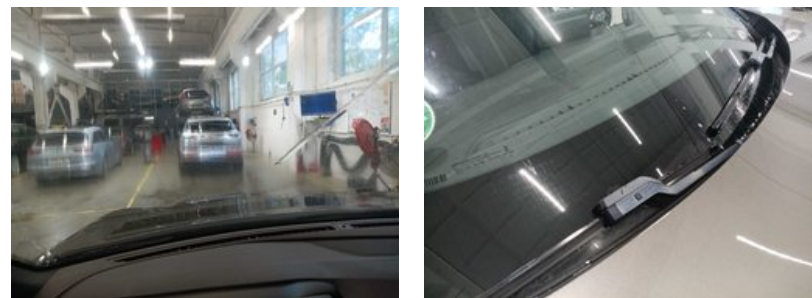
- ✔ 1. Front: Window Wiper Rubber and Handle (Front and Rear) - Condition

- ✓ 1. Change Front Wiper (Mechanical)
- ✓ 2. Engine Oil & Filter Change

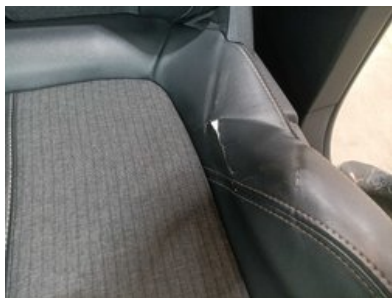
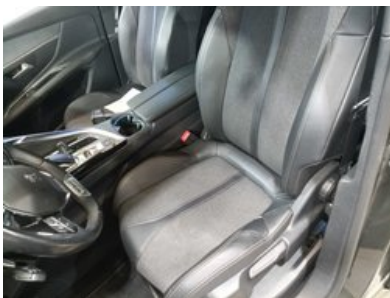
✓ **2. Seats:** All Seats - Condition

- ✓ 1. Sew Front Seat

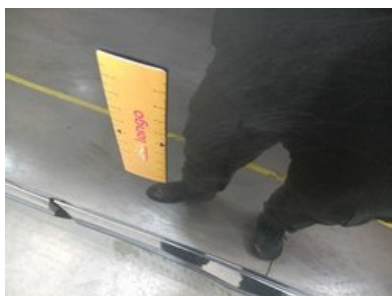
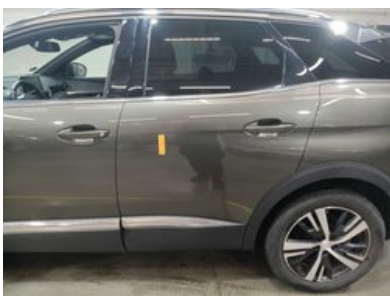
✓ **1. Other:** Additional Polishing Tasks

- ✓ 1. Body wet wash
- ✓ 2. Full interior deep clean using only hypoallergenic cleaning products
- ✓ 3. Post cleaning body polish

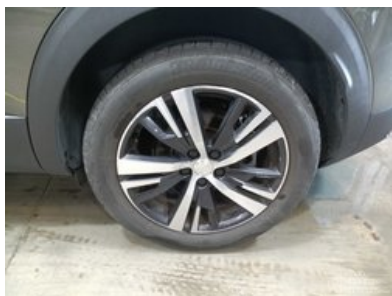
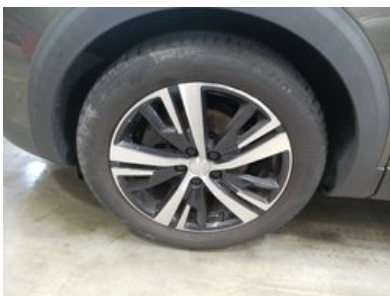
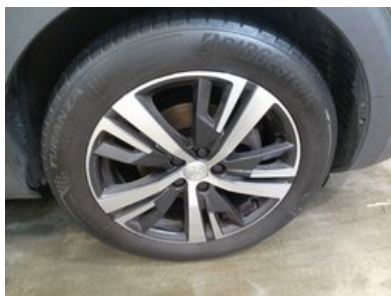
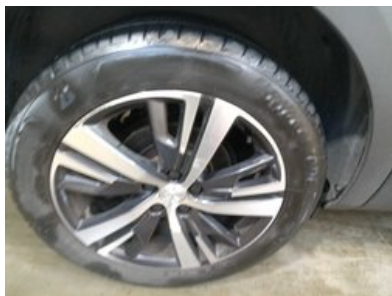
✓ **2. Side:** Wheels - Condition

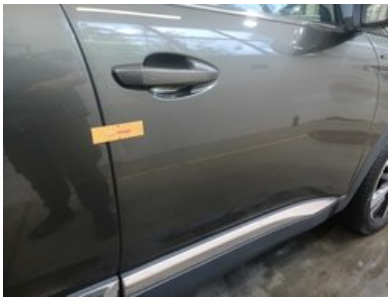
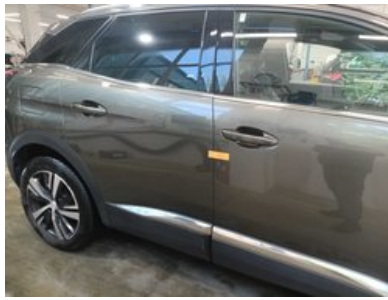
✓ **3. Side:** Left and Right Side - Visual Damage and Scratches

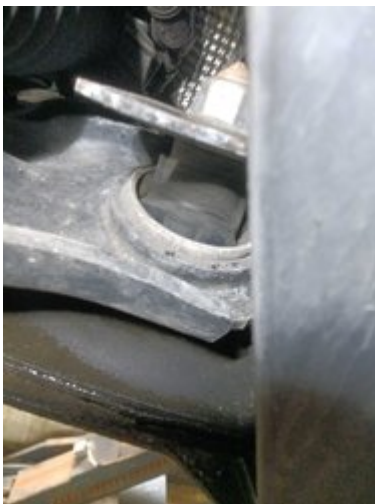
✓ **2. SUSPENSION:** Suspension Lower Arm Rear Both
