# Diagnosis report of 2018 PEUGEOT 308 Executive

# Preparation and repair report of 2018 PEUGEOT 308 Executive

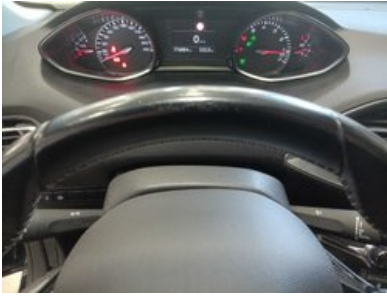
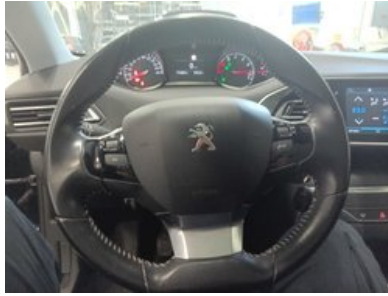
### ✓ 1. Front: Steering Wheel - Condition

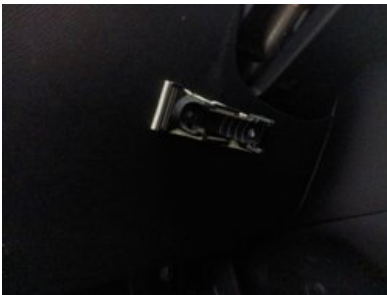
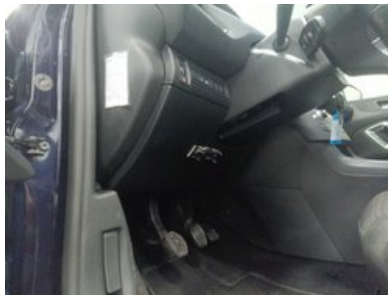
### ✓ 2. Front: Trims - Condition

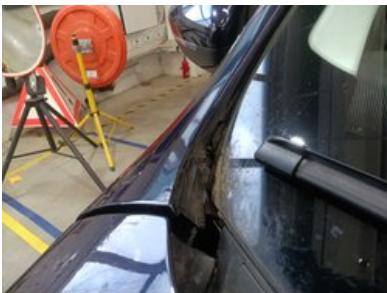
### ✓ 2. Front: Windscreen Integrity - Free from MOT-Excluding Damage

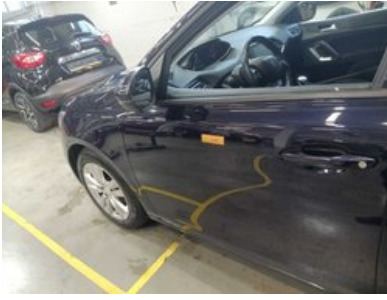
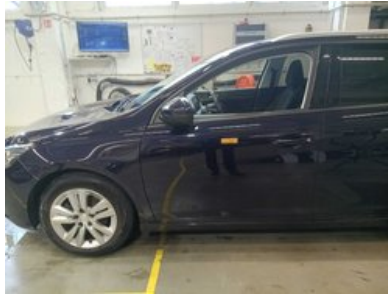
✔ **7. Side:** Left and Right Side - Visual Damage and Scratches
