# Diagnosis report of 2018 HYUNDAI IONIQ Executive

During the comprehensive diagnosis conducted by Longo, 7 issues were identified in the vehicle.

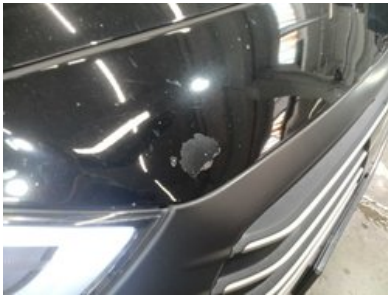
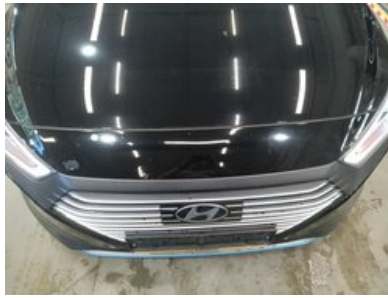
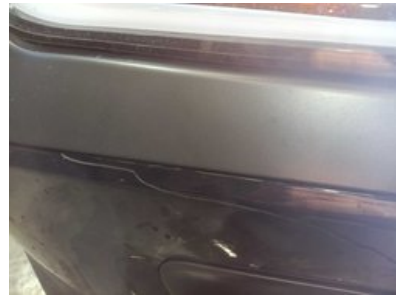
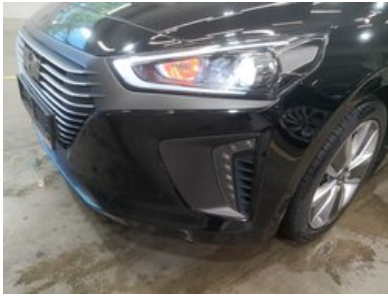
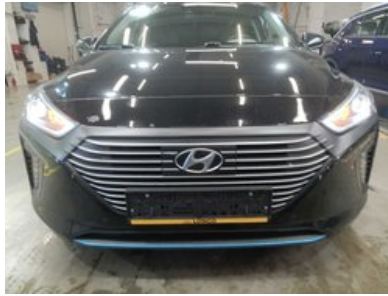
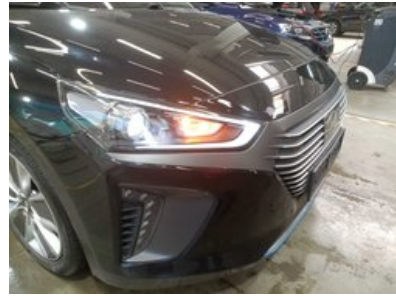
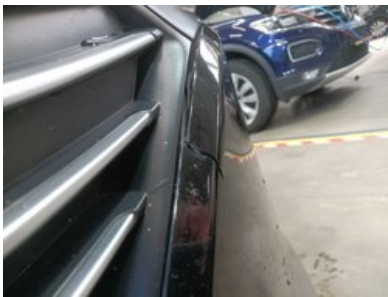
### ✓ 1. Front: Front Bumper - Condition and Alignment

- ✓ 1. Paint Front Bumper

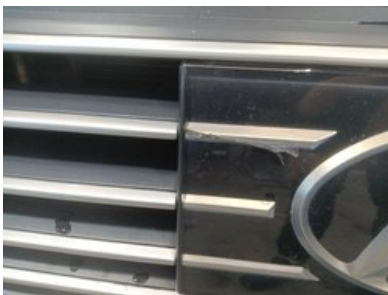
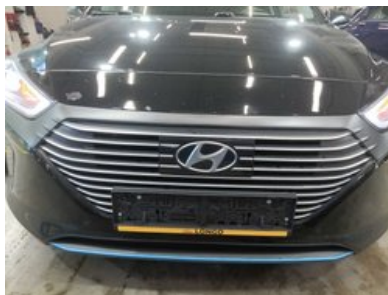
### ✓ 2. Front: Front Grille - Condition

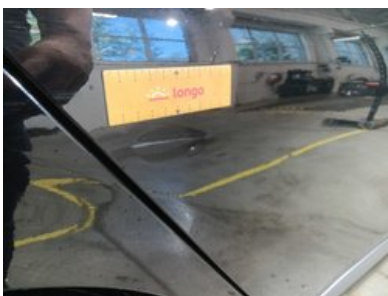
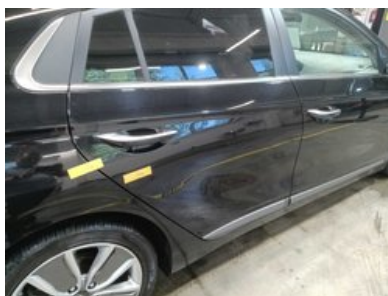
### ✓ 3. Side: Left and Right Side - Visual Damage and Scratches

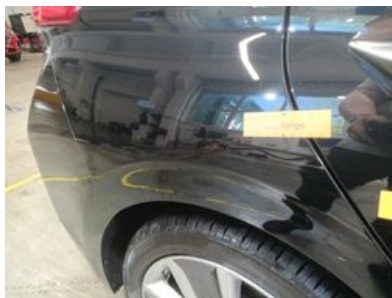
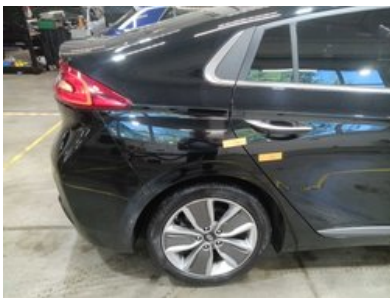
✓ **4. Side:** Left and Right Side - Visual Damage and Scratches

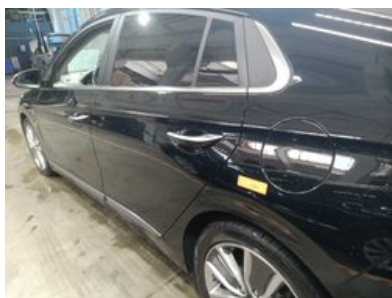
✓ **5. Side:** Left and Right Side - Visual Damage and Scratches

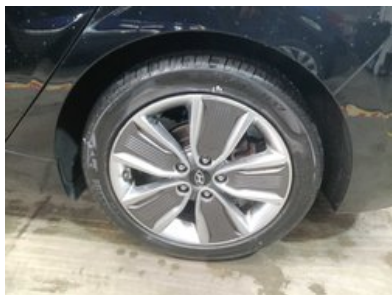
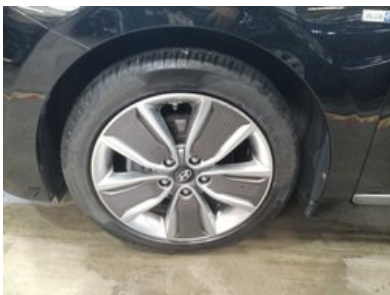
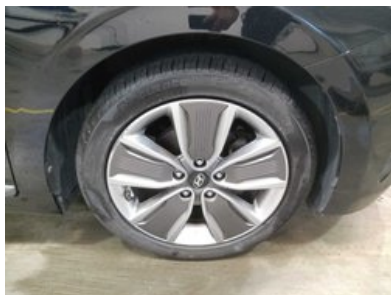
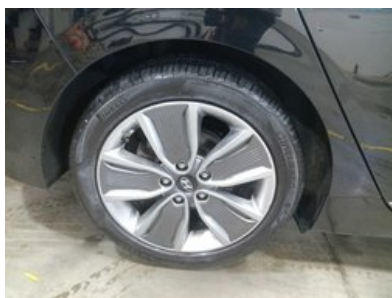
✓ **6. Side:** Wheels - Condition
