# Diagnosis report of 2018 PEUGEOT 2008 Allure

During the comprehensive diagnosis conducted by Longo, 14 issues were identified in the vehicle.

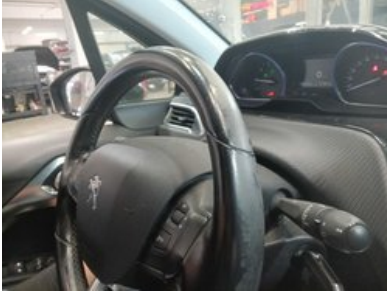
- ✓ **1. Front:** Steering Wheel - Condition

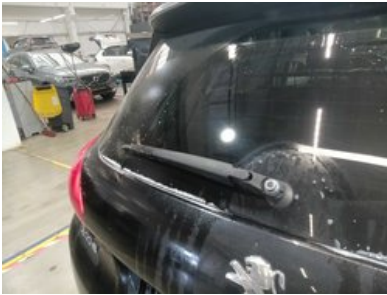
- ✓ **2. Front:** Window Wiper Rubber and Handle (Front and Rear) - Condition

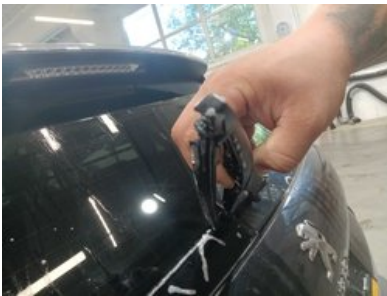
- ✓ **3. Front:** Window Wiper Rubber and Handle (Front and Rear) - Condition

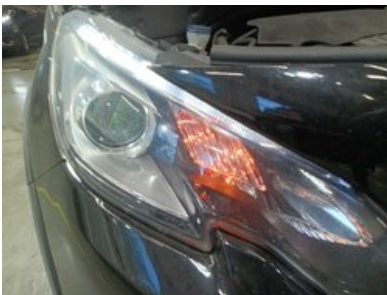
- ✓ **1. Lights:** Light Bulbs

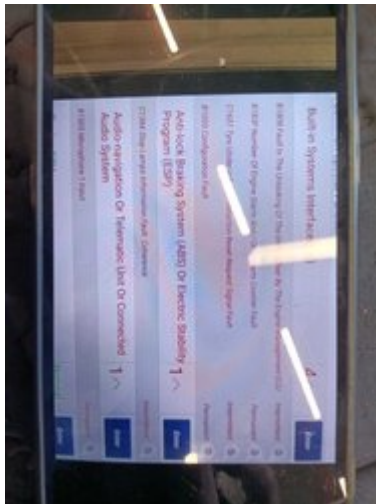
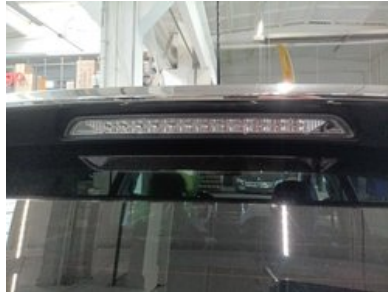
✔ **2. Lights:** Rear Lights (Brake, Fog, Indicator) - Basic Functioning, Damage, and Color

- ✓ 1. Change Brake Lights

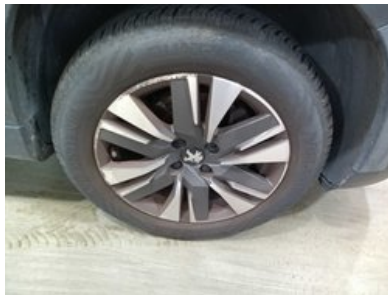
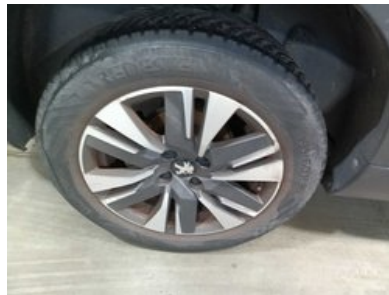
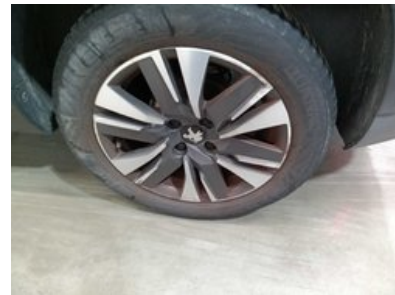
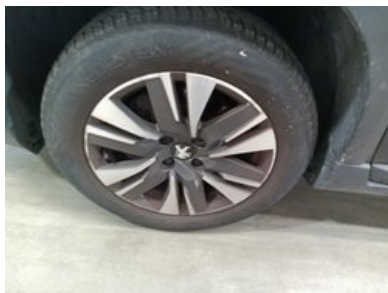
✔ **3. Side:** Wheels - Condition

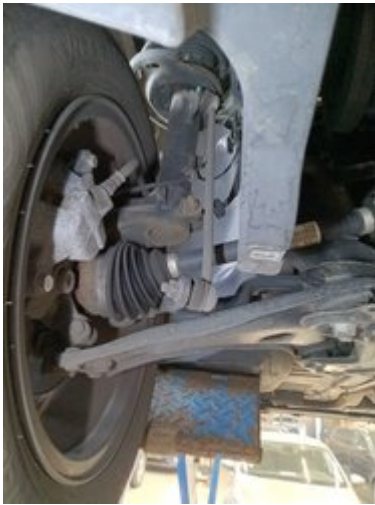
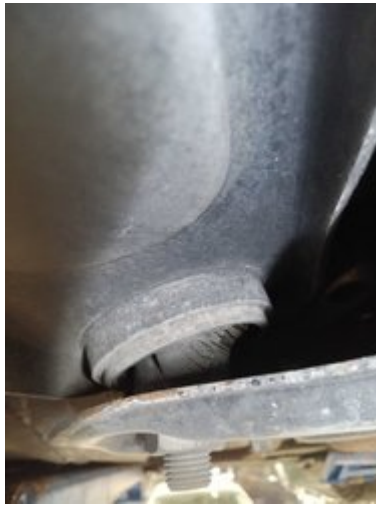
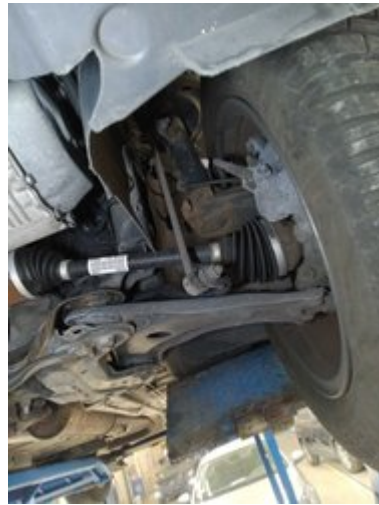
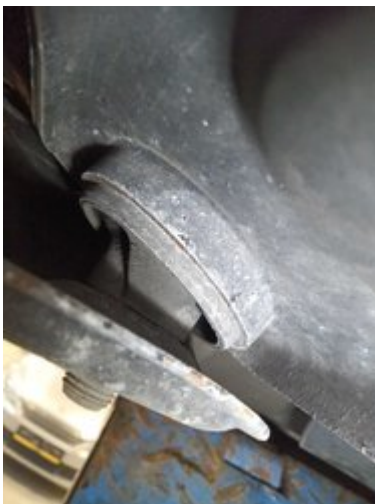
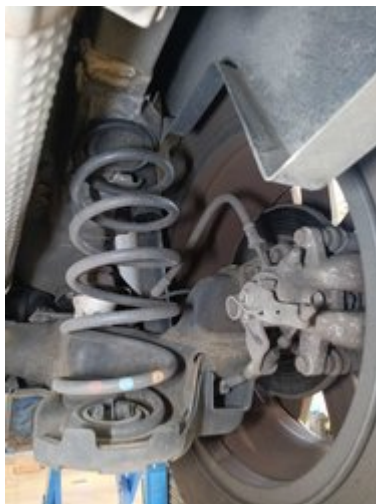
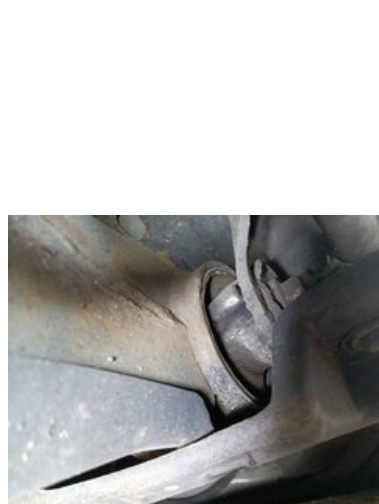
### ✓ 1. SUSPENSION: Suspension Condition

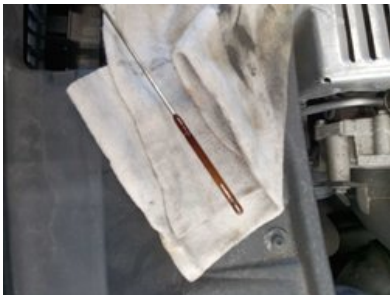
✓ **2. OTHER:** Engine Oil & Filter Change

- ✓ 1. Engine Oil & Filter Change
- ✓ 2. Other: Fix Coolant Level
- ✓ 3. Change Bulb for Headlights
- ✓ 4. Change Tires
- ✓ 5. Brake Lamp Switch

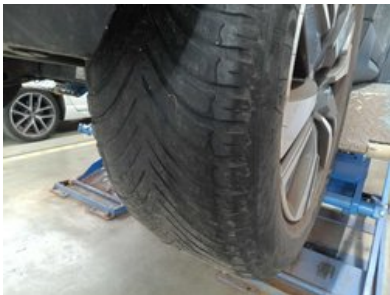
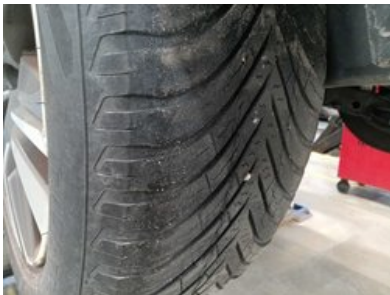
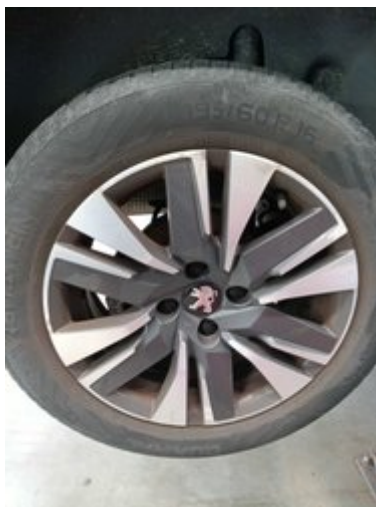
✓ **3. OTHER:** Change Tires

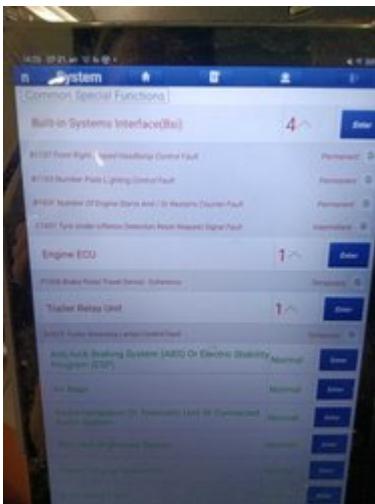
✓ **4. OTHER:** Check Failures

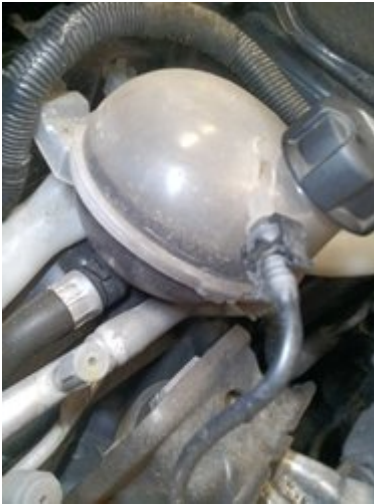
✓ **5. COOLING SYSTEM:** Fix Coolant Level

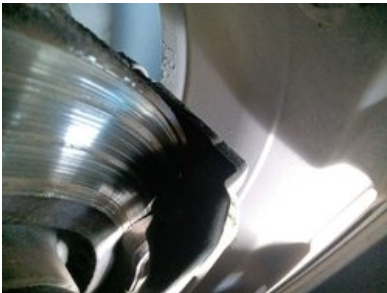
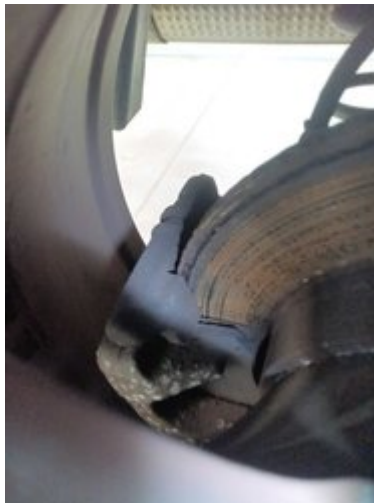
✓ **6. BRAKES:** Brakes Condition

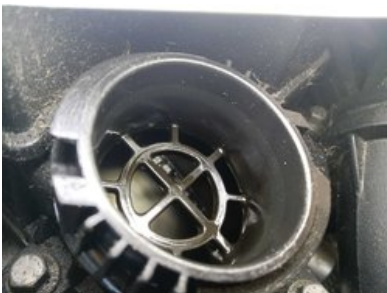
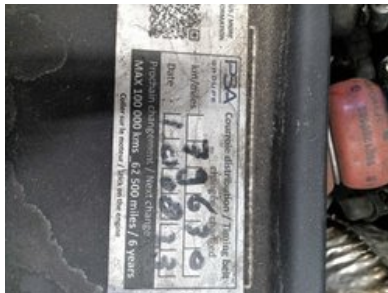
✓ **7. ENGINE:** Camshaft Drive Belt

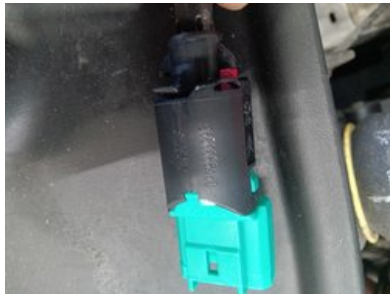
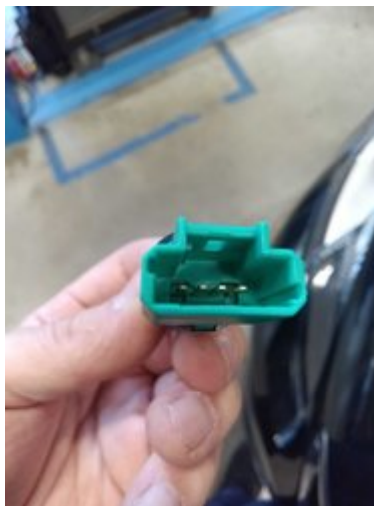
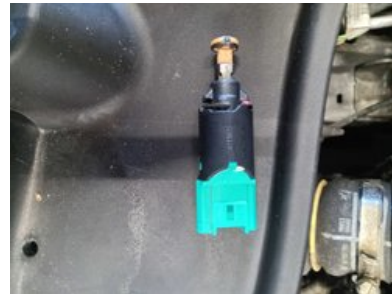
## ✓ 8. GENERAL ELECTRICS: Brake Lamp Switch
