Diagnosis report of 2018 PEUGEOT 3008 GT Line

Preparation and repair report of 2018 PEUGEOT 3008 GT Line

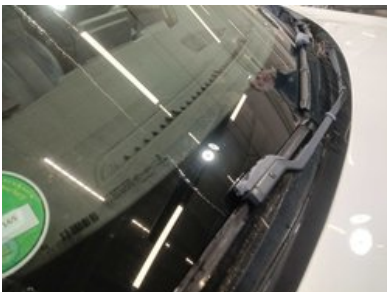
- ✔ **1. Front:** Window Wiper Rubber and Handle (Front and Rear) - Condition

- ✓ 1. Engine Oil & Filter Change
- ✓ 2. Charge Battery
- ✓ 3. Change Front Wiper (Mechanical)

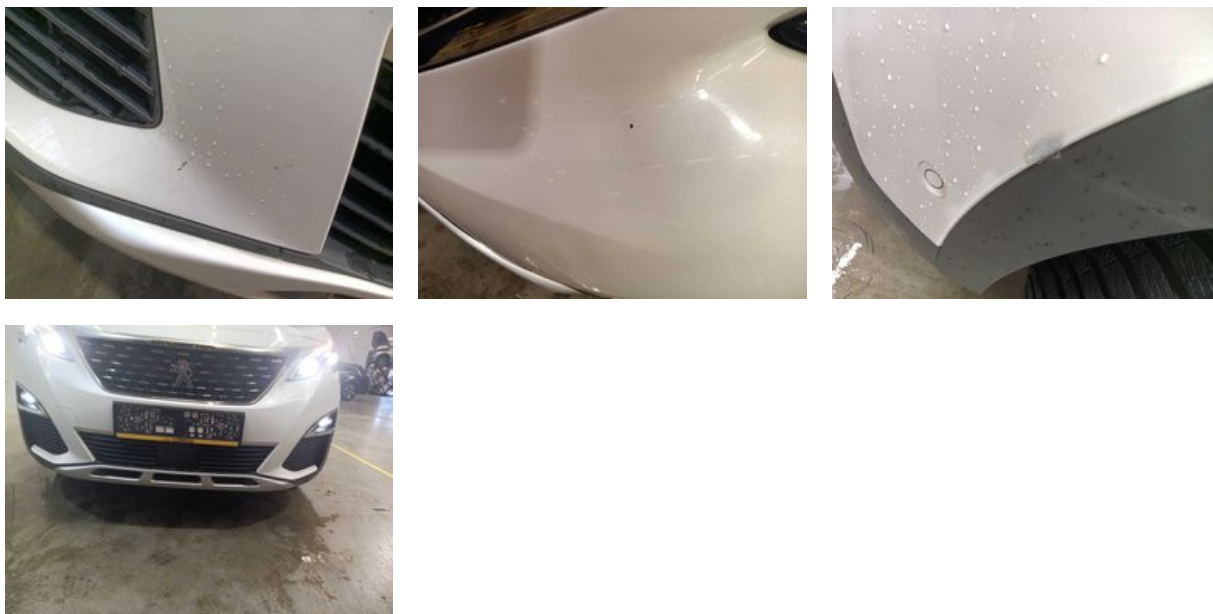
✓ 1. Front: Front Bumper - Condition and Alignment

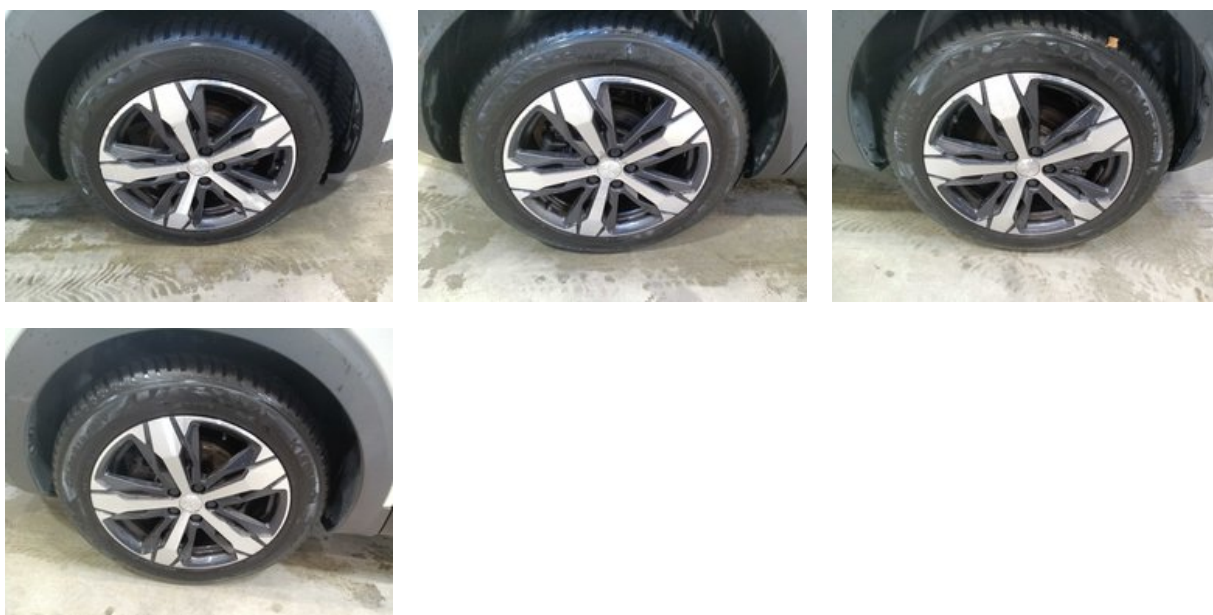
✓ 2. Side: Wheels - Condition

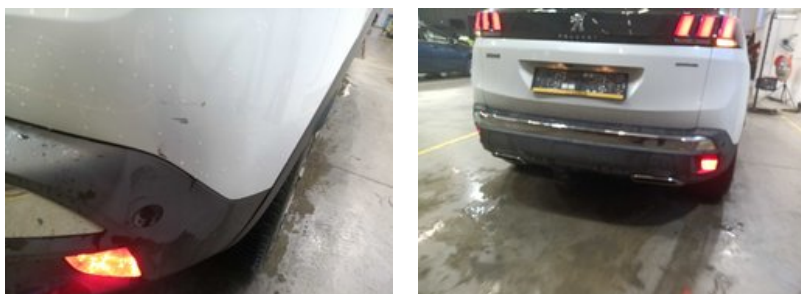
✓ 3. Rear: Rear Bumper - Condition and Alignment

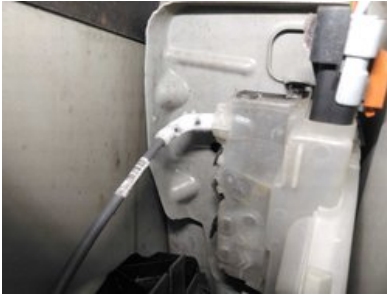
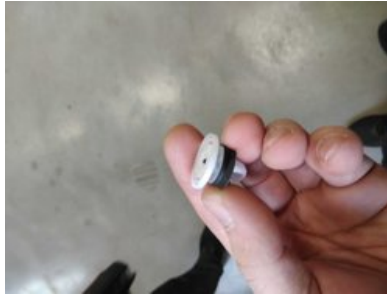
✔ **4. Other:** Door and Trunk Locking Mechanisms Including Fuel Hatch

- ✓ 1. Change Door Lock

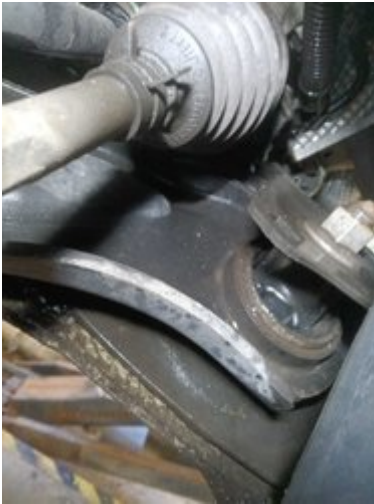
✔ **3. SUSPENSION:** Suspension Lower Arm Bushes
