# Diagnosis report of 2019 PEUGEOT 3008 Executive

# Preparation and repair report of 2019 PEUGEOT 3008 Executive

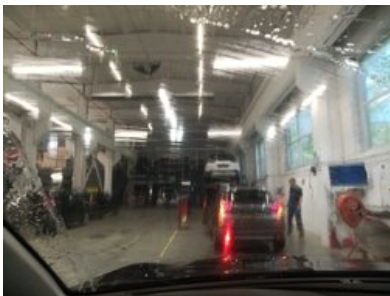
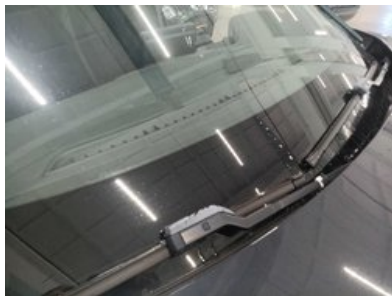
- ✔ **1. Front:** Window Wiper Rubber and Handle (Front and Rear) - Condition

- ✓ 1. Change Front Wiper (Mechanical)
- ✓ 2. Engine Oil & Filter Change
- ✓ 3. Camshaft Drive Belt

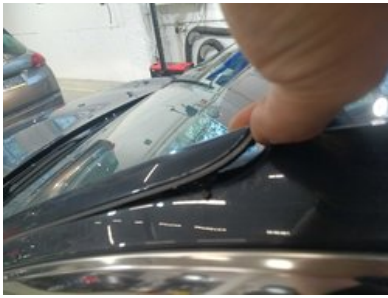
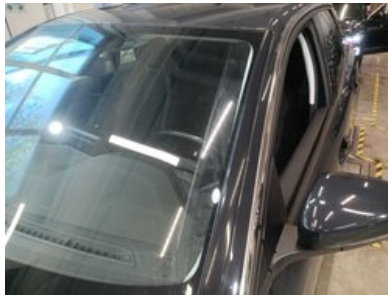
- ✓ **1. Front:** Windscreen Integrity - Free from MOT-Excluding Damage

- ✓ 1. Trim Around Windshield

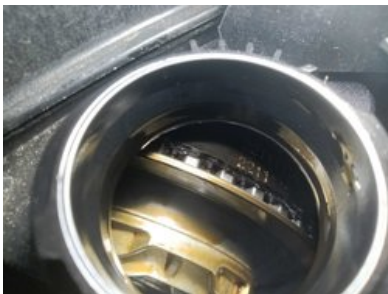
- ✓ **1. ENGINE:** Camshaft Drive Belt
