Diagnosis report of 2019 PEUGEOT 2008 Allure

This vehicle has been inspected in accordance with the Longo 150-point checklist, covering the body exterior, interior, and mechanical condition. Based on the inspection performed and the information available at the time of assessment, no indications of involvement in major accidents were identified. Information regarding maintenance history and mandatory roadworthiness inspections is based on available documentation and records from the country of export. Please note that certain general wear and tear issues are considered acceptable and may not be repaired.

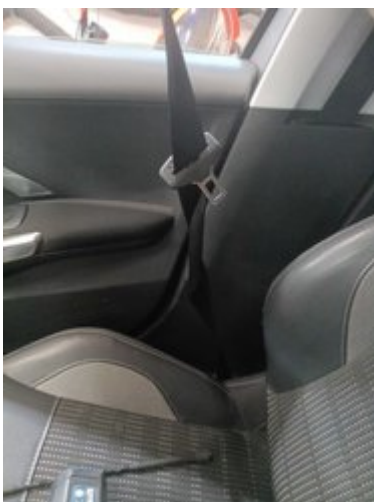
- ✔ **1. Seats:** Seatbelts - Functioning and Locking Mechanism

- ✓ 1. Change Lights on Car Side
- ✓ 2. Change Seatbelts / Mountings

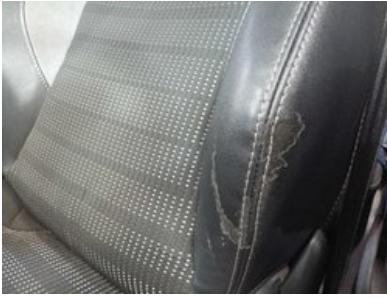
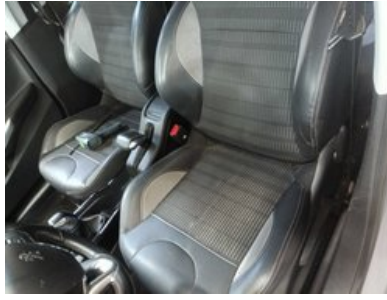
✔ **2. Seats:** All Seats - Condition

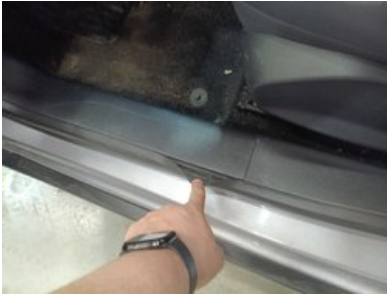
✔ **3. Doors:** Door Rubber Seals

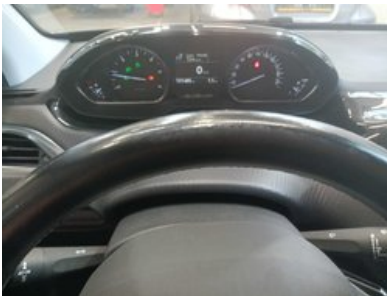
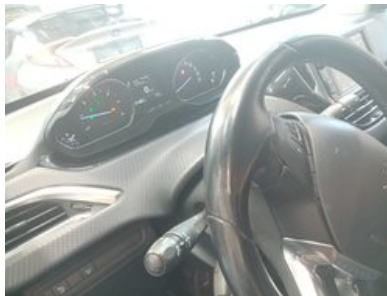
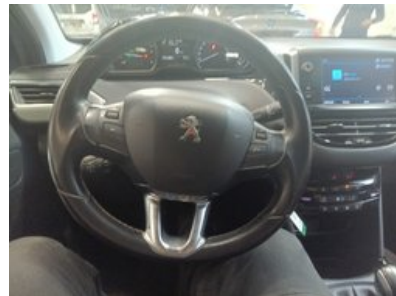
✔ **4. Front:** Steering Wheel - Condition

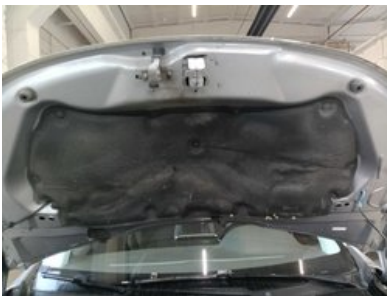
✔ **1. Front:** Hood Sound Insulation - Condition

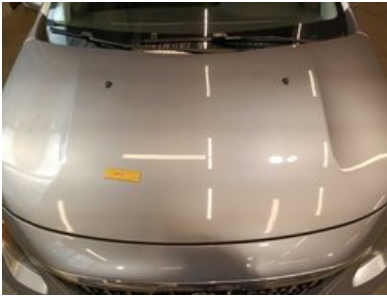
✔ **2. Front:** Hood - Visual Damage

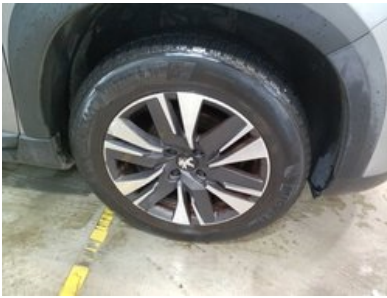
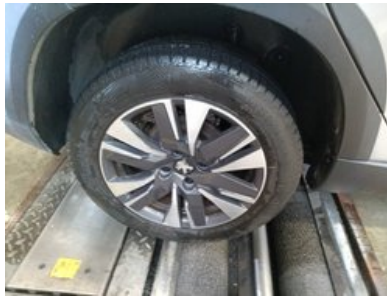
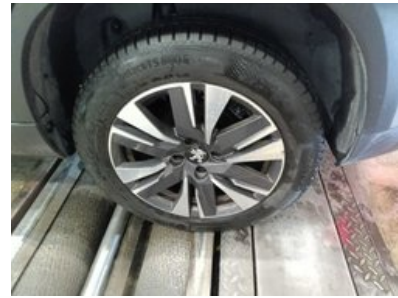
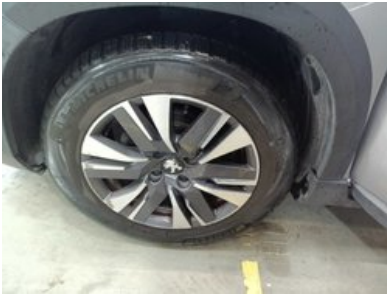
✔ **3. Side:** Wheels - Condition

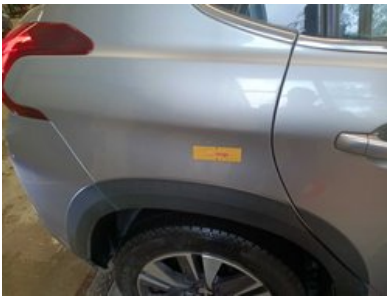
✔ **4. Side:** Left and Right Side - Visual Damage and Scratches

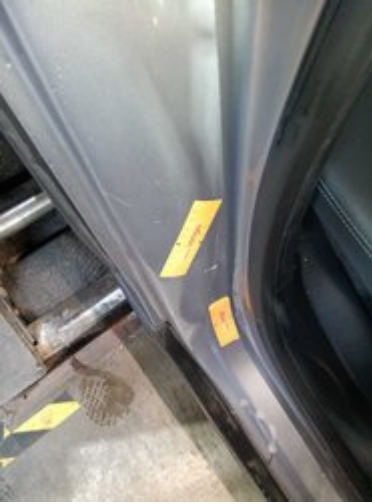
✓ **5. Side:** Left and Right Side - Visual Damage and Scratches

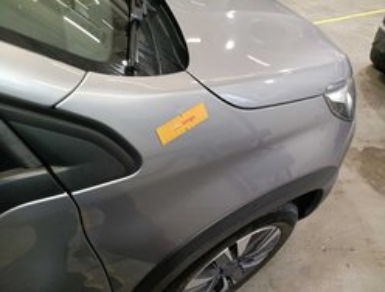
✓ **6. Side:** Left and Right Side - Visual Damage and Scratches

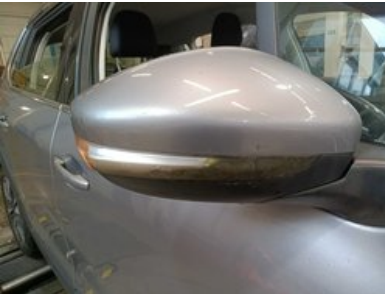
✓ **7. Lights:** Car Side Lights - Basic Functioning, Damage, and Color

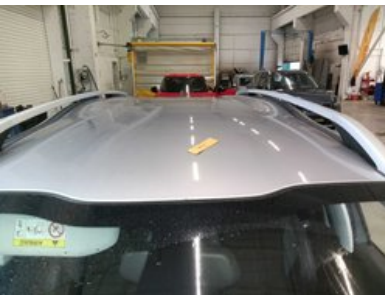
✓ **8. Other:** Roof - Visual Damage (e.g., Hail Damage)

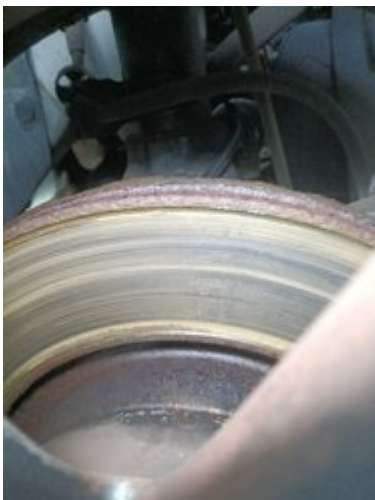
✓ **1. BRAKES:** Front Brake Discs Both

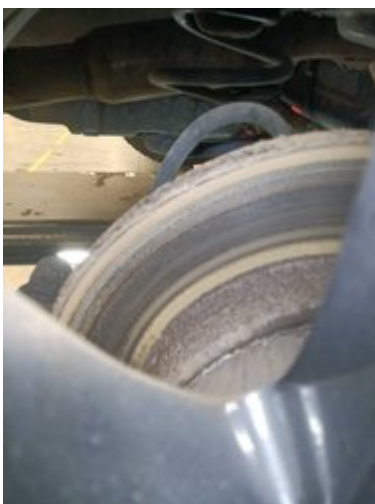
✓ **2. BRAKES:** Rear Brake Disc (Both)

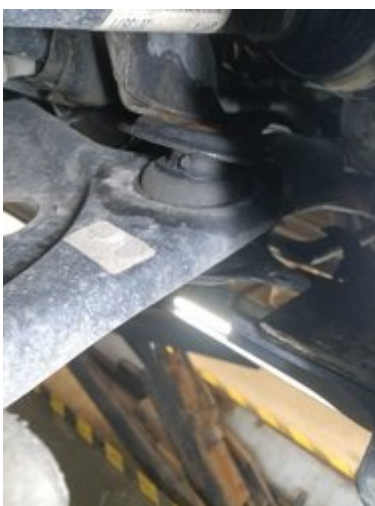
✓ **3. SUSPENSION:** Suspension Lower Arm Both
