# Diagnosis report of 2021 HYUNDAI TUCSON MHEV Ultimate

2021 HYUNDAI TUCSON MHEV Ultimate

Diagnosis details

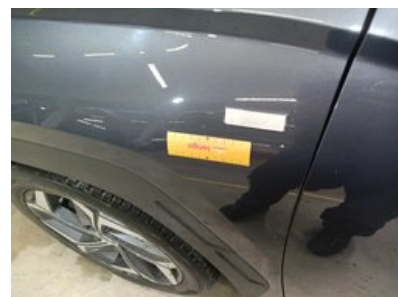
- ✔ 1. Side: Left and Right Side - Visual Damage and Scratches

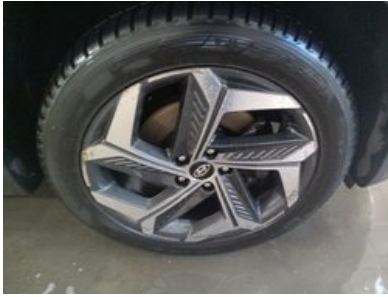
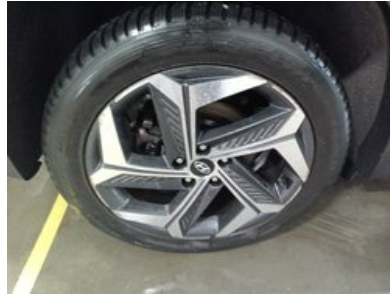
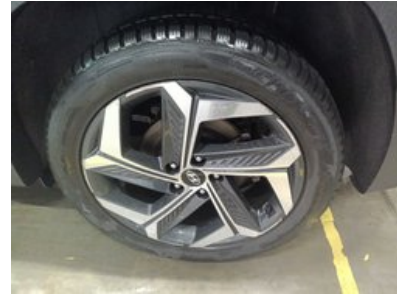
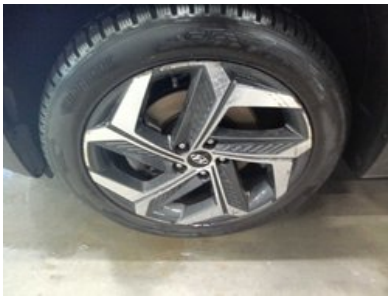
✓ **2. Side: Wheels - Condition**
