# Diagnosis report of 2017 PEUGEOT 2008 Allure

During the comprehensive diagnosis conducted by Longo, 10 issues were identified in the vehicle.

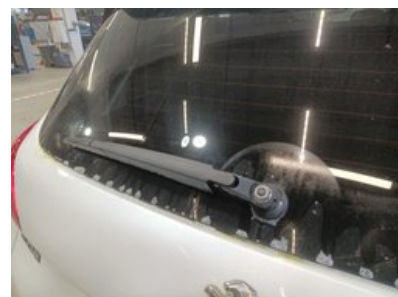
- ✔ 1. Front: Window Wiper Rubber and Handle (Front and Rear) - Condition

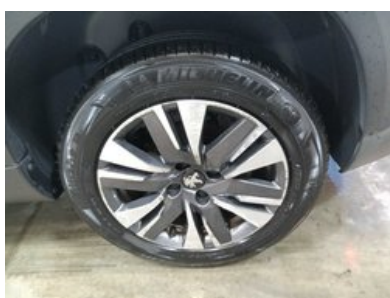
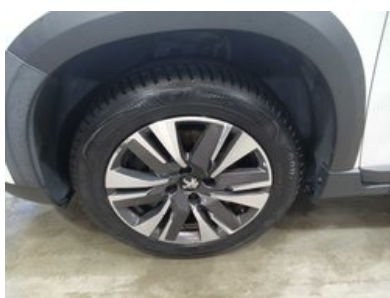
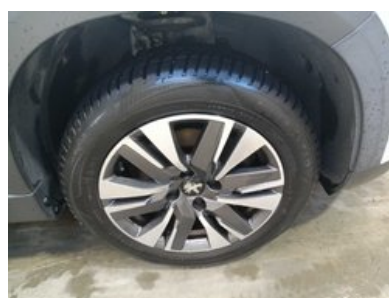
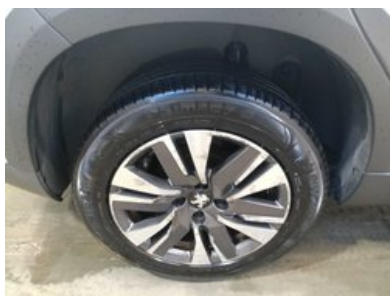
### ✓ 2. Side: Wheels - Condition

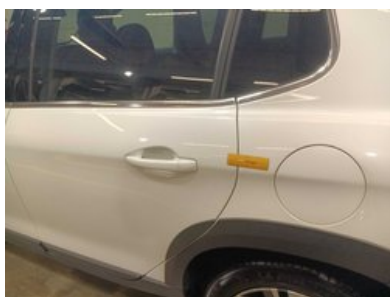
### ✓ 3. Side: Left and Right Side - Visual Damage and Scratches

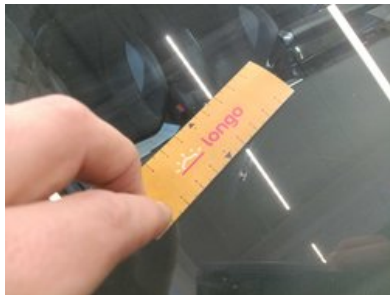
✓ **4. Front:** Windscreen Integrity - Free from MOT-Excluding Damage

- ✓ 1. Windshield Repair

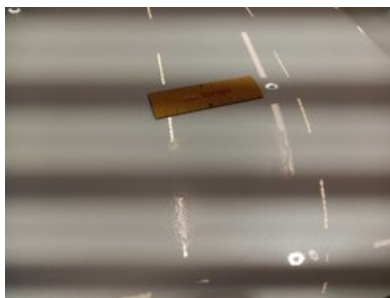
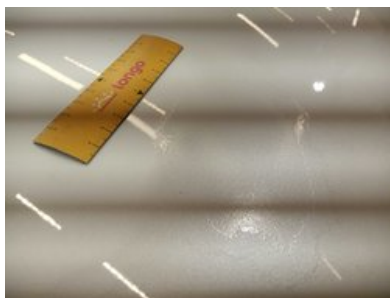
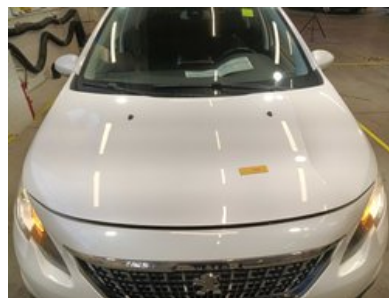
✓ **5. Front:** Hood - Visual Damage

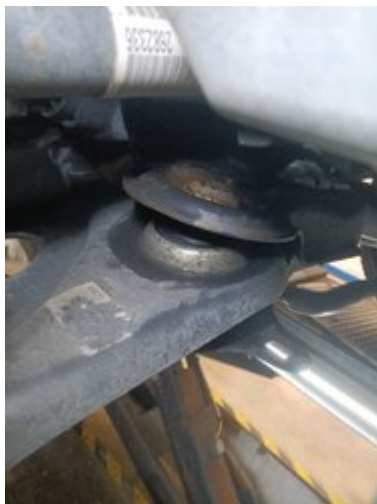
✓ **1. SUSPENSION:** Suspension Lower Arm Both

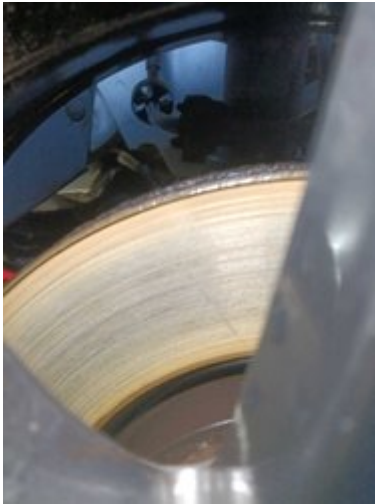
✓ **3. BRAKES:** Front Brake Discs Both

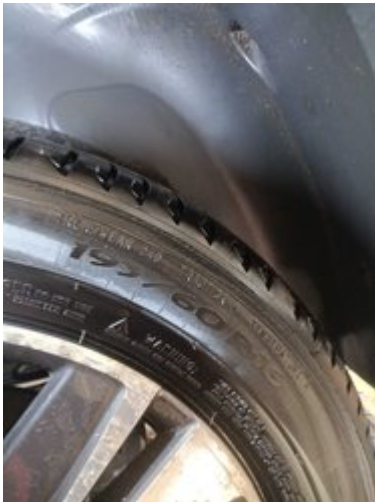
✓ **4. OTHER:** Change Tires

- ✓ 1. Change Tires

- 1. Maxtrek 195/60R16 89H Trek (MXT00009)
