# Diagnosis report of 2020 PEUGEOT 3008 GT Line

During the comprehensive diagnosis conducted by Longo, 4 issues were identified in the vehicle.

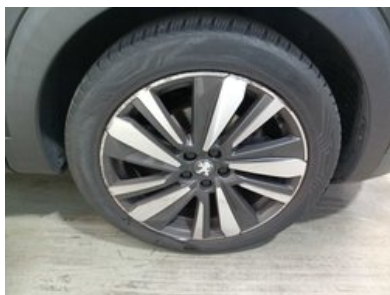
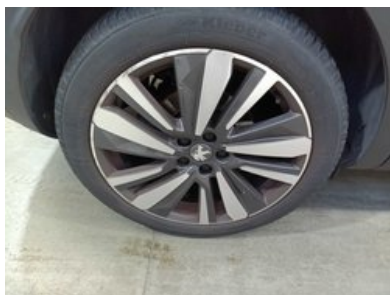
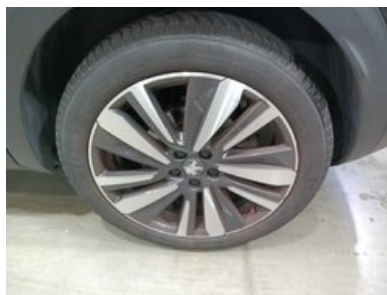
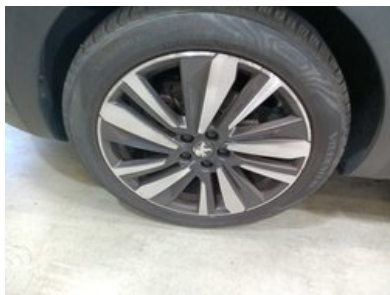
### ✓ 1. Side: Wheels - Condition

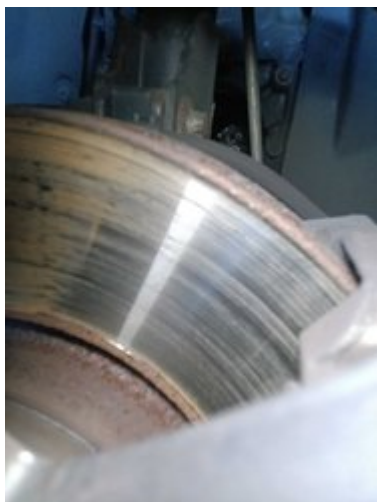
### ✓ 2. BRAKES: Front Brake Discs Both

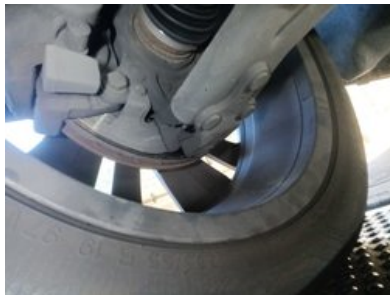
### ✓ 3. SUSPENSION: Ball Joint Lower

- ✓ 1. Ball Joint - Lower
