# Diagnosis report of 2016 SUZUKI VITARA Exclusive Allgrip

# Preparation and repair report of 2016 SUZUKI VITARA Exclusive Allgrip

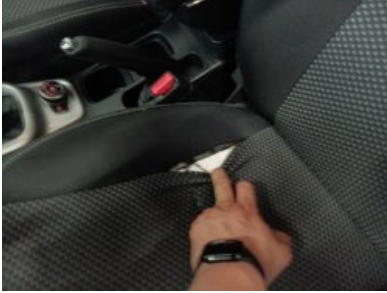
### ✓ 1. Seats: All Seats - Condition

- ✓ 1. Sew Front Seat

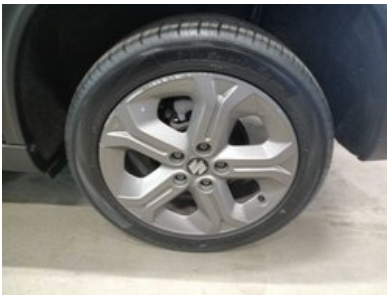
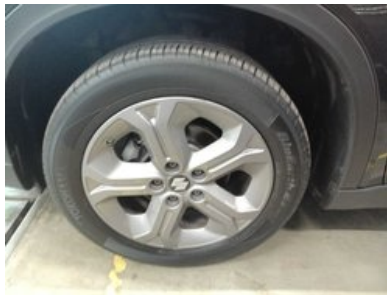
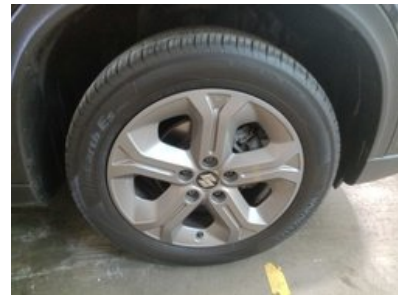
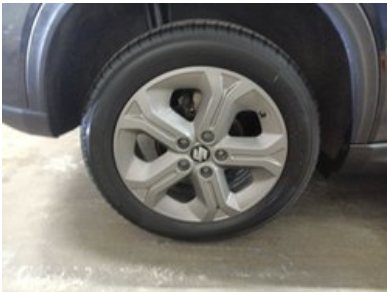
### ✓ 1. Side: Wheels - Condition

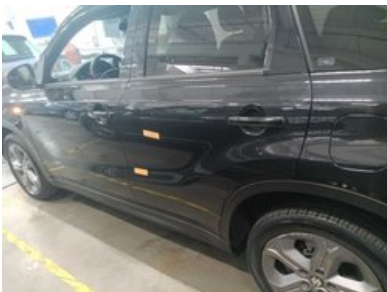
### ✓ 2. Side: Left and Right Side - Visual Damage and Scratches

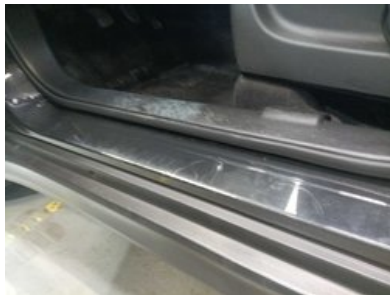
✓ **3. Side:** Left and Right Side - Visual Damage and Scratches

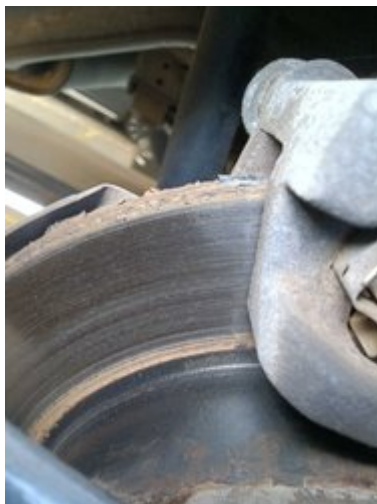
✓ **2. BRAKES:** Rear Brake Disc (Both)

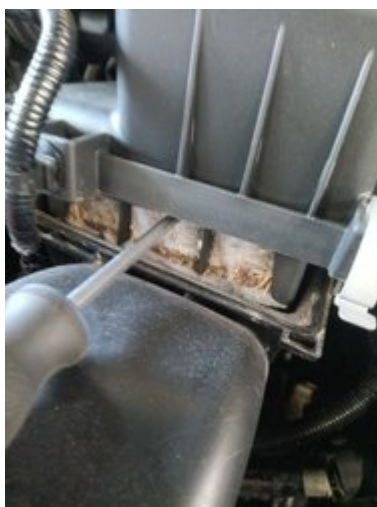
✓ **4. ENGINE MANAGEMENT - FUEL:** Air Filter Element

- ✓ 1. Engine Oil & Filter Change
- ✓ 2. Air Filter Element
- ✓ 3. Fog Lamp Adjustment
